# 2023 Data Report for

# Second Fortune Lake, Iron County

Site ID: 360177

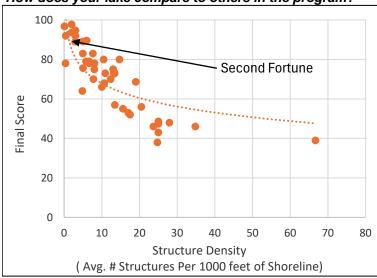
Overall, the lakeshore habitat of Second Fortune Lake is doing well and scored higher than average when compared to other lakes in the program. All of the 1000 foot sections scored either Fair or Good: 1 fair, and 9 good.

The lake sections scored high for erosion control meaning that there are a low amount of sea walls, rock rip-rap, and other shoreline erosion structures, and scored high in the riparian score, meaning that (in general) there were plentiful non-mowed areas providing a buffer between houses and roads and the lake.

The littoral zone was the weak point in Second Fortune Lake's habitat (scoring an average of 77). A score of 77 is good, but if residents of want to improve the overall shoreline quality, this is the component to concentrate on. To improve the littoral zone score, leave woody debris in place and allow native aquatic vegetation to grow in the shallow waters.

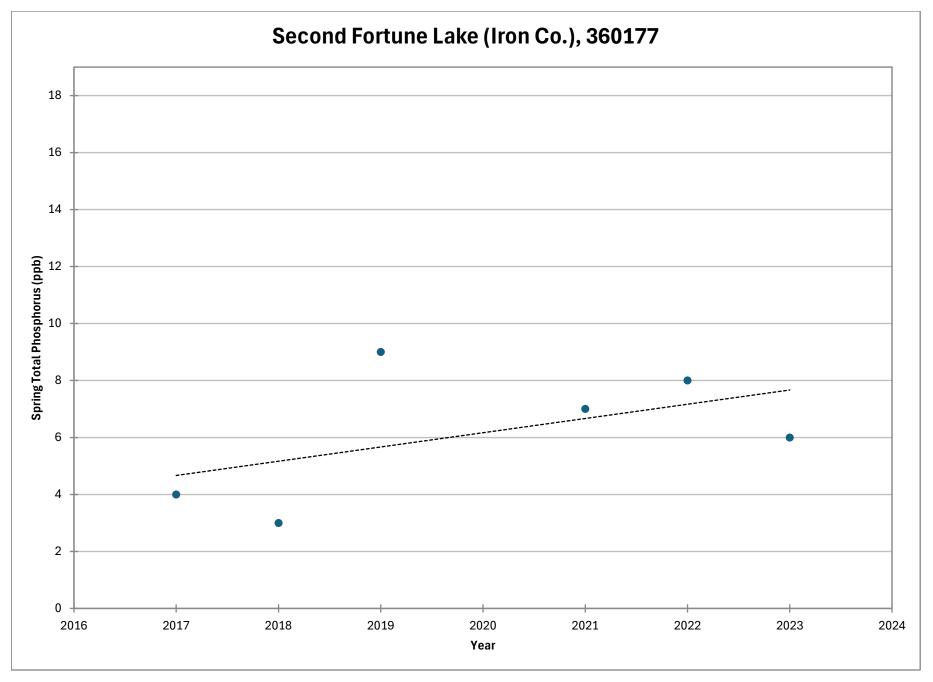
#### COOPERATIVE LAKES MONITORING PROGRAM SPRING TOTAL PHOSPHORUS

Year	# Samples	Min	Max	Average	Std. Dev	
2023	1	6.0	6.0	6.0	NA	
2018-2022	3	<=3 W	9.0	6.3	3.1	
2017	1	<5 T	<5 T	<5 T	NA	
2023 All CLMP Lakes	220	<5	220.0	20.7	21.3	
Spring Total Phosphorus (ppb) D p c 21			•		<b>.</b>	₽ =

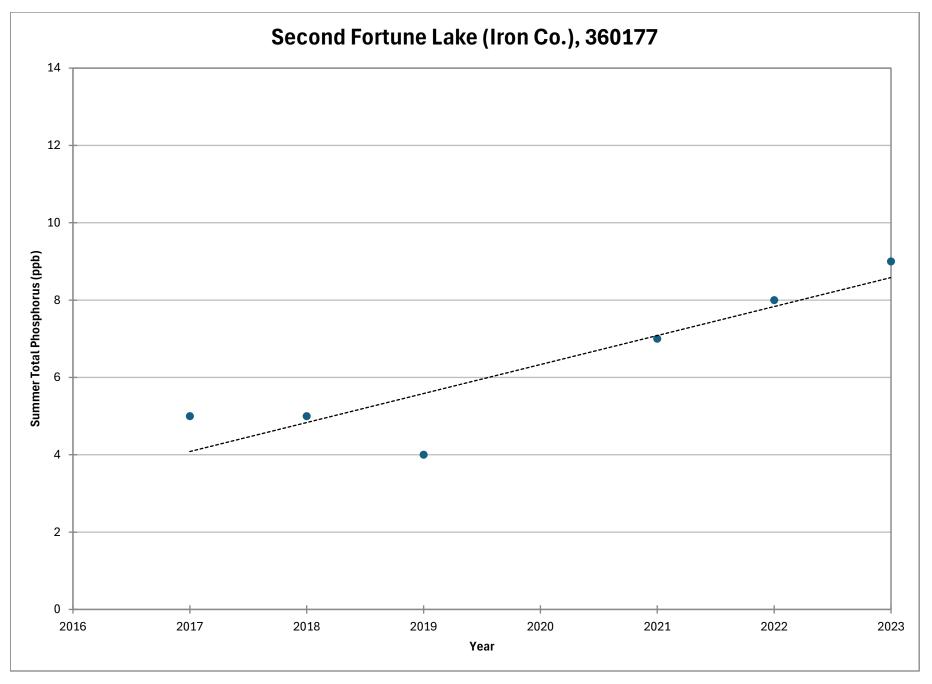
#### COOPERATIVE LAKES MONITORING PROGRAM SUMMER TOTAL PHOSPHORUS

Year	# Samples	Min	Max	Average	Std. Dev	Carlson TSI	
2023	1	9.0	9.0	9.0	NA	36	
2018-2022	3	<5 T	7.0	5.3	1.5	29	
2017	1	5.0	5.0	5.0	NA	27	
2023 All CLMP Lakes	234	<= 3	150.0	17 4	15.3	45
