2023 Data Report for

Blue Lake, Mecosta County

Site ID: 540092

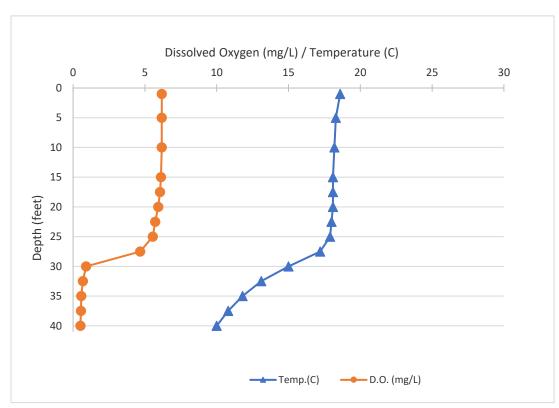
Name: Blue Lake County: Mecosta Site ID: 540092 Date: 9/14/2006

Depth (ft)	Temp.(C)	D.O. (mg/L)
1	18.6	6.18
5	18.3	6.17
10	18.2	6.17
15	18.1	6.12
17.5	18.1	6.05
20	18.1	5.93
22.5	18	5.72
25	17.9	5.55
27.5	17.2	4.67
30	15	0.91
32.5	13.1	0.68
35	11.8	0.57
37.5	10.8	0.55
40	10	0.51
