2023 Data Report for

Chippewa Lake, Mecosta County

Site ID: 540050

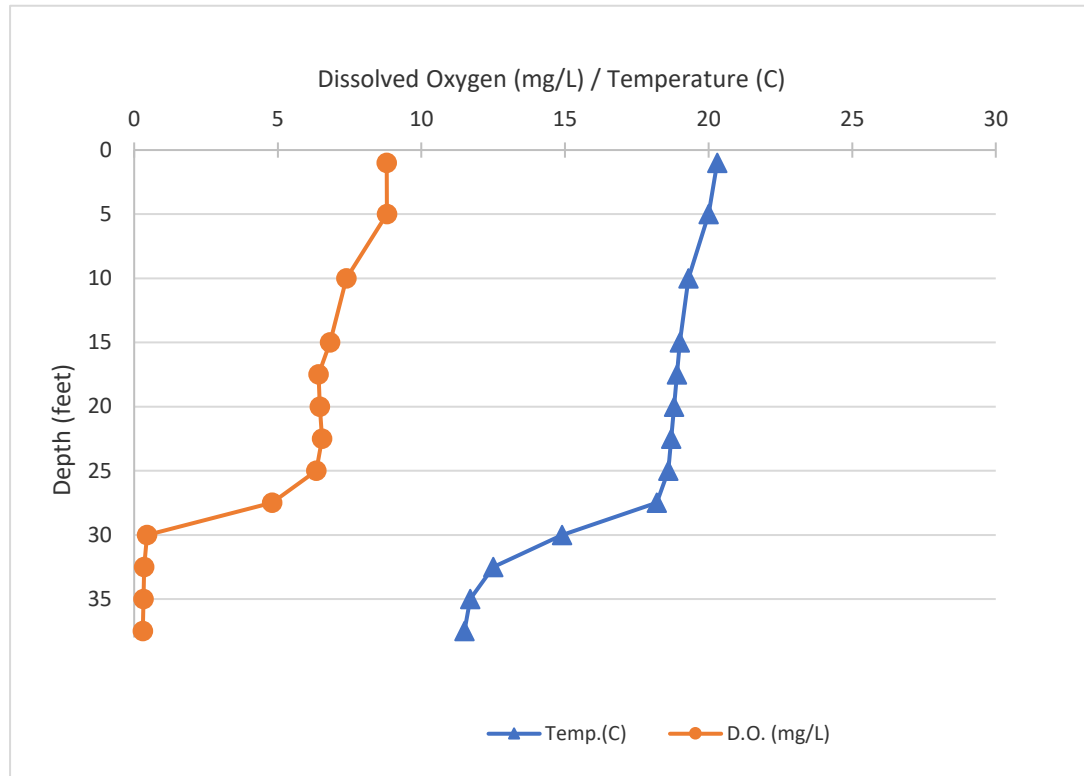
9/21/2023

Dissolved Oxygen and Temperature Profile

Depth (ft)	Temp.(C)	D.O. (mg/L)
1	20.3	8.79
5	20	8.8
10	19.3	7.39
15	19	6.82
17.5	18.9	6.42
20	18.8	6.47
22.5	18.7	6.54
25	18.6	6.34
27.5	18.2	4.8
30	14.9	0.45
32.5	12.5	0.35
35	11.7	0.32
37.5	11.5	0.3
