# 2023 Data Report for Crockery Lake, Ottawa County

Site ID: 700422

# Crockery Lake, Ottawa County 2023 CLMP Results

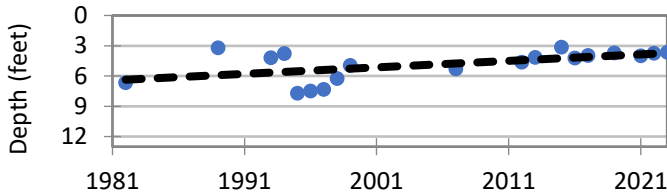
## Secchi Disk Transparency (feet)

Year	# Readings	Min	Max	Average	Std. Dev	Carlson TSI
2023	16	2.0	6.0	3.7	1.2	58
2018-2022	59	1.5	7.5	3.8	1.2	58
1982-2017	230	0.3	15.0	5.1	1.8	54
2023 All CLMP Lakes	2825	0.5	51.0	12.2	2.7	43

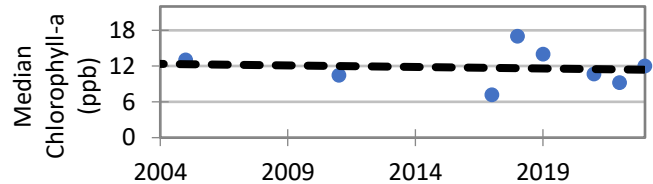
## Chlorophyll-a (parts per billion)

Year	# Samples	Min	Max	Median	Std. Dev	Carlson TSI
2023	5	<1.0	31.0	12.0	12.8	55
2018-2022	19	5.0	33.0	12.4	6.9	55
2001-2017	28	2.0	100.0	12.4	13.7	54
2023 All CLMP Lakes	687	< 1.0	43.0	3.7	5.3	43

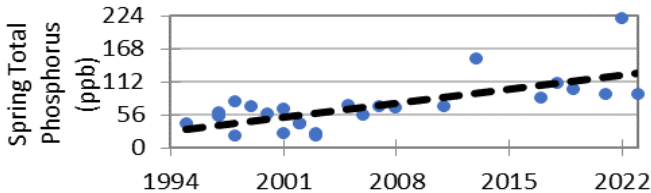
## Spring Phosphorus (parts per billion)

Year	# Samples	Min	Max	Average	Std. Dev
2023	1	90.0	90.0	90.0	NA
2018-2022	4	91.0	220.0	130.3	60.3
1995-2017	20	21.0	150.0	58.6	29.4
2023 All CLMP Lakes	220	<5	220.0	20.7	21.3

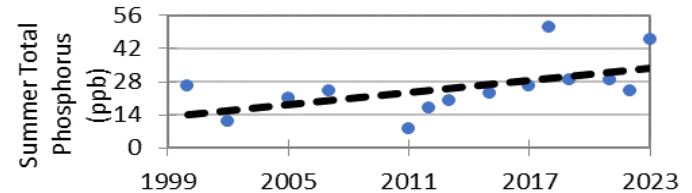
## Summer Phosphorus (parts per billion)

Year	# Samples	Min	Max	Average	Std. Dev	Carlson TSI
2023	1	46.0	46.0	46.0	NA	59
2018-2022	4	24.0	51.0	33.3	12.1	54
2000-2017	9	8.0	26.0	19.6	6.4	46
2023 All CLMP Lakes	234	<= 3	150.0	17.4	15.3	45

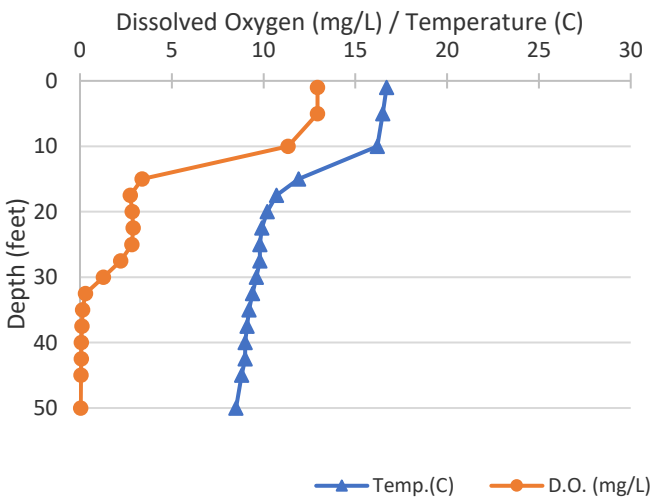
## Dissolved Oxygen and Temperature Profile 5/21/23

Due to the high nutrient level, the lake loses dissolved oxygen in the bottom waters in the spring and this condition persists through the whole monitoring season.

If you enrolled in Dissolved Oxygen/Temperature, the summary page will have a graph of one of the profiles taken during the late summer (typically August or September). If your lake stratifies, we will use a graph showing the earliest time of stratification, because identifying the timing of this condition and the depth at which it occurs is typically the most important use of dissolved oxygen measurements.

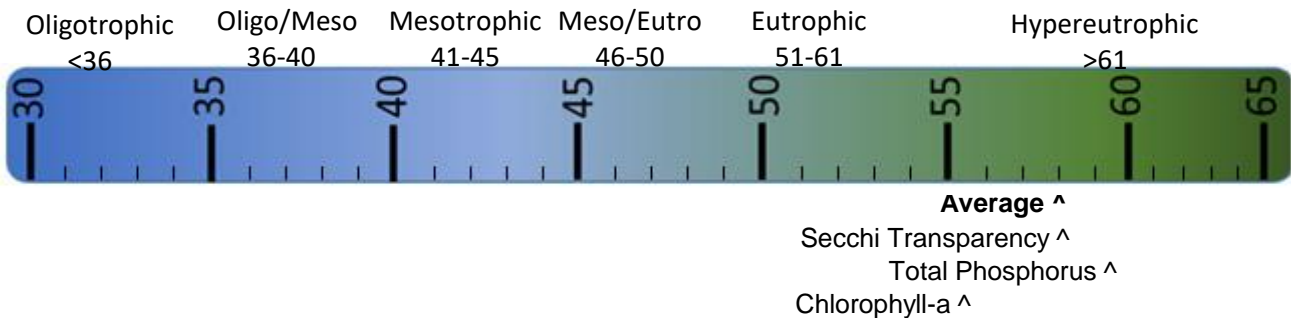
In 1977, limnologist Dr. Robert Carlson developed a numerical scale (0-100) where the numbers indicate the level of nutrient enrichment. Using the proper equations, we can convert results from Summer Total Phosphorus, Secchi Depth, and Chlorophyll-a to this Trophic Status Index (TSI). The TSI numbers are furthermore grouped into general categories (oligotrophic, mesotrophic, eutrophic, and hypereutrophic), to quickly give us a way to understand the general nutrient level of any lake.

TSI for Crockery Lake in 2023	
Average	58
Secchi Disk	58
Summer TP	59
Chlorophyll-a	55

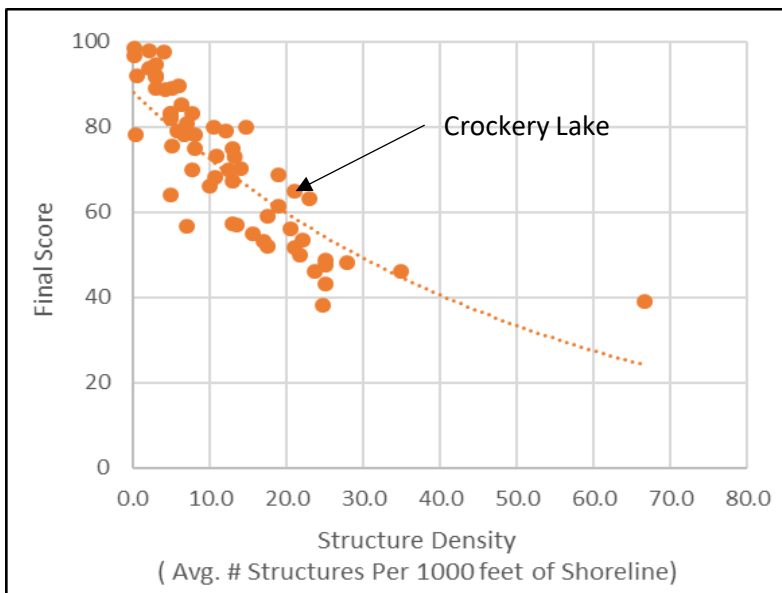
### How does your lake compare to others in the program?

<b>Crockery Lake:</b>	
Number of Sections:	8
Number of Structures:	187
Structure Density:	23
Final Score:	63

<b>All 42 Participating Lakes from 2015-2019:</b>	
Avg. Number of Sections:	16
Avg. Number of Structures:	226
Avg. Structure Density:	12.5
Avg. Final Score:	71.1

Overall, the lakeshore habitat of Crockery Lake scored lower when average when compared to other lakes in the program, but probably scored exactly as expected considering the amount of development along the shores.

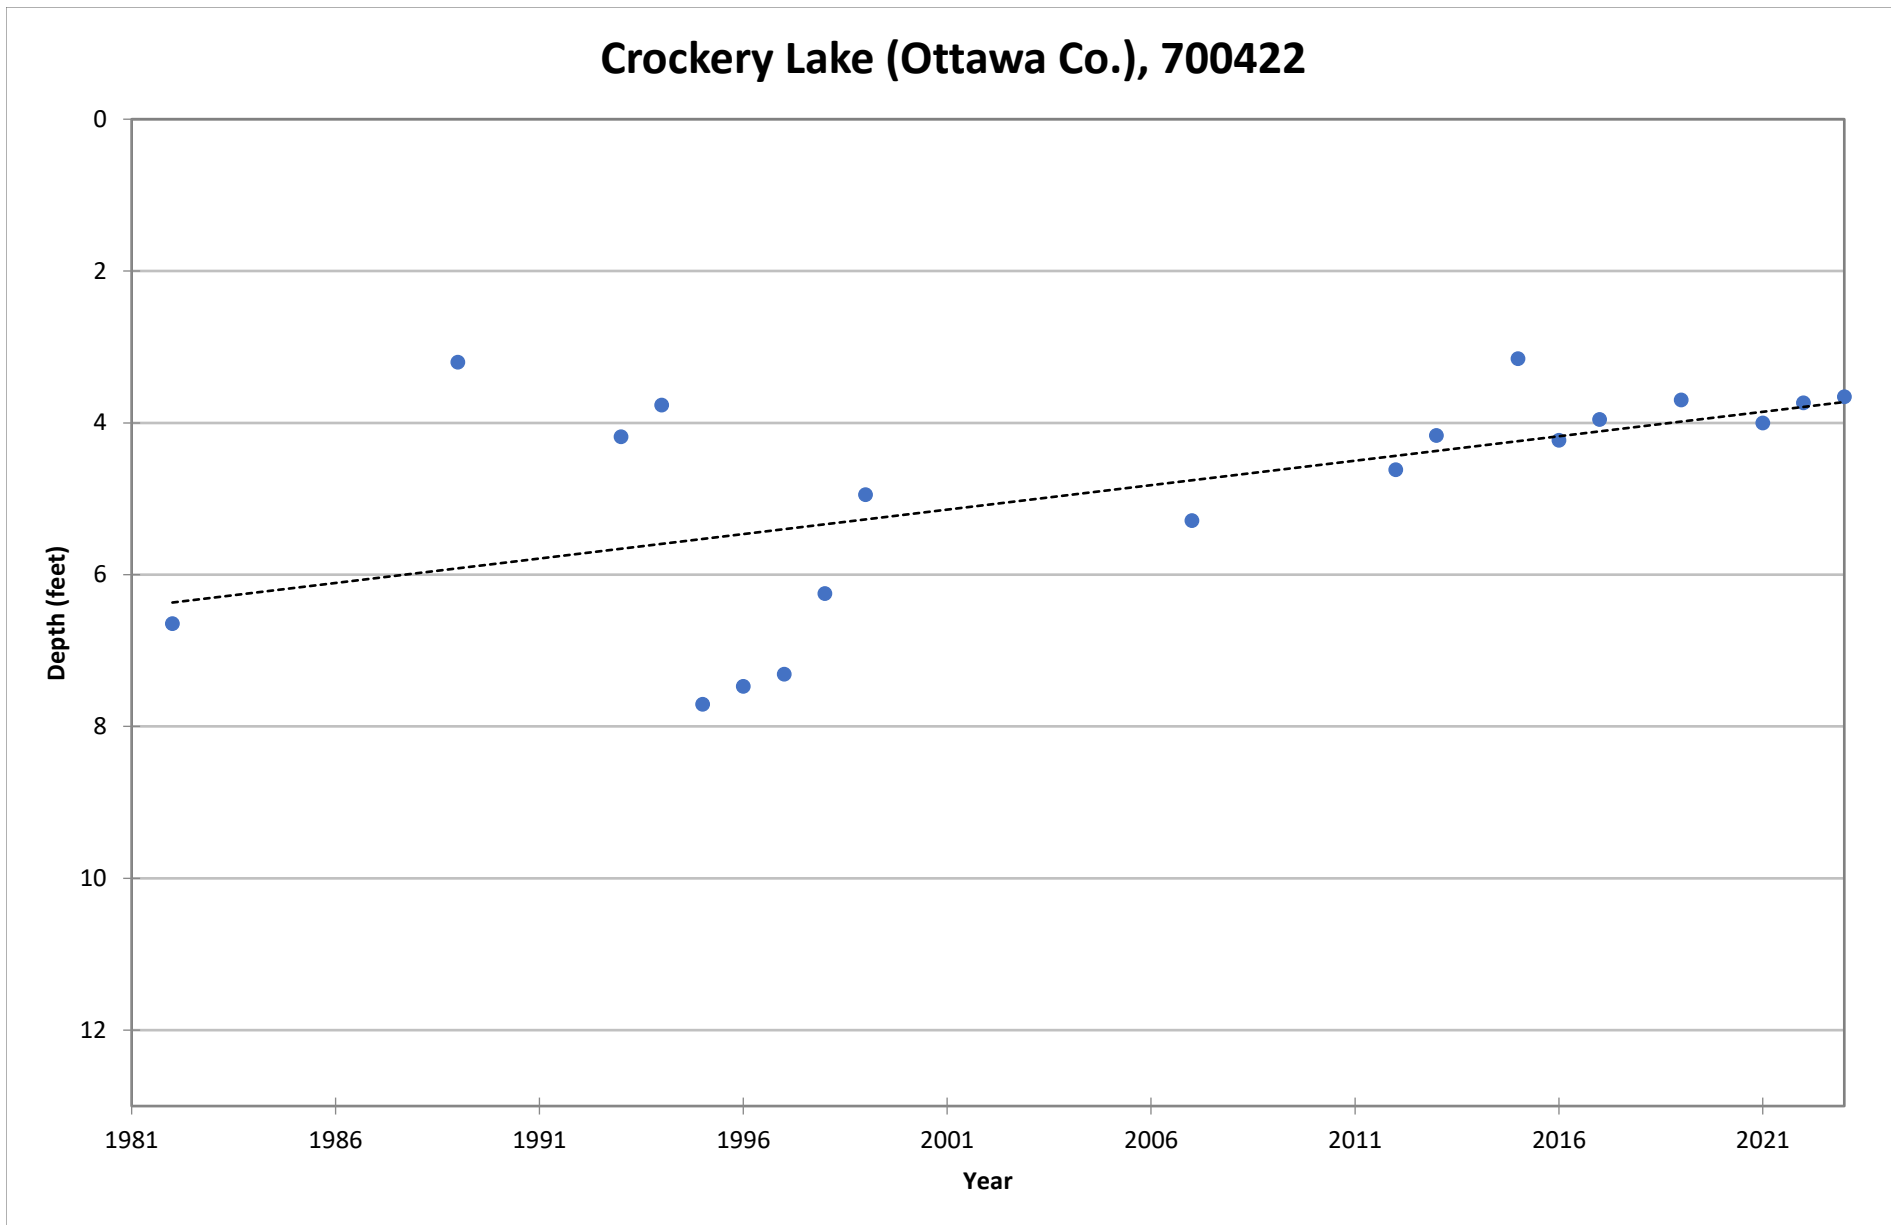
COOPERATIVE LAKES MONITORING PROGRAM  
SUMMER MEAN TRANSPARENCY

**Crockery Lake (Ottawa Co.), 700422**

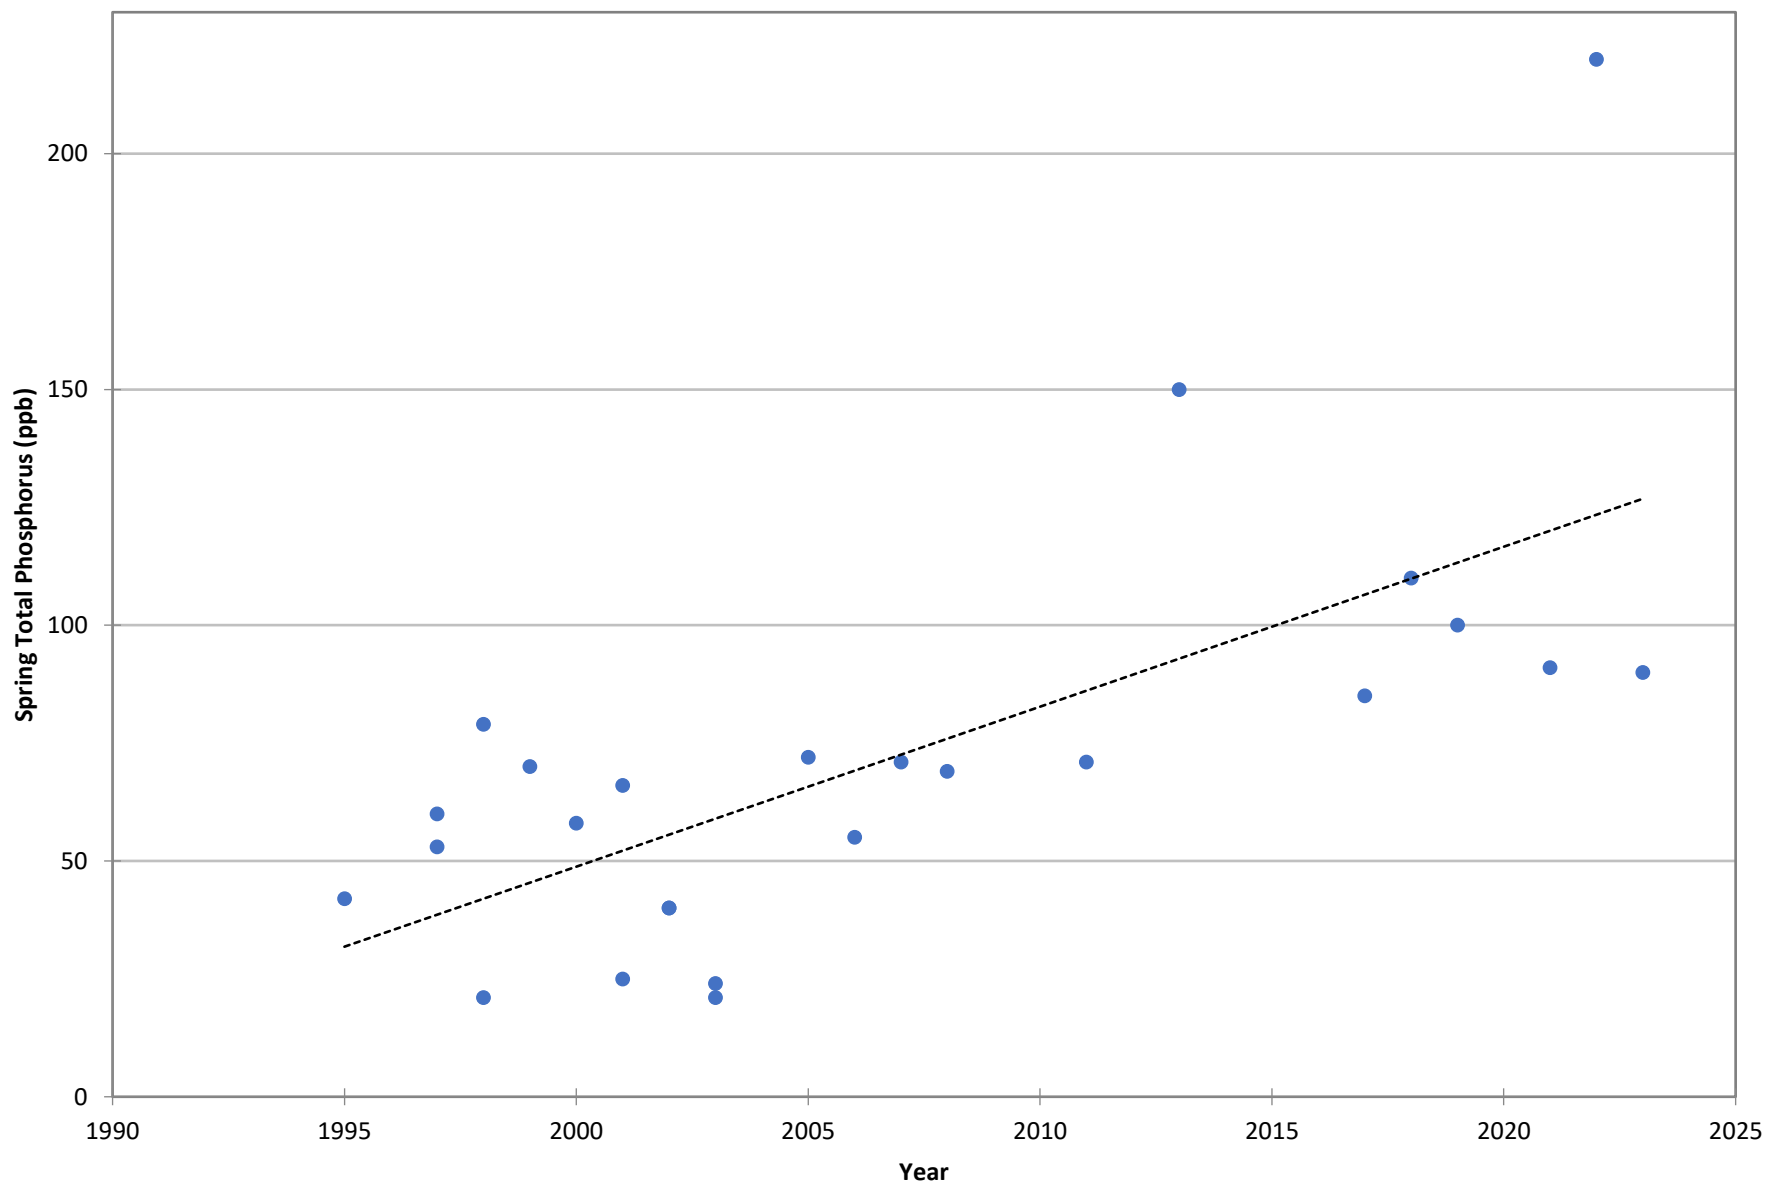
COOPERATIVE LAKES MONITORING PROGRAM  
SPRING TOTAL PHOSPHORUS

**Crockery Lake (Ottawa Co.), 700422**

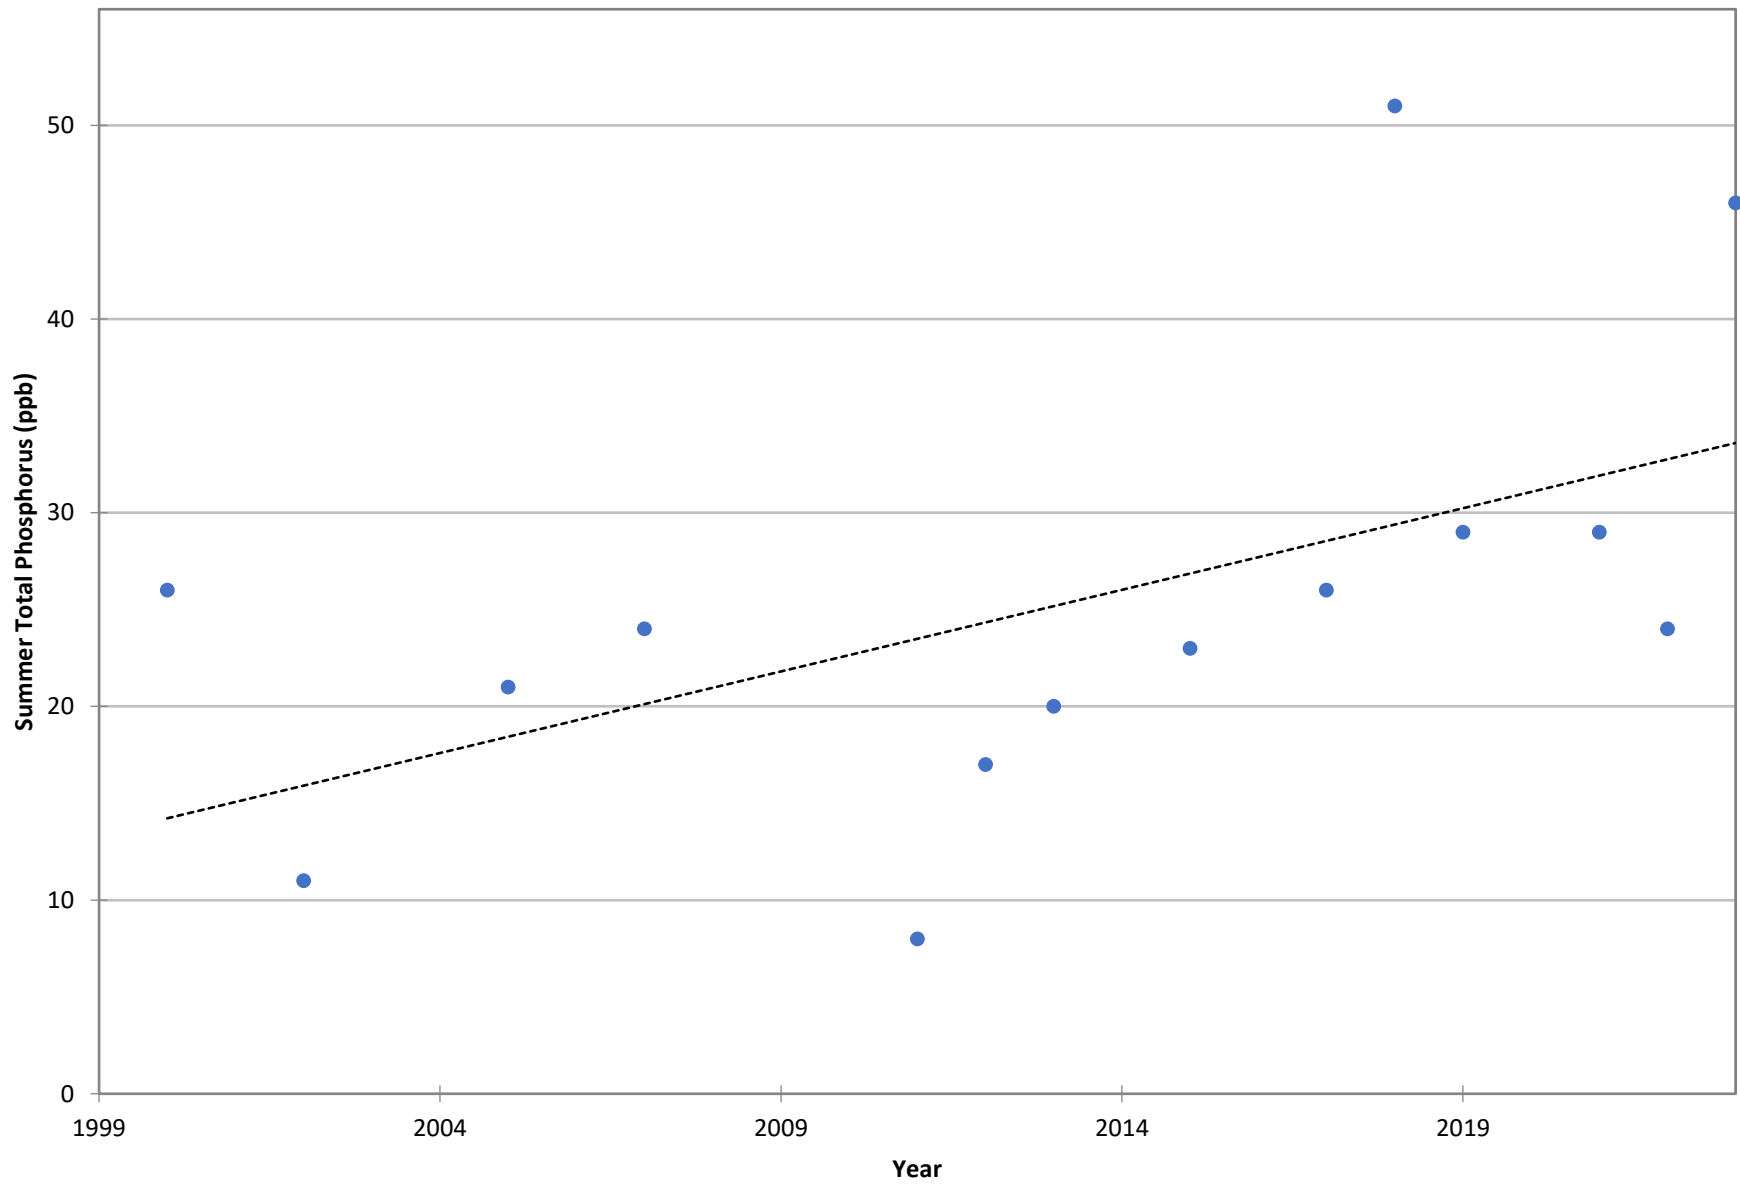
COOPERATIVE LAKES MONITORING PROGRAM  
SUMMER TOTAL PHOSPHORUS

**Crockery Lake (Ottawa Co.), 700422**

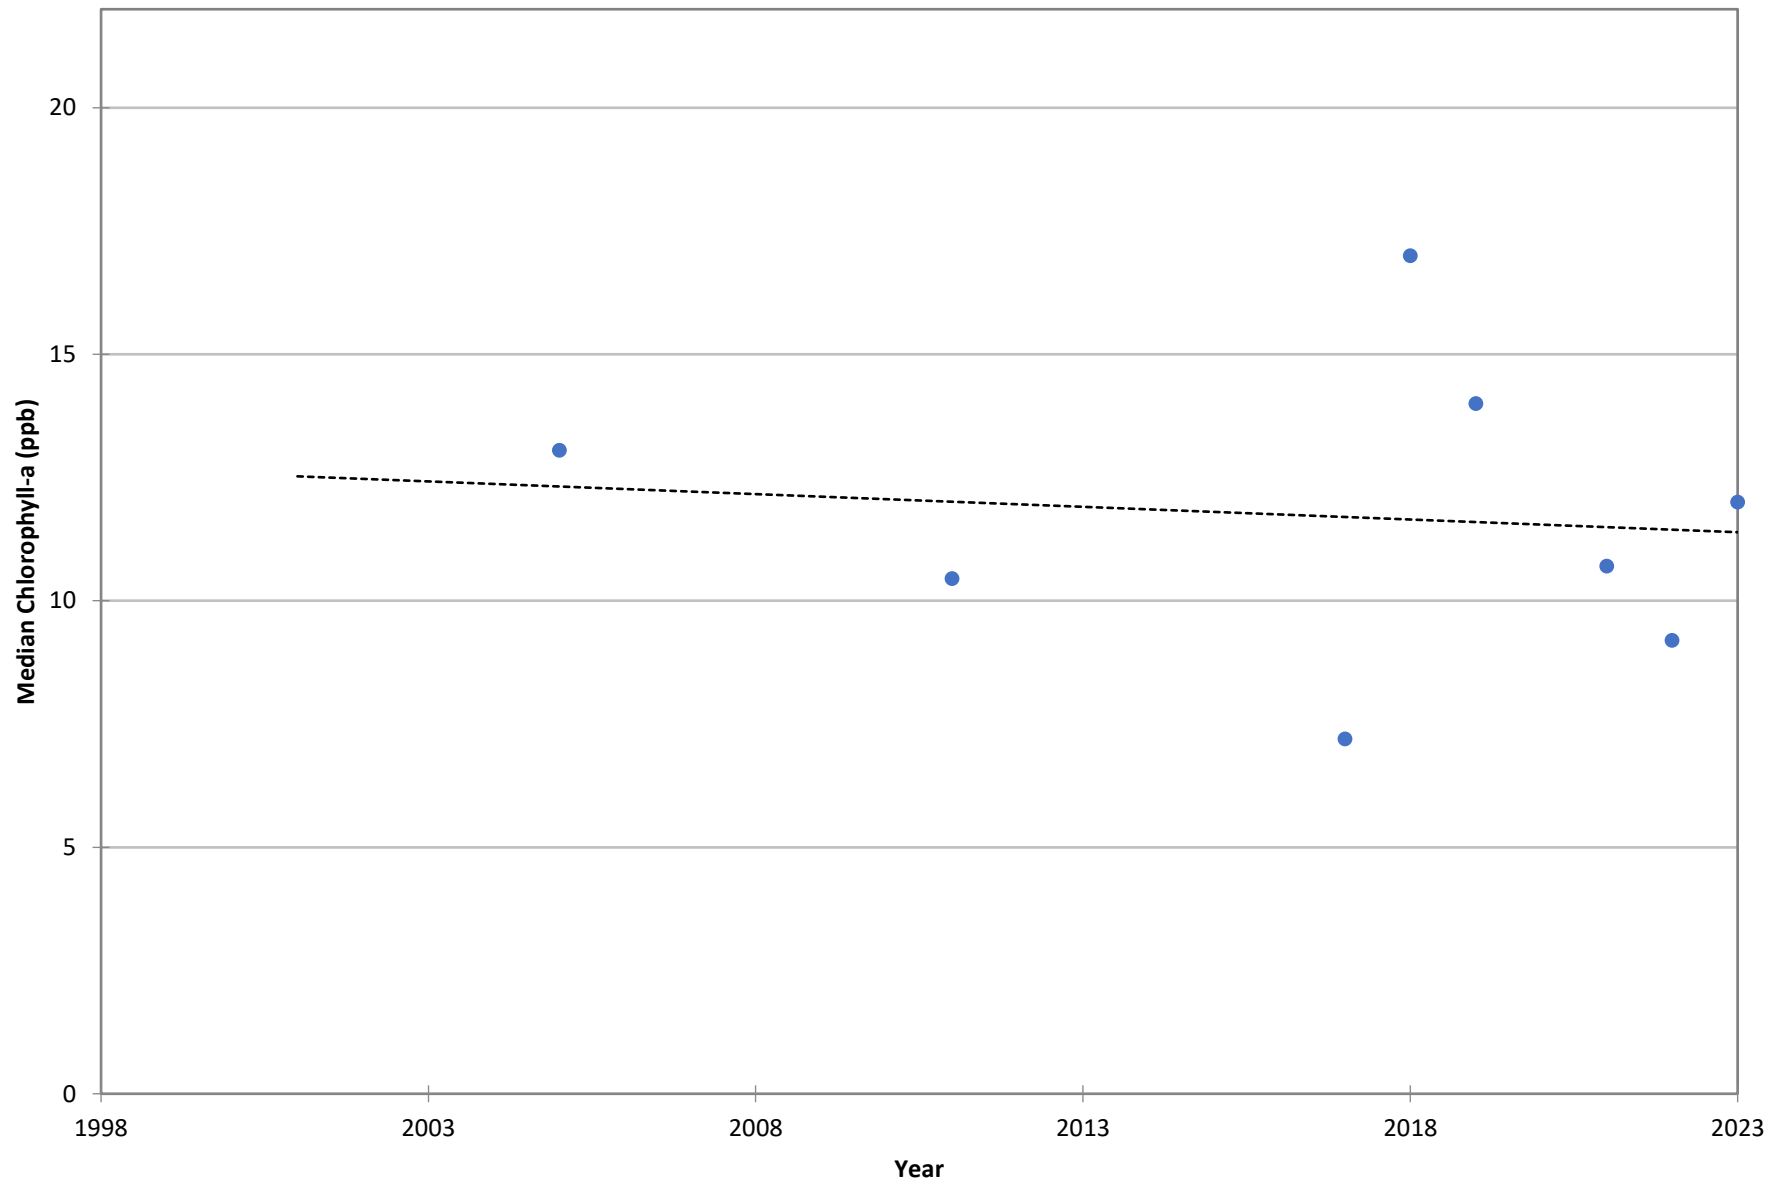
COOPERATIVE LAKES MONITORING PROGRAM  
SUMMER MEDIAN CHLOROPHYLL-A

**Crockery Lake (Ottawa Co.), 700422**

Vertical bars indicate standard deviation

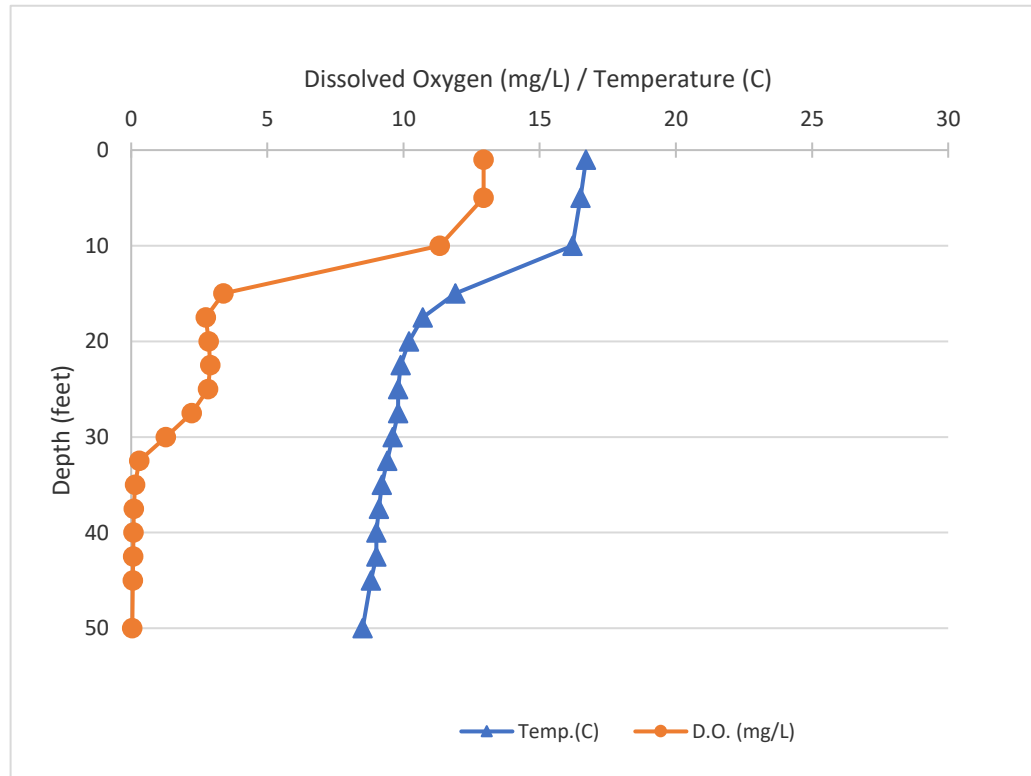
Name: Crockery Lake  
County: Ottawa  
Site ID: 700422  
Date: 5/21/2023

Depth (ft)	Temp.(C)	D.O. (mg/L)
1	16.7	12.94
5	16.5	12.94
10	16.2	11.33
15	11.9	3.39
17.5	10.7	2.74
20	10.2	2.84
22.5	9.9	2.9
25	9.8	2.82
27.5	9.8	2.22
30	9.6	1.27
32.5	9.4	0.3
35	9.2	0.14
37.5	9.1	0.1
40	9	0.08
42.5	9	0.07
45	8.8	0.06
50	8.5	0.04

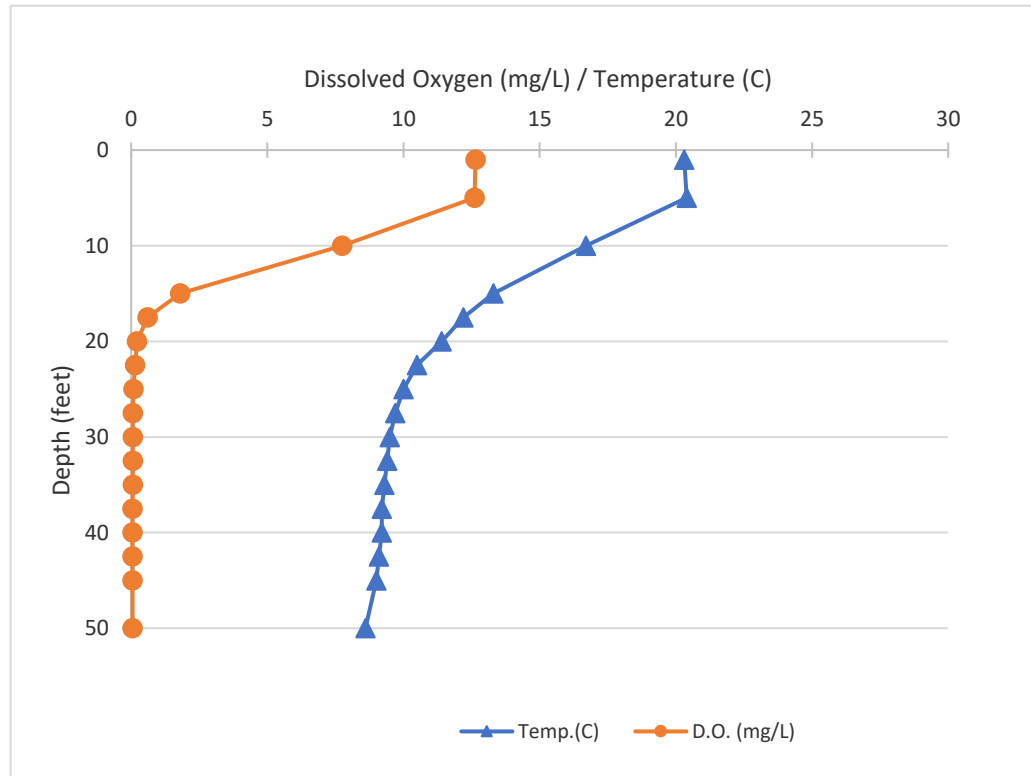
Name: Crockery Lake  
 County: Ottawa  
 Site ID: 700422  
 Date: 5/28/2023

Depth (ft)	Temp.(C)	D.O. (mg/L)
1	20.3	12.64
5	20.4	12.61
10	16.7	7.74
15	13.3	1.8
17.5	12.2	0.6
20	11.4	0.21
22.5	10.5	0.14
25	10	0.08
27.5	9.7	0.06
30	9.5	0.06
32.5	9.4	0.06
35	9.3	0.06
37.5	9.2	0.05
40	9.2	0.05
42.5	9.1	0.05
45	9	0.05
50	8.6	0.05

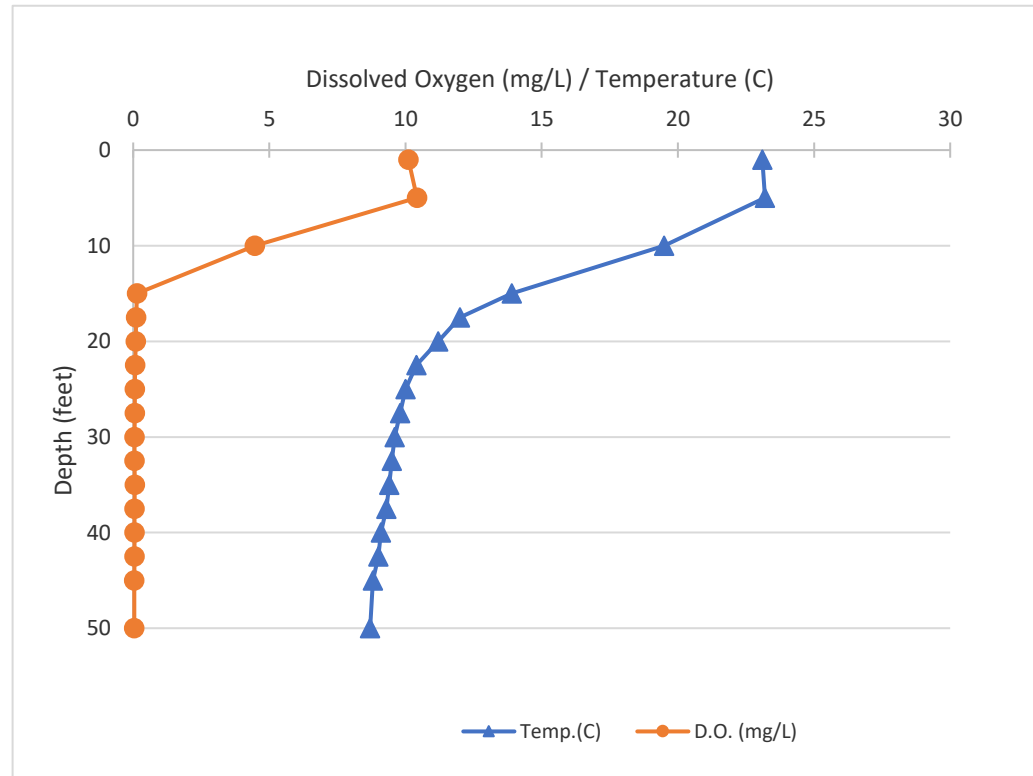
Name: Crockery Lake  
County: Ottawa  
Site ID: 700422  
Date: 6/5/2023

Depth (ft)	Temp.(C)	D.O. (mg/L)
1	23.1	10.11
5	23.2	10.42
10	19.5	4.47
15	13.9	0.14
17.5	12	0.11
20	11.2	0.09
22.5	10.4	0.07
25	10	0.06
27.5	9.8	0.06
30	9.6	0.05
32.5	9.5	0.05
35	9.4	0.06
37.5	9.3	0.05
40	9.1	0.05
42.5	9	0.05
45	8.8	0.04
50	8.7	0.04

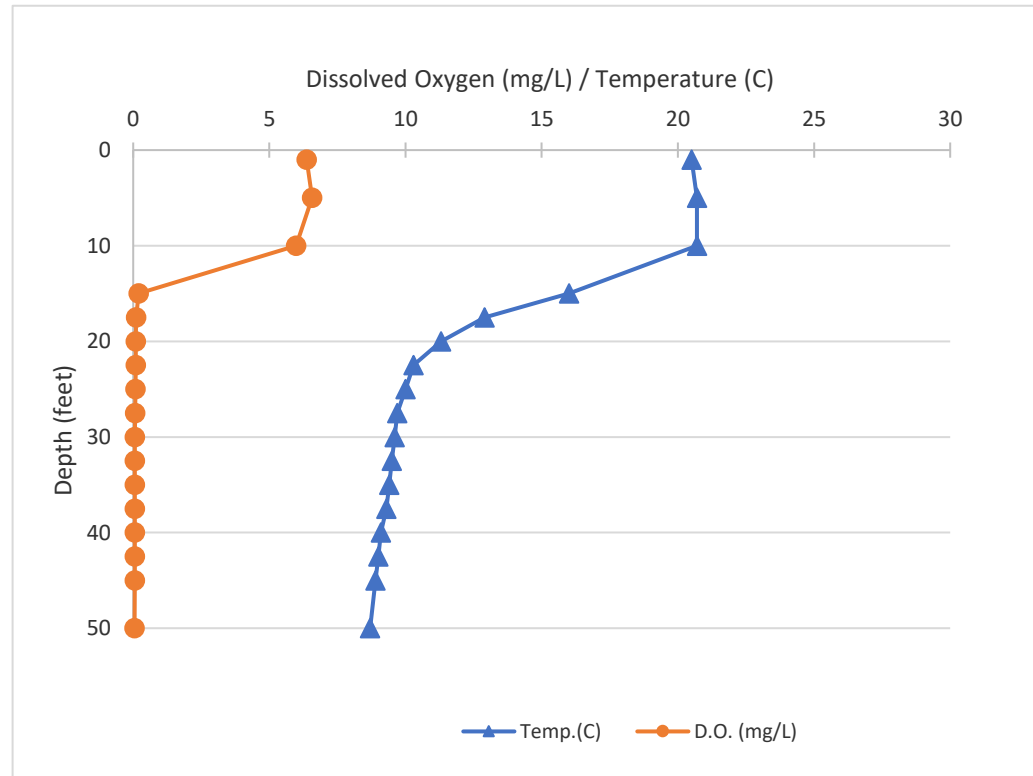
Name: Crockery Lake  
County: Ottawa  
Site ID: 700422  
Date: 6/12/2023

Depth (ft)	Temp.(C)	D.O. (mg/L)
1	20.5	6.37
5	20.7	6.57
10	20.7	5.98
15	16	0.2
17.5	12.9	0.11
20	11.3	0.09
22.5	10.3	0.09
25	10	0.08
27.5	9.7	0.07
30	9.6	0.06
32.5	9.5	0.06
35	9.4	0.06
37.5	9.3	0.06
40	9.1	0.06
42.5	9	0.06
45	8.9	0.06
50	8.7	0.05

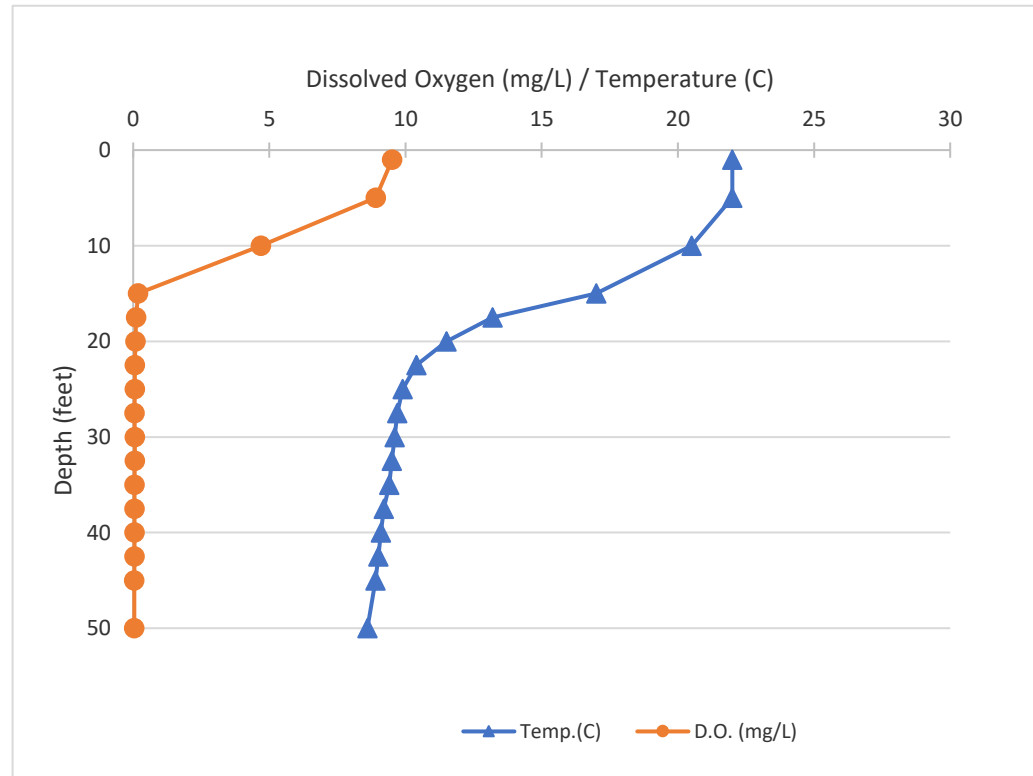
Name: Crockery Lake  
County: Ottawa  
Site ID: 700422  
Date: 6/19/2023

Depth (ft)	Temp.(C)	D.O. (mg/L)
1	22	9.51
5	22	8.91
10	20.5	4.69
15	17	0.18
17.5	13.2	0.11
20	11.5	0.08
22.5	10.4	0.06
25	9.9	0.06
27.5	9.7	0.05
30	9.6	0.06
32.5	9.5	0.06
35	9.4	0.05
37.5	9.2	0.05
40	9.1	0.05
42.5	9	0.05
45	8.9	0.04
50	8.6	0.04

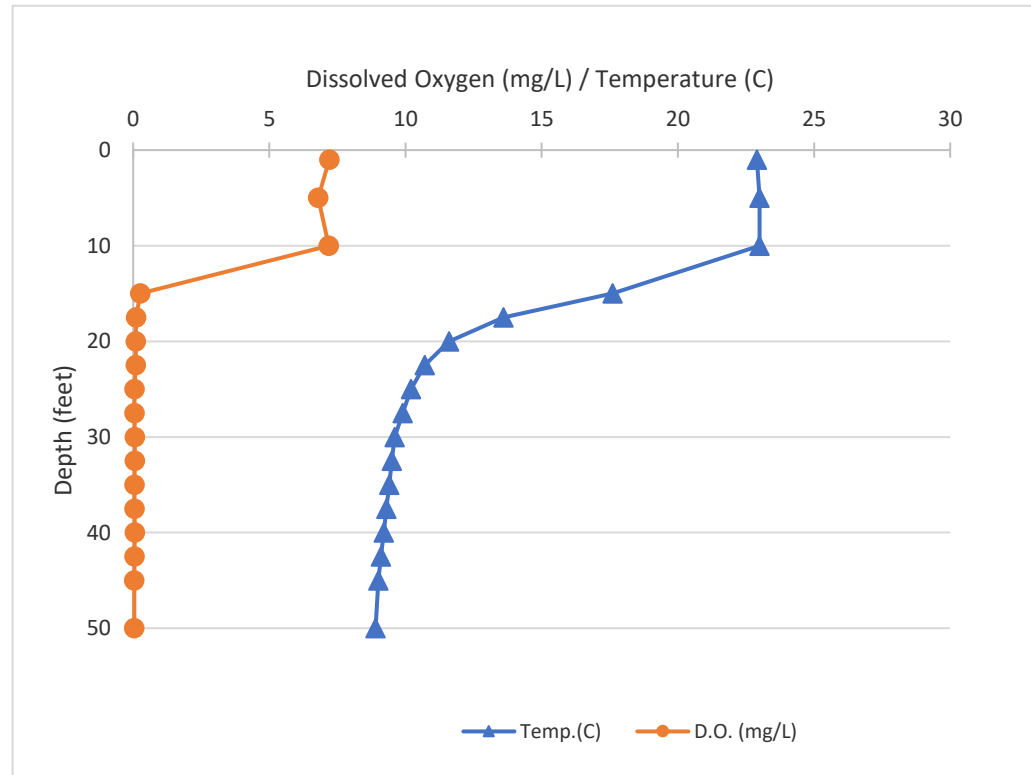
Name: Crockery Lake  
County: Ottawa  
Site ID: 700422  
Date: 6/27/2023

Depth (ft)	Temp.(C)	D.O. (mg/L)
1	22.9	7.2
5	23	6.79
10	23	7.18
15	17.6	0.26
17.5	13.6	0.11
20	11.6	0.09
22.5	10.7	0.09
25	10.2	0.05
27.5	9.9	0.05
30	9.6	0.06
32.5	9.5	0.06
35	9.4	0.05
37.5	9.3	0.05
40	9.2	0.06
42.5	9.1	0.05
45	9	0.04
50	8.9	0.04

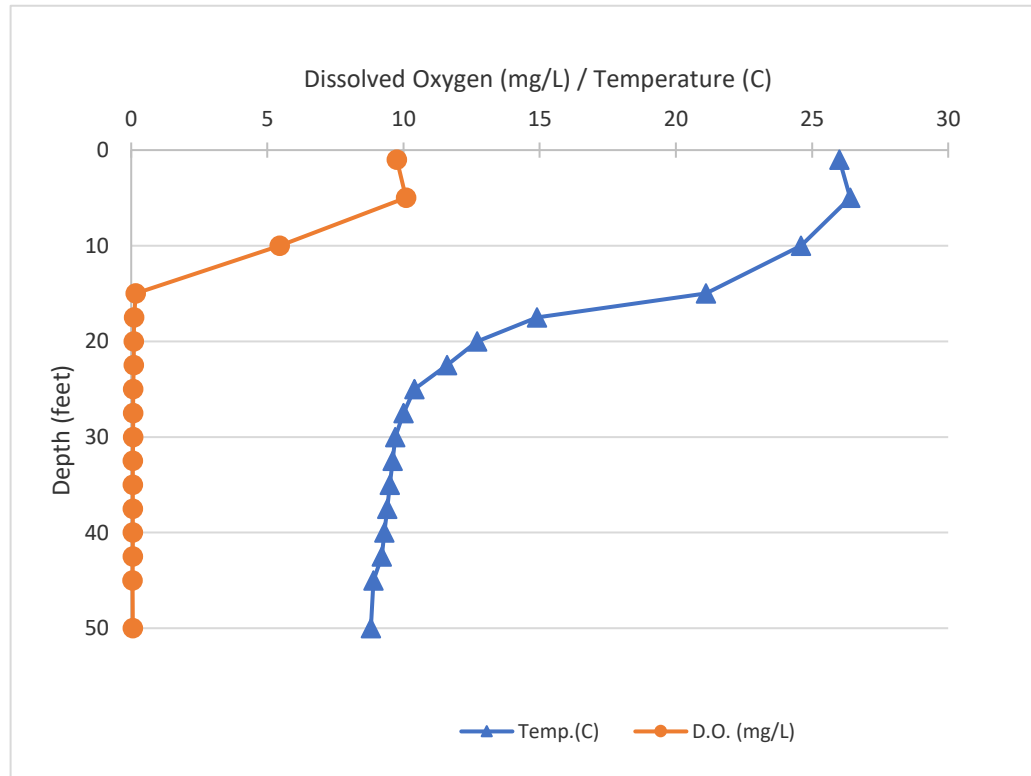
Name: Crockery Lake  
County: Ottawa  
Site ID: 700422  
Date: 7/6/2023

Depth (ft)	Temp.(C)	D.O. (mg/L)
1	26	9.75
5	26.4	10.09
10	24.6	5.45
15	21.1	0.17
17.5	14.9	0.11
20	12.7	0.09
22.5	11.6	0.09
25	10.4	0.07
27.5	10	0.07
30	9.7	0.07
32.5	9.6	0.06
35	9.5	0.06
37.5	9.4	0.06
40	9.3	0.06
42.5	9.2	0.06
45	8.9	0.05
50	8.8	0.06

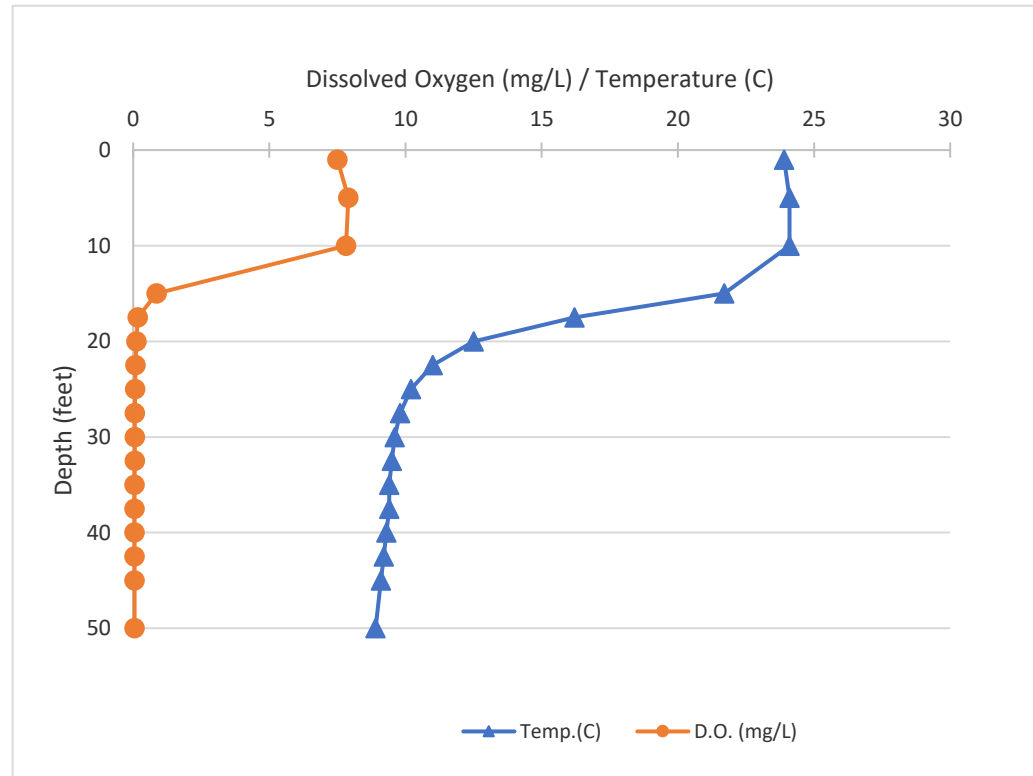
Name: Crockery Lake  
County: Ottawa  
Site ID: 700422  
Date: 7/13/2023

Depth (ft)	Temp.(C)	D.O. (mg/L)
1	23.9	7.5
5	24.1	7.9
10	24.1	7.82
15	21.7	0.86
17.5	16.2	0.17
20	12.5	0.12
22.5	11	0.08
25	10.2	0.07
27.5	9.8	0.06
30	9.6	0.06
32.5	9.5	0.06
35	9.4	0.05
37.5	9.4	0.05
40	9.3	0.05
42.5	9.2	0.05
45	9.1	0.05
50	8.9	0.05

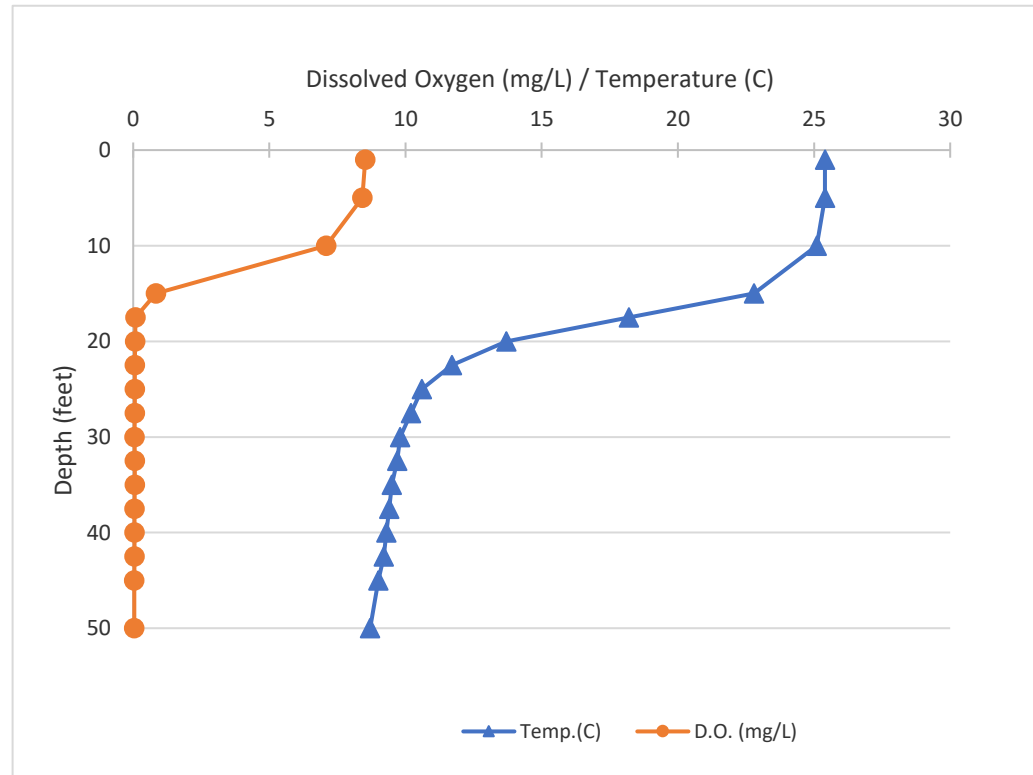
Name: Crockery Lake  
 County: Ottawa  
 Site ID: 700422  
 Date: 7/25/2023

Depth (ft)	Temp.(C)	D.O. (mg/L)
1	25.4	8.52
5	25.4	8.41
10	25.1	7.09
15	22.8	0.84
17.5	18.2	0.08
20	13.7	0.07
22.5	11.7	0.06
25	10.6	0.06
27.5	10.2	0.06
30	9.8	0.05
32.5	9.7	0.06
35	9.5	0.06
37.5	9.4	0.05
40	9.3	0.05
42.5	9.2	0.05
45	9	0.04
50	8.7	0.04

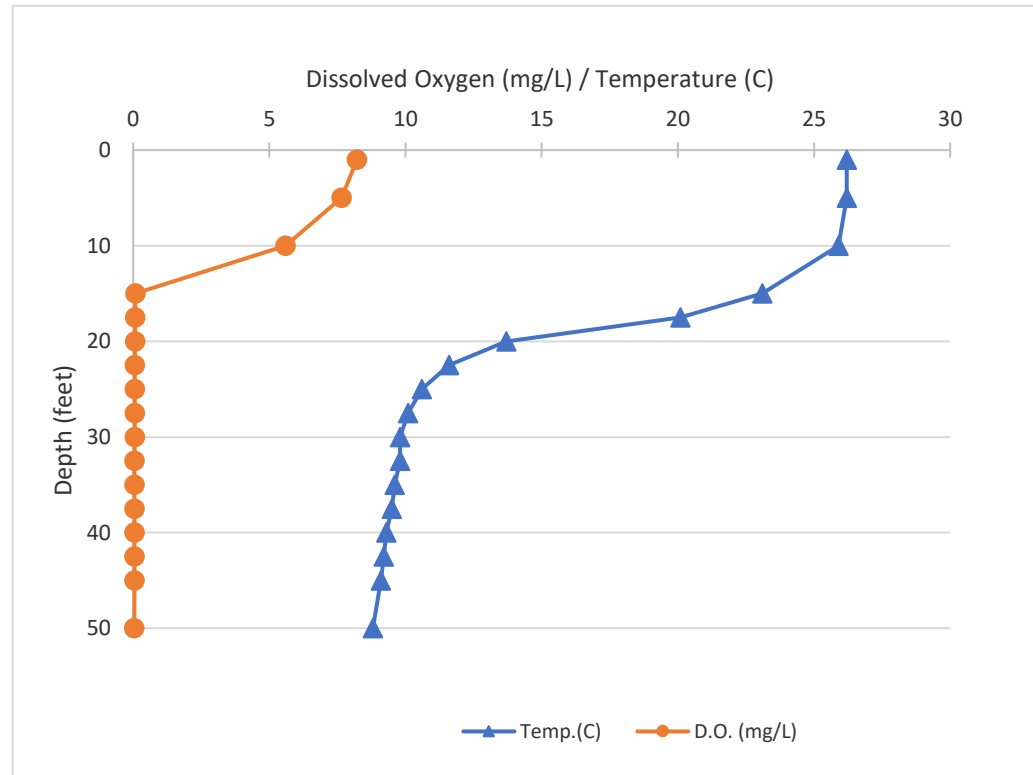
Name: Crockery Lake  
County: Ottawa  
Site ID: 700422  
Date: 7/31/2023

Depth (ft)	Temp.(C)	D.O. (mg/L)
1	26.2	8.22
5	26.2	7.65
10	25.9	5.59
15	23.1	0.08
17.5	20.1	0.07
20	13.7	0.07
22.5	11.6	0.06
25	10.6	0.06
27.5	10.1	0.06
30	9.8	0.06
32.5	9.8	0.05
35	9.6	0.05
37.5	9.5	0.05
40	9.3	0.05
42.5	9.2	0.05
45	9.1	0.05
50	8.8	0.04

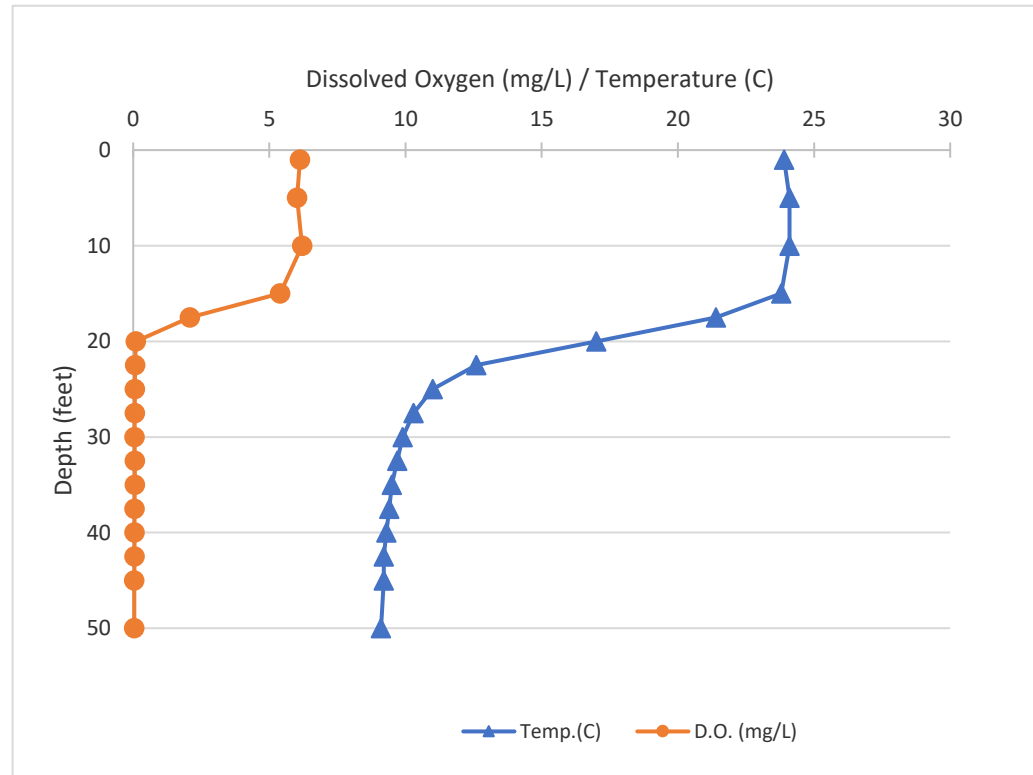
Name: Crockery Lake  
 County: Ottawa  
 Site ID: 700422  
 Date: 8/7/2023

Depth (ft)	Temp.(C)	D.O. (mg/L)
1	23.9	6.12
5	24.1	6.02
10	24.1	6.2
15	23.8	5.39
17.5	21.4	2.08
20	17	0.09
22.5	12.6	0.07
25	11	0.06
27.5	10.3	0.06
30	9.9	0.05
32.5	9.7	0.06
35	9.5	0.06
37.5	9.4	0.05
40	9.3	0.05
42.5	9.2	0.05
45	9.2	0.04
50	9.1	0.04

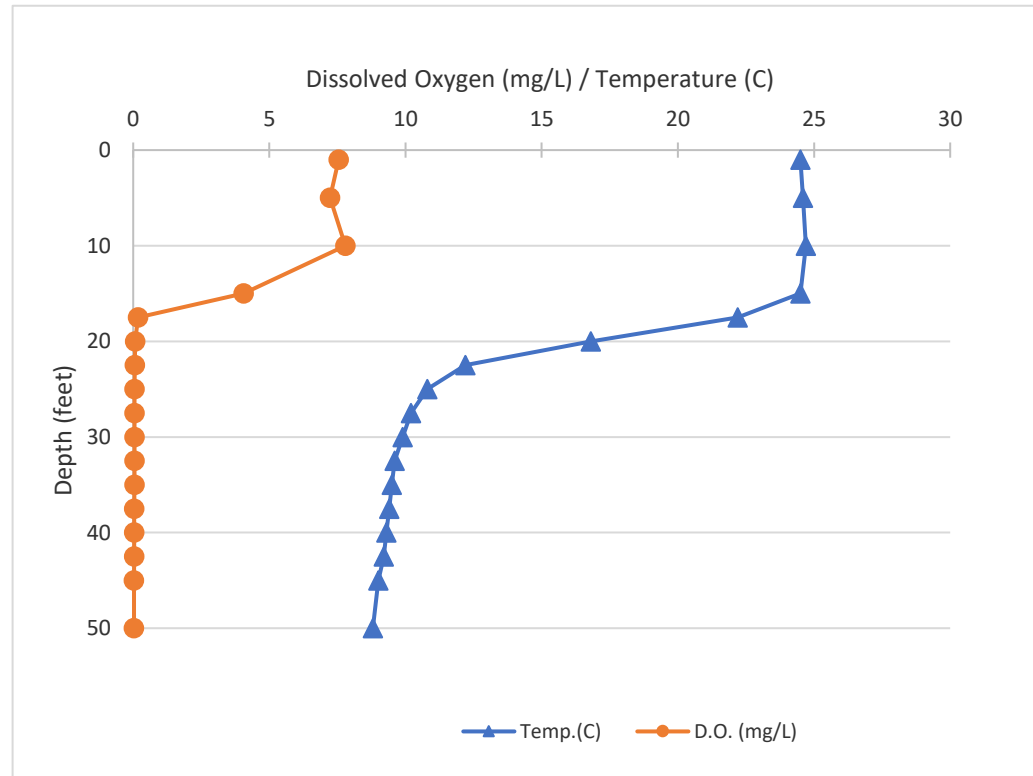
Name: Crockery Lake  
 County: Ottawa  
 Site ID: 700422  
 Date: 8/14/2023

Depth (ft)	Temp.(C)	D.O. (mg/L)
1	24.5	7.54
5	24.6	7.23
10	24.7	7.79
15	24.5	4.06
17.5	22.2	0.18
20	16.8	0.07
22.5	12.2	0.06
25	10.8	0.05
27.5	10.2	0.05
30	9.9	0.05
32.5	9.6	0.05
35	9.5	0.05
37.5	9.4	0.04
40	9.3	0.04
42.5	9.2	0.04
45	9	0.03
50	8.8	0.03

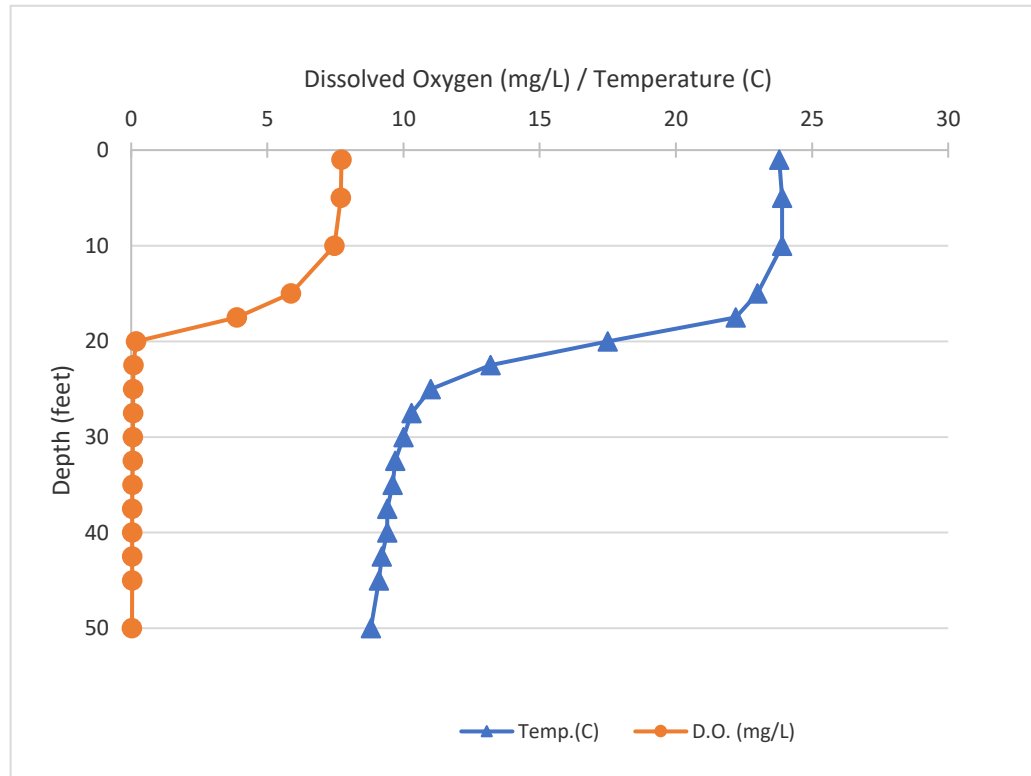
Name: Crockery Lake  
 County: Ottawa  
 Site ID: 700422  
 Date: 8/21/2023

Depth (ft)	Temp.(C)	D.O. (mg/L)
1	23.8	7.72
5	23.9	7.7
10	23.9	7.46
15	23	5.87
17.5	22.2	3.88
20	17.5	0.18
22.5	13.2	0.08
25	11	0.07
27.5	10.3	0.07
30	10	0.06
32.5	9.7	0.06
35	9.6	0.05
37.5	9.4	0.04
40	9.4	0.04
42.5	9.2	0.04
45	9.1	0.04
50	8.8	0.03
