# 2023 Data Report for Crockery Lake, Ottawa County

Site ID: 700422

# Crockery Lake, Ottawa County 2023 CLMP Results

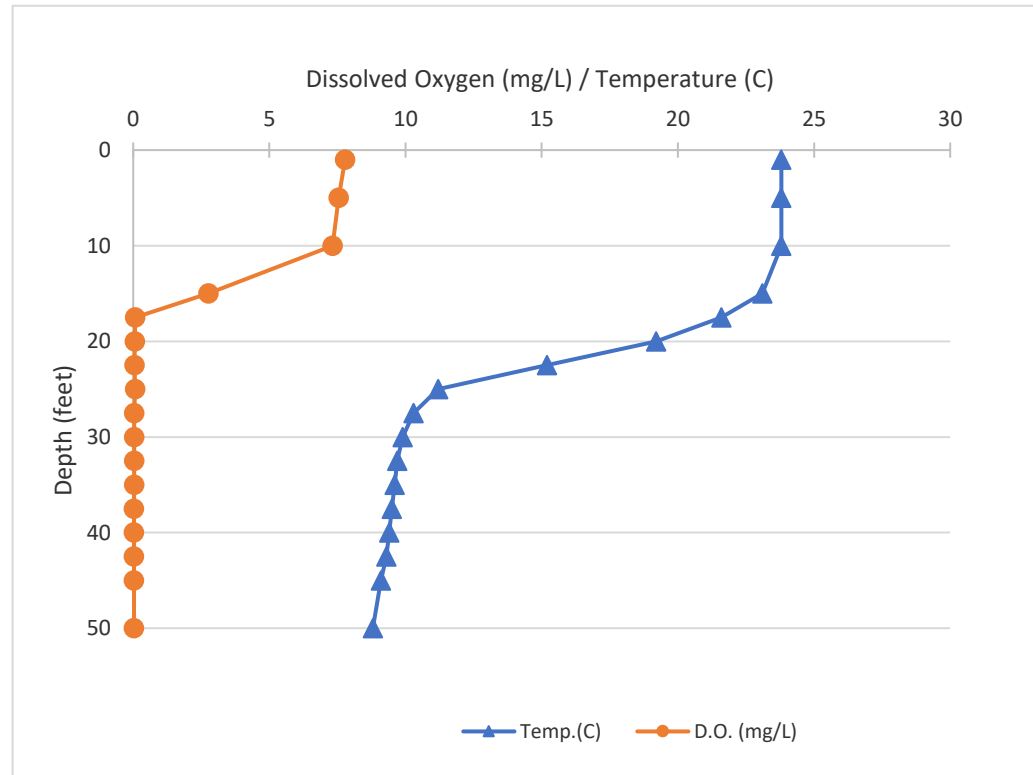
Name: Crockery Lake  
County: Ottawa  
Site ID: 700422  
Date: 8/28/2023

Depth (ft)	Temp.(C)	D.O. (mg/L)
1	23.8	7.78
5	23.8	7.54
10	23.8	7.32
15	23.1	2.76
17.5	21.6	0.07
20	19.2	0.06
22.5	15.2	0.05
25	11.2	0.07
27.5	10.3	0.04
30	9.9	0.04
32.5	9.7	0.04
35	9.6	0.04
37.5	9.5	0.03
40	9.4	0.03
42.5	9.3	0.03
45	9.1	0.03
50	8.8	0.03

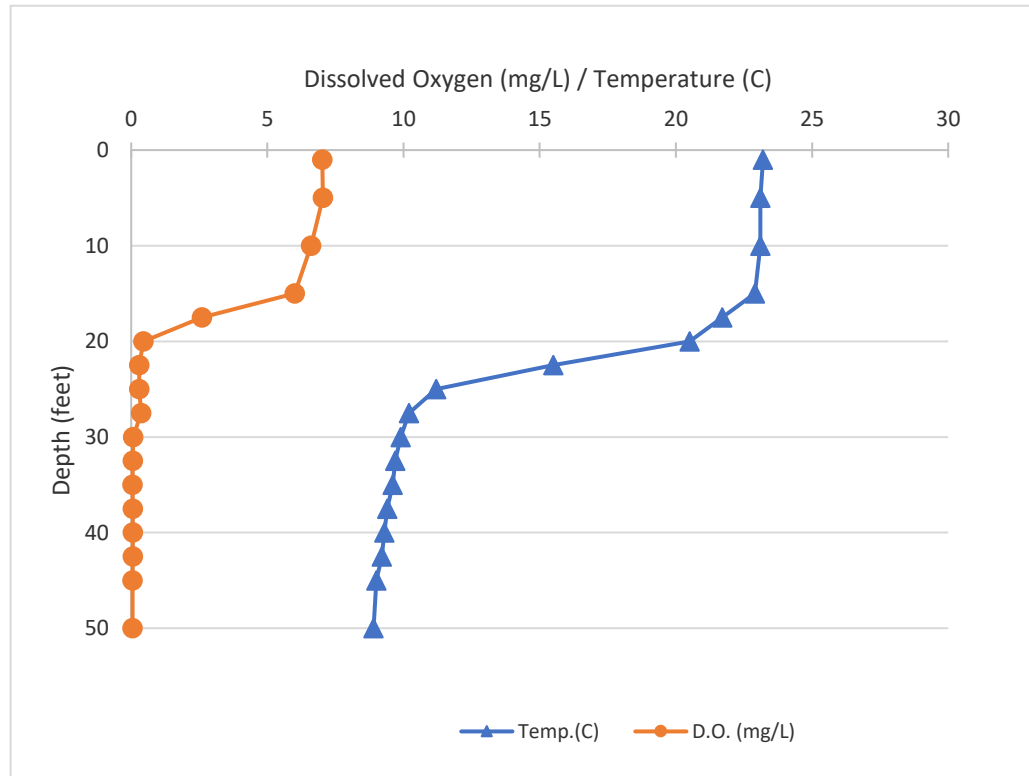
Name: Crockery Lake  
County: Ottawa  
Site ID: 700422  
Date: 9/4/2023

Depth (ft)	Temp.(C)	D.O. (mg/L)
1	23.2	7.02
5	23.1	7.04
10	23.1	6.6
15	22.9	6
17.5	21.7	2.6
20	20.5	0.45
22.5	15.5	0.3
25	11.2	0.29
27.5	10.2	0.36
30	9.9	0.07
32.5	9.7	0.06
35	9.6	0.05
37.5	9.4	0.06
40	9.3	0.06
42.5	9.2	0.06
45	9	0.05
50	8.9	0.05

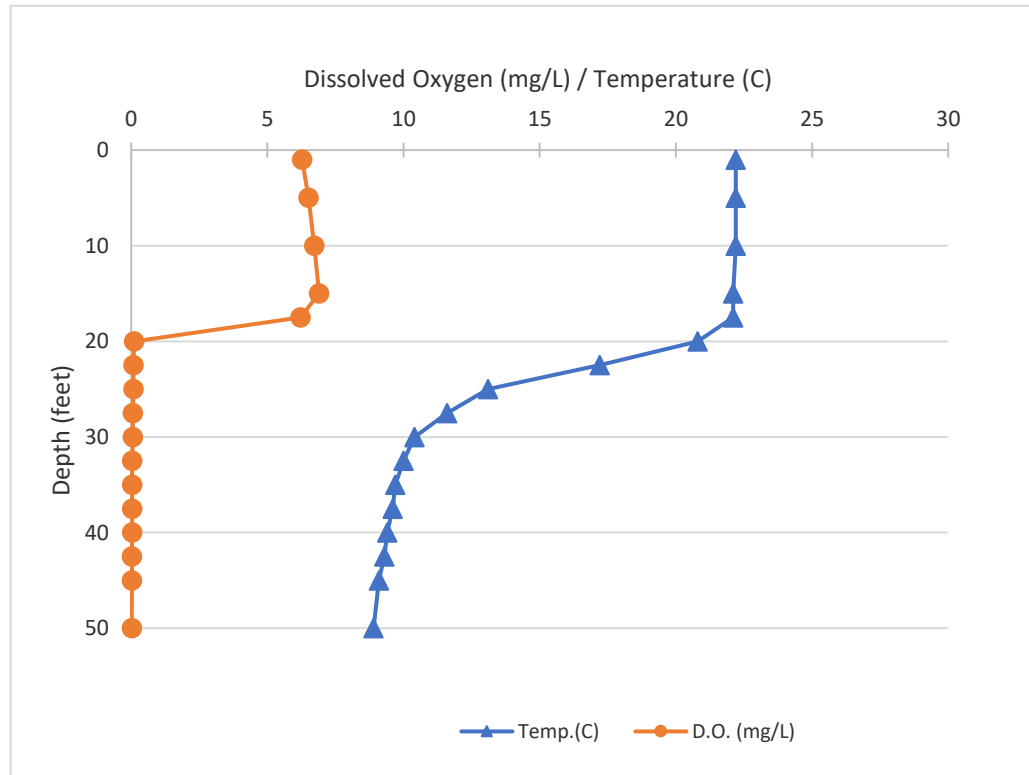
Name: Crockery Lake  
County: Ottawa  
Site ID: 700422  
Date: 9/12/2023

Depth (ft)	Temp.(C)	D.O. (mg/L)
1	22.2	6.28
5	22.2	6.51
10	22.2	6.72
15	22.1	6.9
17.5	22.1	6.22
20	20.8	0.11
22.5	17.2	0.08
25	13.1	0.08
27.5	11.6	0.06
30	10.4	0.06
32.5	10	0.04
35	9.7	0.04
37.5	9.6	0.04
40	9.4	0.04
42.5	9.3	0.03
45	9.1	0.03
50	8.9	0.02
