2023 Data Report for Big Bass Lake, Lake County

Site ID: 430029

Big Bass Lake, Lake County 2023 CLMP Results

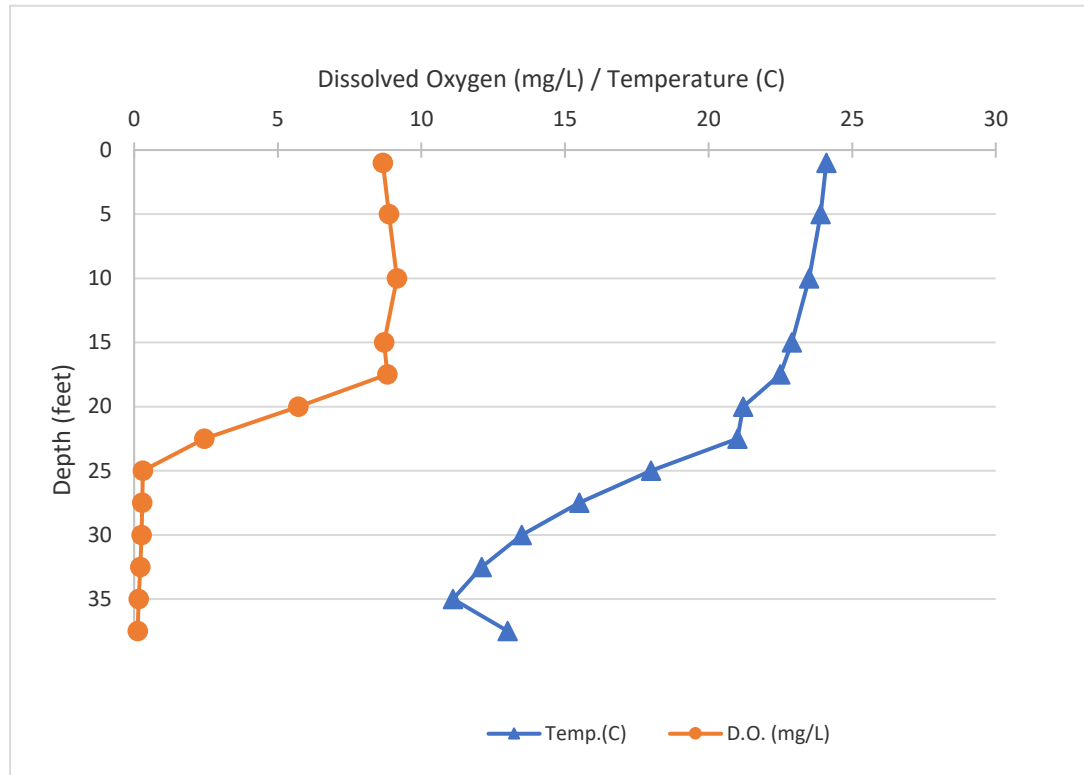
9/5/2023

Dissolved Oxygen and Temperature Profile

Depth (ft)	Temp.(C)	D.O. (mg/L)
1	24.1	8.66
5	23.9	8.87
10	23.5	9.15
15	22.9	8.7
17.5	22.5	8.82
20	21.2	5.72
22.5	21	2.44
25	18	0.3
27.5	15.5	0.28
30	13.5	0.26
32.5	12.1	0.21
35	11.1	0.16
37.5	13	0.12
