2023 Data Report for

Maceday Lake, Oakland County

Site ID: 630415

Maceday Lake, Oakland County 2023 CLMP Results

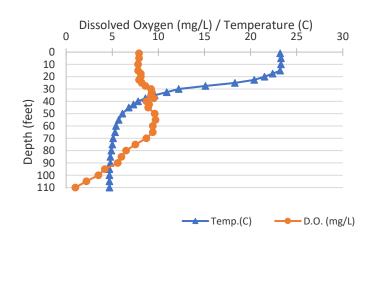
9/8/23 **Dissolved Oxygen and Temperature Profile**

The low level of nutrients in the lake results in dissolved oxygen being available throughout the water column for most of the summer, and only by the end of the summer does the bottom of the lake become anoxic.

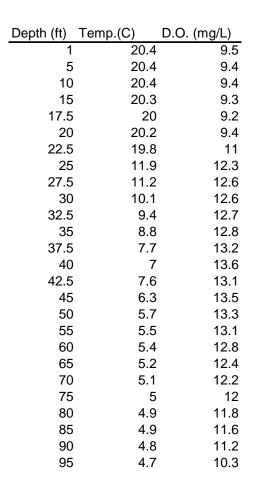
Lake:Maceday Lake (Oakland Co.)6/12/2023

Name:Maceday LakeCounty:OaklandSite ID:630415Date:6/12/2023

Dissolved Oxygen and Temperature Profile

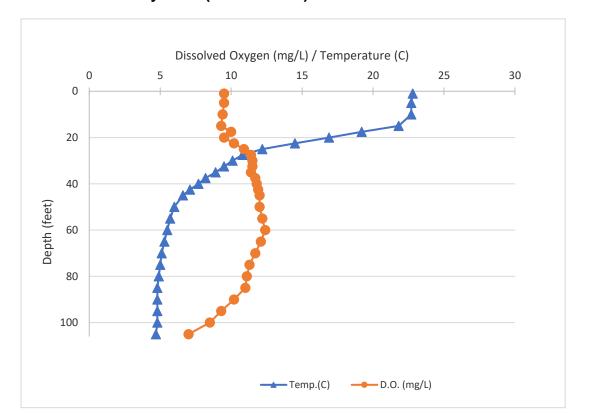
Lake: Maceday Lake (Oakland Co.)

Name:Maceday LakeCounty:OaklandSite ID:630415Date:6/29/2023

Dissolved Oxygen and Temperature Profile

Depth (ft)	Temp.(C)	D.O. (mg/L)
1	22.8	9.5
5	22.7	9.5
10	22.7	9.4
15	21.8	9.3
17.5	19.2	10
20	16.9	9.5
22.5	14.5	10.2
25	12.2	10.9
27.5	10.8	11.4
30	10.1	11.5
32.5	9.5	11.5
35	8.9	11.4
37.5	8.2	11.7
40	7.7	11.8
42.5	7.1	11.9
45	6.6	12
50	6	12
55	5.7	12.2
60	5.5	12.4
65	5.3	12.1
70	5.1	11.7
75	5	11.3
80	4.9	11.1
85	4.8	11
90	4.8	10.2
95	4.8	9.3
100	4.8	8.5
105	4.7	7

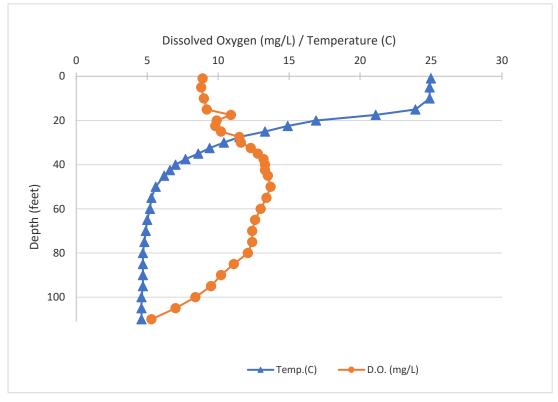
Lake: Maceday Lake (Oakland Co.)

Name:Maceday LakeCounty:OaklandSite ID:630415Date:7/14/2023

Dissolved Oxygen and Temperature Profile

Depth (ft) T	emp.(C)	D.O. (mg/L)
1	25	8.9
5	24.9	8.8
10	24.9	9
15	23.9	9.2
17.5	21.1	10.9
20	16.9	9.9
22.5	14.9	9.8
25	13.3	10.2
27.5	11.5	11.5
30	10.4	11.6
32.5	9.4	12.3
35	8.6	12.8
37.5	7.7	13.2
40	7	13.3
42.5	6.6	13.3
45	6.2	13.5
50	5.6	13.7
55	5.3	13.4
60	5.2	13
65	5	12.6
70	4.9	12.4
75	4.8	12.4
80	4.7	12.1
85	4.7	11.1
90	4.7	10.2
95	4.7	9.5
100	4.6	8.4
105	4.6	7
110	4.6	5.3

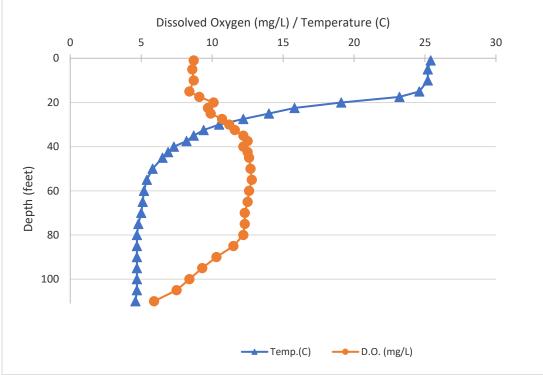
Lake:
 Maceday Lake (Oakland Co.)
 7/25/2023

Name:Maceday LakeCounty:OaklandSite ID:630415Date:7/25/2023

Dissolved Oxygen and Temperature Profile

Depth (ft)	Temp.(C)	D.O. (mg/L)
1	25.4	8.7
5	25.2	8.6
10	25.2	8.7
15	24.6	8.4
17.5	23.2	9.1
20	19.1	10.1
22.5	15.8	9.7
25	14	9.9
27.5	12.2	10.7
30	10.5	11.2
32.5	9.4	11.6
35	8.7	12.2
37.5	8.2	12.5
40	7.3	12.2
42.5	6.9	12.5
45	6.5	12.6
50	5.8	12.7
55	5.4	12.8
60	5.2	12.6
65	5.1	12.5
70	5	12.3
75	4.8	12.3
80	4.7	12.2
85	4.7	11.5
90	4.7	10.3
95	4.7	9.3
100	4.7	8.4
105	4.7	7.5
110	4.6	5.9

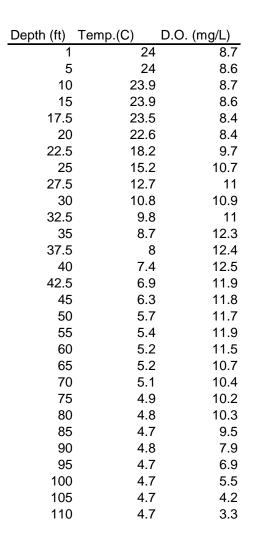
Name: Maceday Lake County: Oakland Site ID: 630415 Date: 8/11/2023

Dissolved Oxygen and Temperature Profile

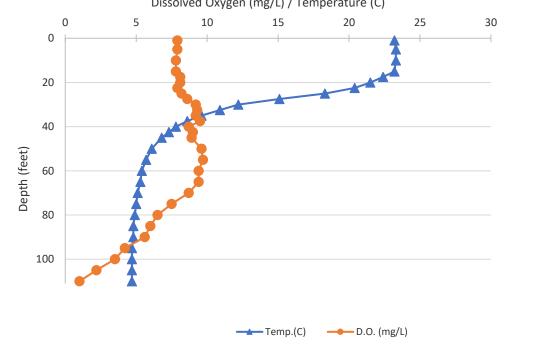
Name: Maceday Lake County: Oakland Site ID: 630415 Date: 9/8/2023

Dissolved Oxygen and Temperature Profile

Depth (ft)	Temp.(C)	D.O. (mg/L)
1	23.2	7.9
5	23.3	7.9
10	23.3	7.8
15	23.2	7.8
17.5	22.4	8.1
20	21.5	8.1
22.5	20.4	7.9
25	18.3	8.2
27.5	15.1	8.6
30	12.2	9.2
32.5	10.9	9.3
35	9.6	9.2
37.5	8.6	9.5
40	7.8	8.7
42.5	7.3	9
45	6.8	8.9
50	6.1	9.6
55	5.7	9.7
60	5.4	9.4
65	5.3	9.4
70	5.1	8.7
75	5	7.5
80	4.9	6.5
85	4.8	6
90	4.8	5.6
95	4.7	4.2
100	4.7	3.5
105	4.7	2.2
110	4.7	1
