2023 Data Report for Oneida Lake, Livingston County

Site ID: 470593

Oneida Lake, Livingston County 2023 CLMP Results

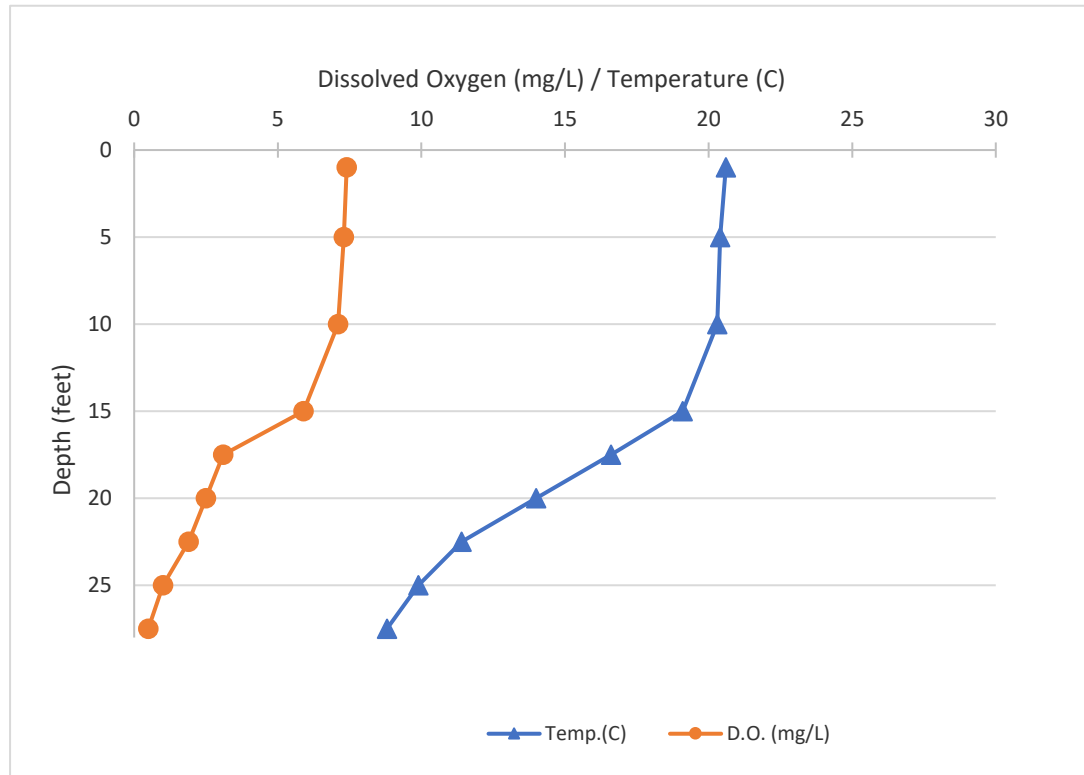
9/15/2023

Depth (ft)	Temp.(C)	D.O. (mg/L)
1	20.6	7.4
5	20.4	7.3
10	20.3	7.1
15	19.1	5.9
17.5	16.6	3.1
20	14	2.5
22.5	11.4	1.9
25	9.9	1
27.5	8.8	0.49
