2023 Data Report for Painter Lake, Cass County

Site ID: 140108

Painter Lake, Cass County 2023 CLMP Results

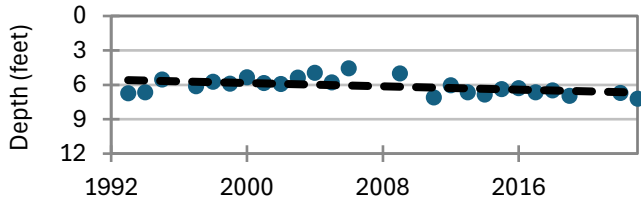
Secchi Disk Transparency (feet)

Year	# Readings	Min	Max	Average	Std. Dev	Carlson TSI
2023	9	6.0	8.0	7.2	0.6	49
2018-2022	34	4.5	9.0	6.7	1.1	50
1993-2017	317	2.5	13.0	6.0	1.3	51
2023 All CLMP Lakes	2825	0.5	51.0	12.2	2.7	43

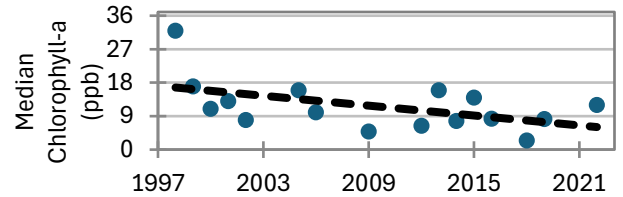
Chlorophyll-a (parts per billion)

Year	# Samples	Min	Max	Median	Std. Dev	Carlson TSI
2022	5	7.1	22.0	12.0	6.6	55
2017-2021	5	1.1	17.0	2.5	6.7	40
1998-2016	69	1.6	190.0	2.5	20.8	54
2023 All CLMP Lakes	687	< 1.0	43.0	3.7	5.3	43

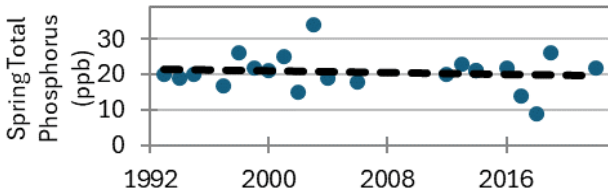
Spring Phosphorus (parts per billion)

Year	# Samples	Min	Max	Average	Std. Dev
2022	1	22.0	22.0	22.0	NA
2017-2021	3	9.0	26.0	16.3	8.7
1993-2016	17	15.0	34.0	21.4	4.2
2023 All CLMP Lakes	220	<5	220.0	20.7	21.3

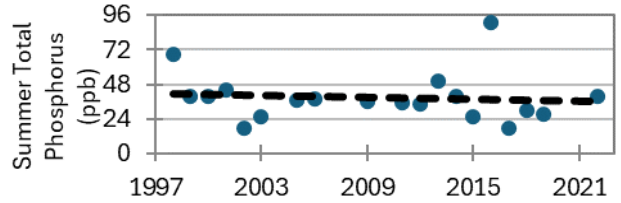
Summer Phosphorus (parts per billion)

Year	# Samples	Min	Max	Average	Std. Dev	Carlson TSI
2022	1	40.0	40.0	40.0	NA	57
2017-2021	2	18.0	30.0	24.0	8.5	50
1998-2016	15	18.0	91.0	41.6	17.9	57
2023 All CLMP Lakes	234	<= 3	150.0	17.4	15.3	45

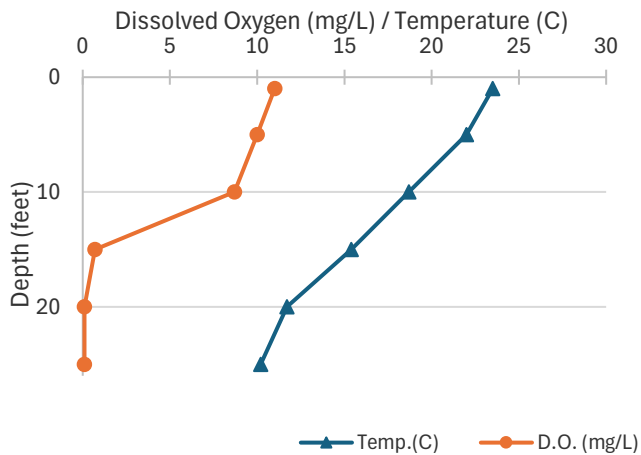
Dissolved Oxygen and Temperature Profile

6/13/2022

Monitoring data indicates that this lake is devoid of oxygen in the bottom waters by early summer and that the lakes remain stratified through early fall.

If you enrolled in Dissolved Oxygen/Temperature, the summary page will have a graph of one of the profiles taken during the late summer (typically August or September). If your lake stratifies, we will use a graph showing the earliest time of stratification, because identifying the timing of this condition and the depth at which it occurs is typically the most important use of dissolved oxygen measurements.

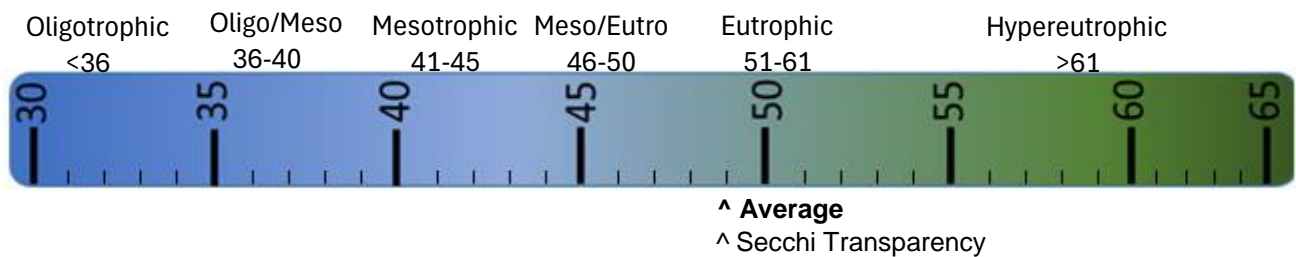
TSI for Painter Lake in 2023	
Average	49
Secchi Disk	49
Summer TP	
Chlorophyll-a

In 1977, limnologist Dr. Robert Carlson developed a numerical scale (0-100) where the numbers indicate the level of nutrient enrichment. Using the proper equations, we can convert results from Summer Total Phosphorus, Secchi Depth, and Chlorophyll-a to this Trophic Status Index (TSI). The TSI numbers are furthermore grouped into general categories (oligotrophic, mesotrophic, eutrophic, and hypereutrophic), to quickly give us a way to understand the general nutrient level of any lake.

Oligotrophic: Generally deep and clear lakes with little aquatic plant or algae growth. These lakes maintain sufficient dissolved oxygen in the cool, deep-bottom waters during late summer to support cold water fish, such as trout and whitefish.

Mesotrophic: Lakes that fall between oligotrophic and eutrophic. Mid-ranged amounts of nutrients.

Eutrophic: Highly productive eutrophic lakes are generally shallow, turbid, and support abundant aquatic plant growth. In deep eutrophic lakes, the cool bottom waters usually contain little or no dissolved oxygen. Therefore, these lakes can only support warm water fish, such as bass and pike.

Hypereutrophic: A specialized category of eutrophic lakes. These lakes exhibit extremely high productivity, such as nuisance algae and weed growth.

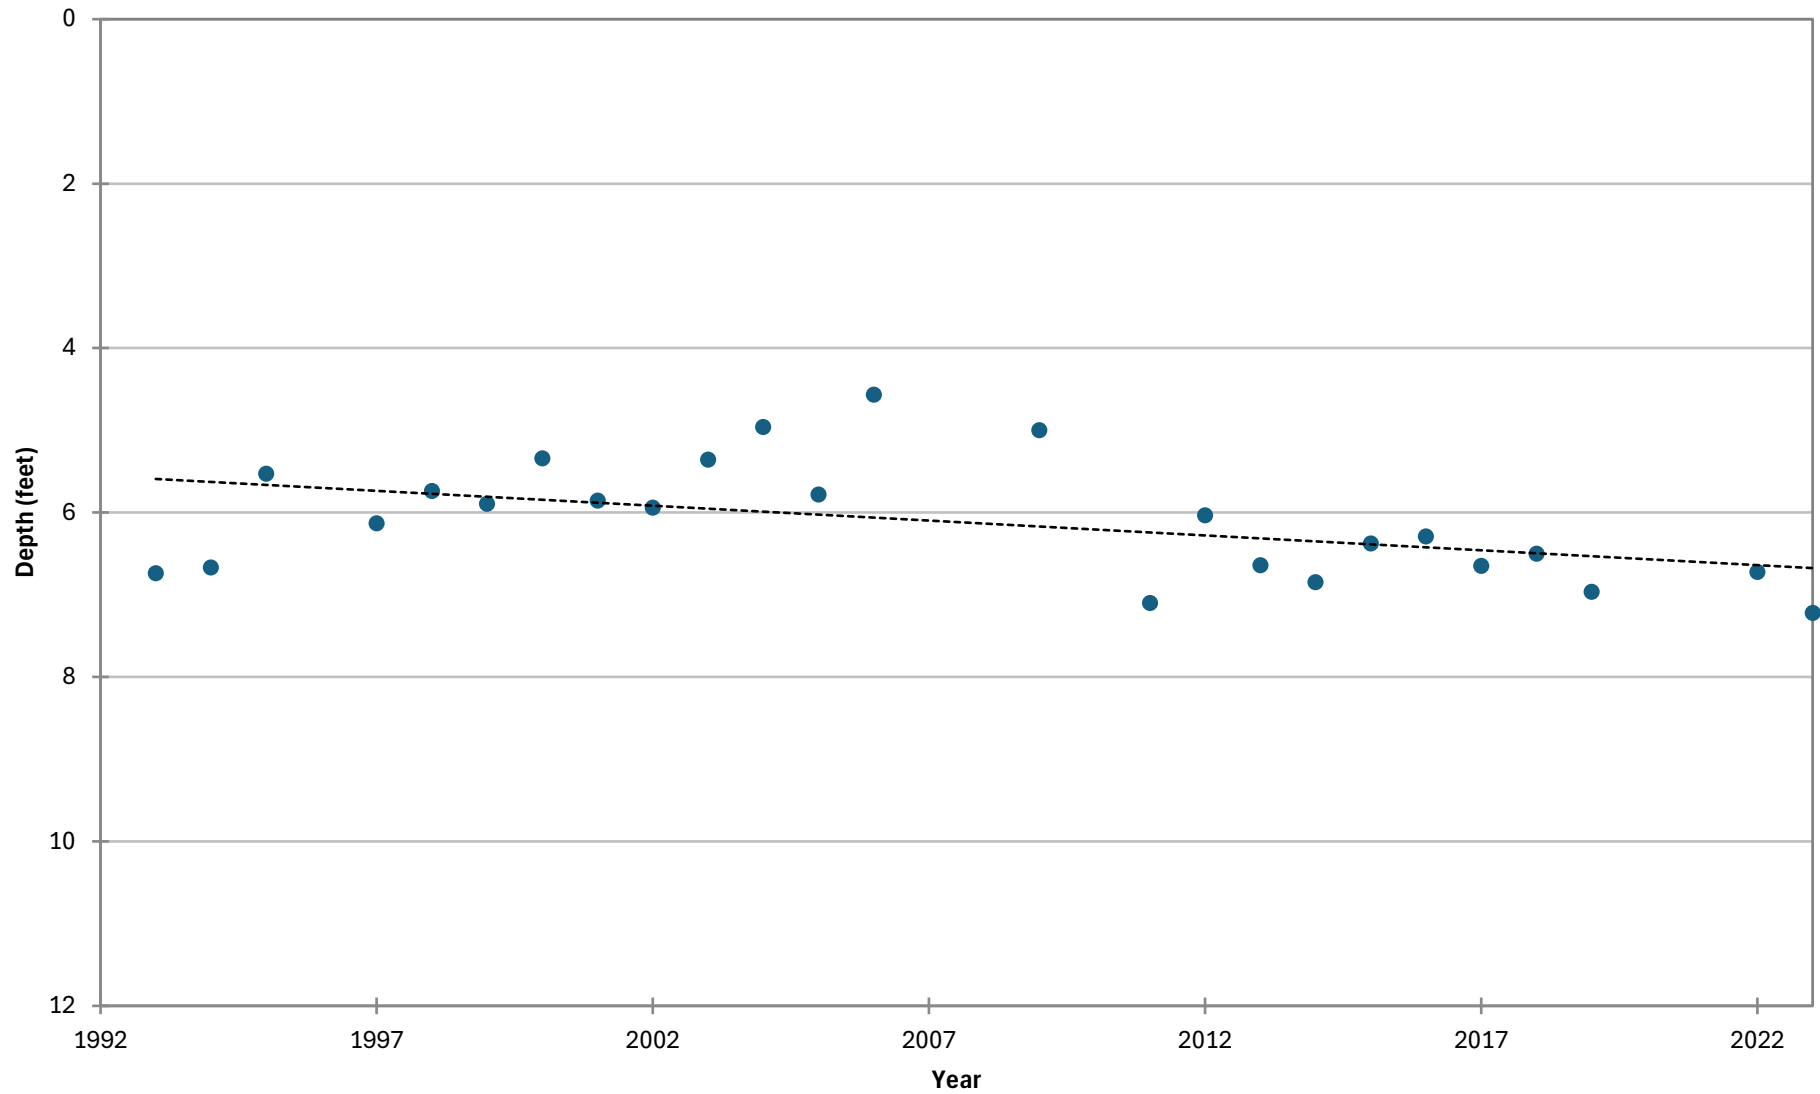
COOPERATIVE LAKES MONITORING PROGRAM
SUMMER MEAN TRANSPARENCY

Painter Lake (Cass Co.), 140108

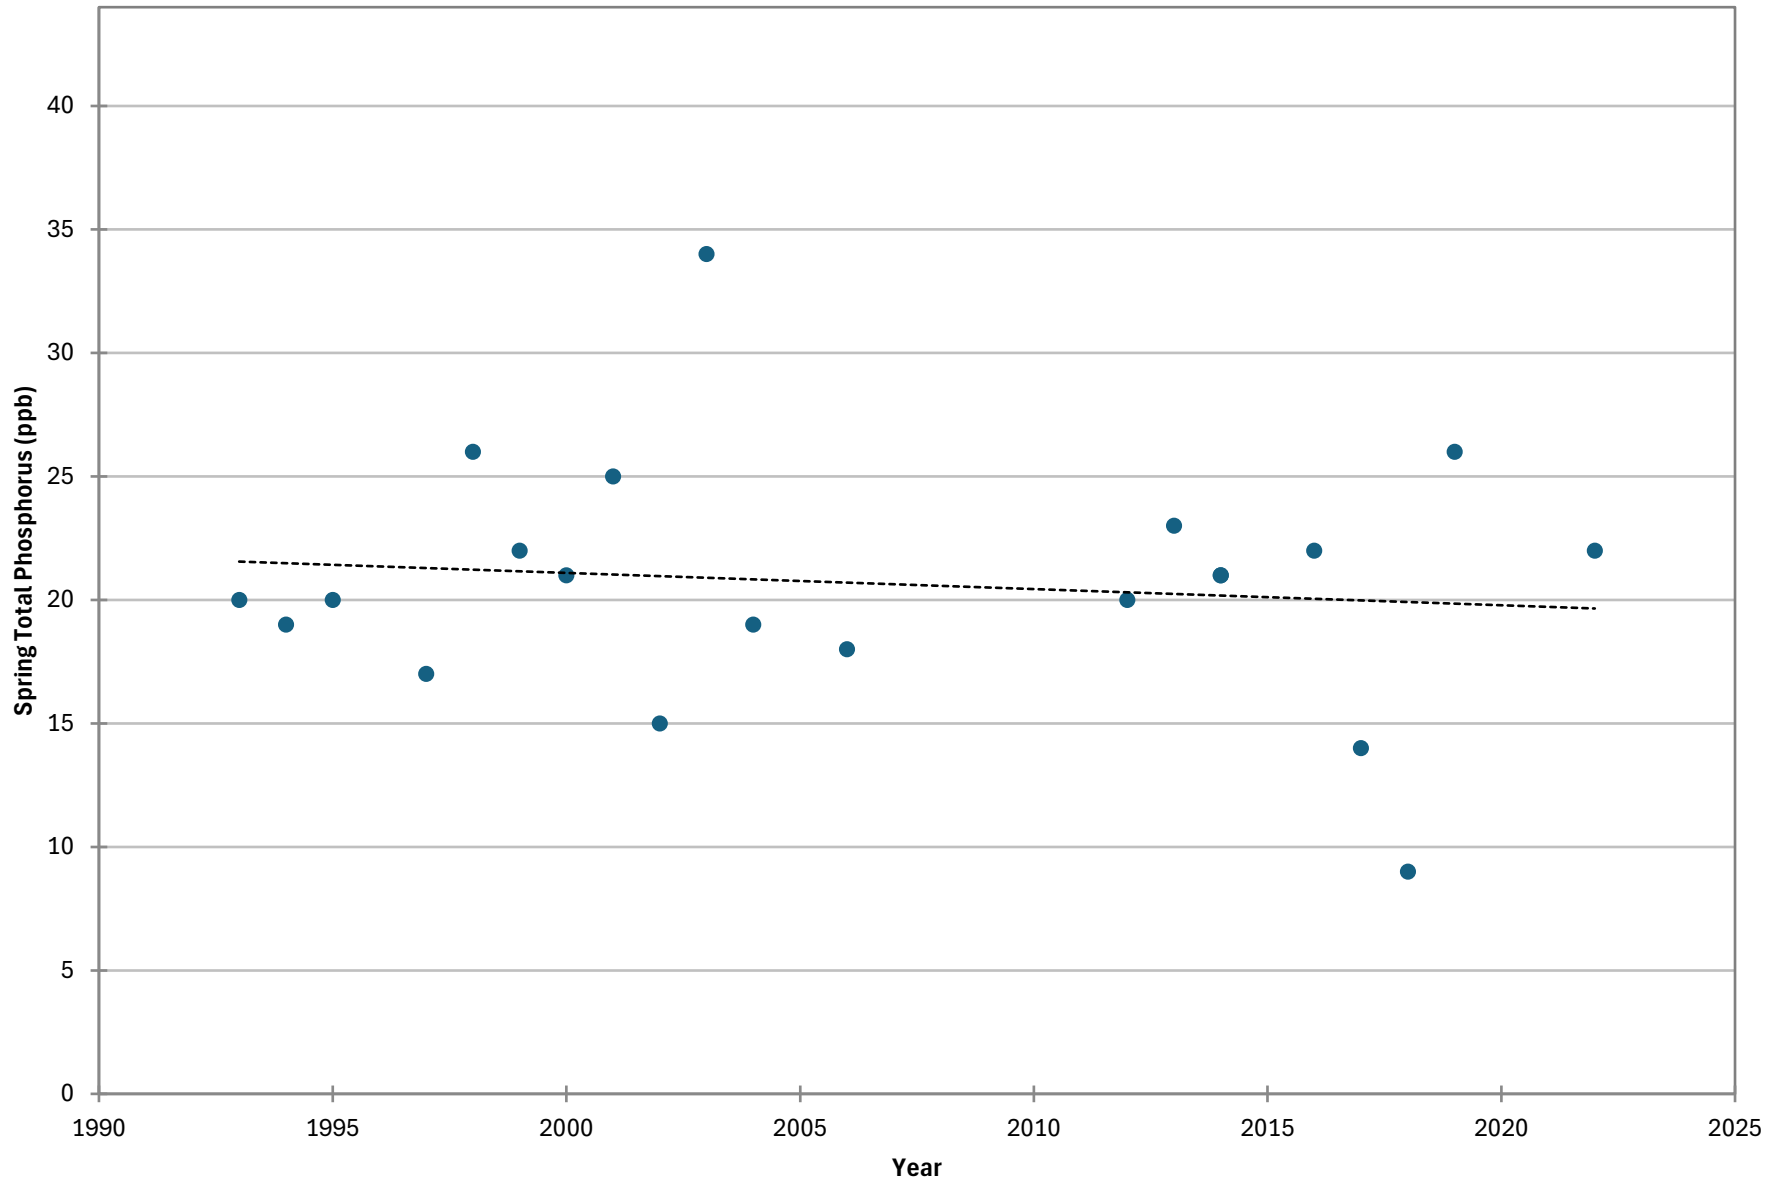
COOPERATIVE LAKES MONITORING PROGRAM
SPRING TOTAL PHOSPHORUS

Painter Lake (Cass Co.), 140108

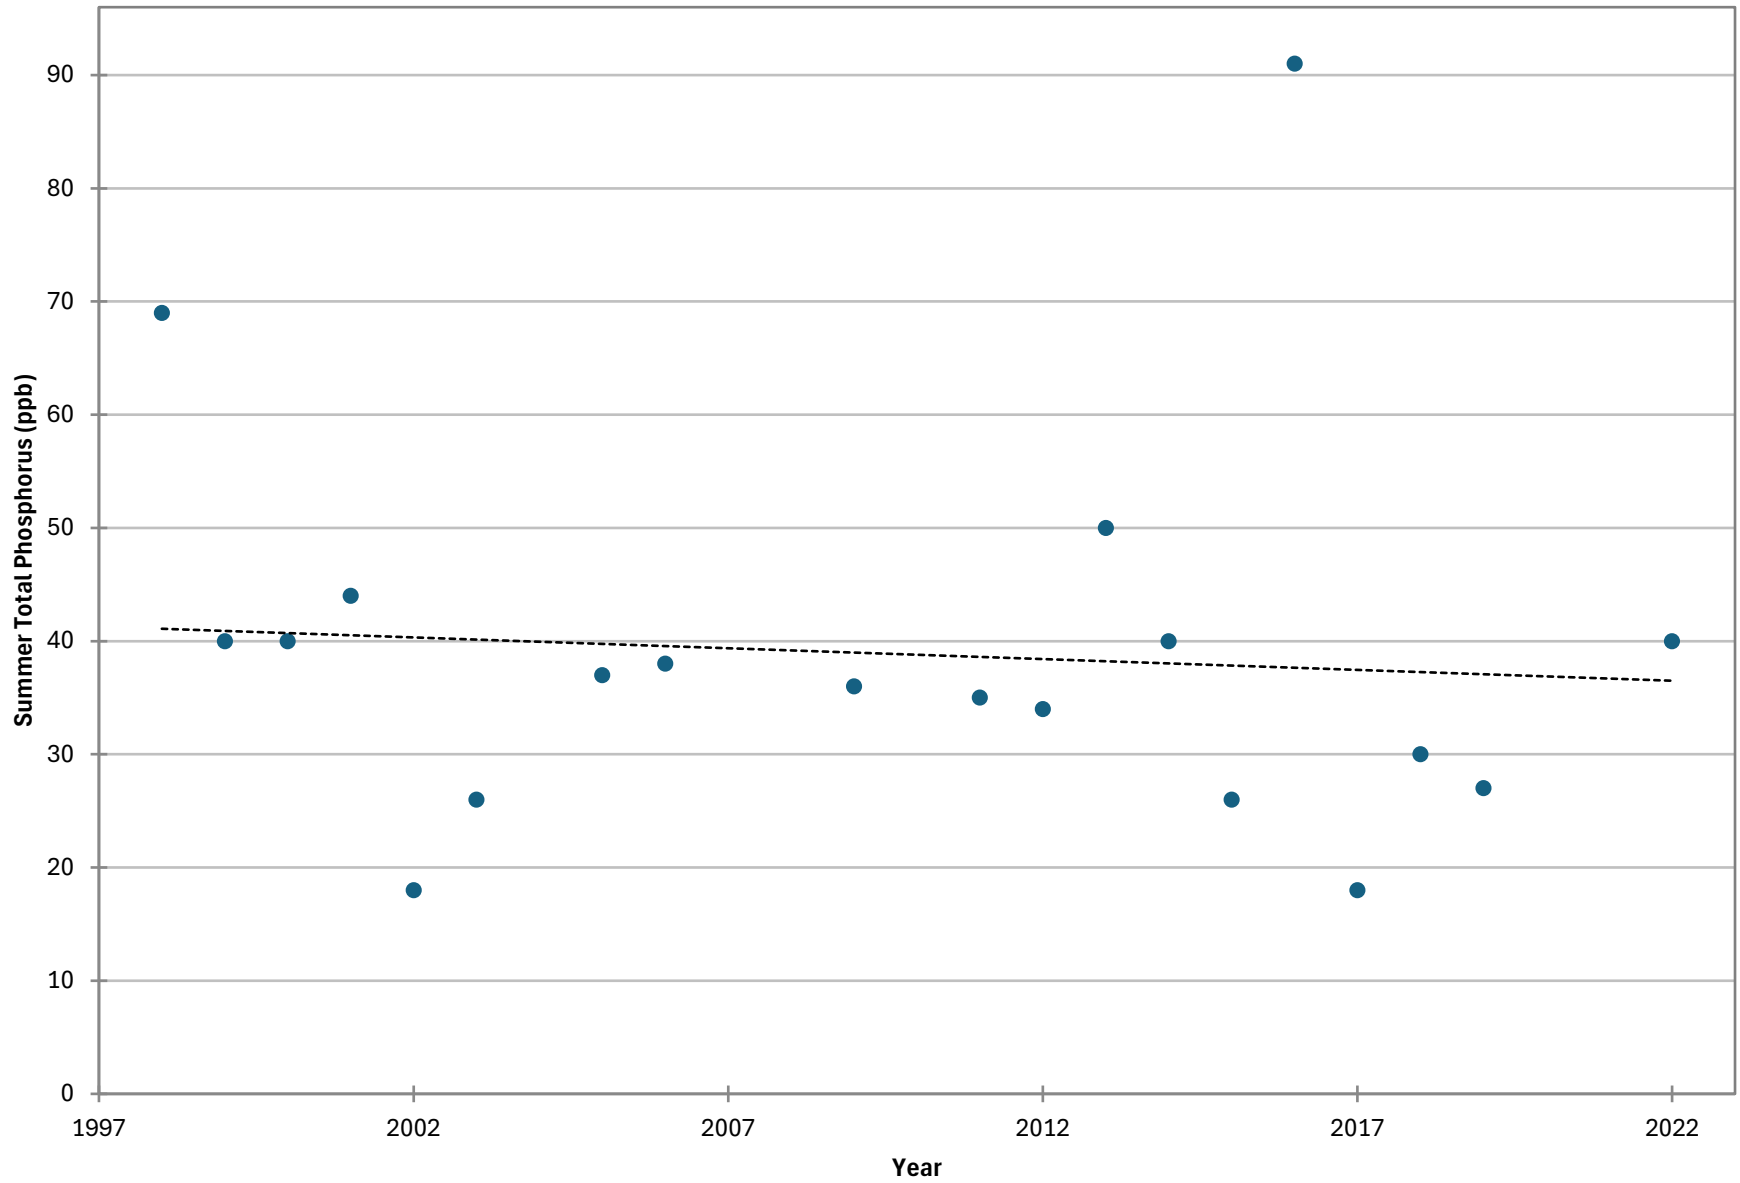
COOPERATIVE LAKES MONITORING PROGRAM
SUMMER TOTAL PHOSPHORUS

Painter Lake (Cass Co.), 140108

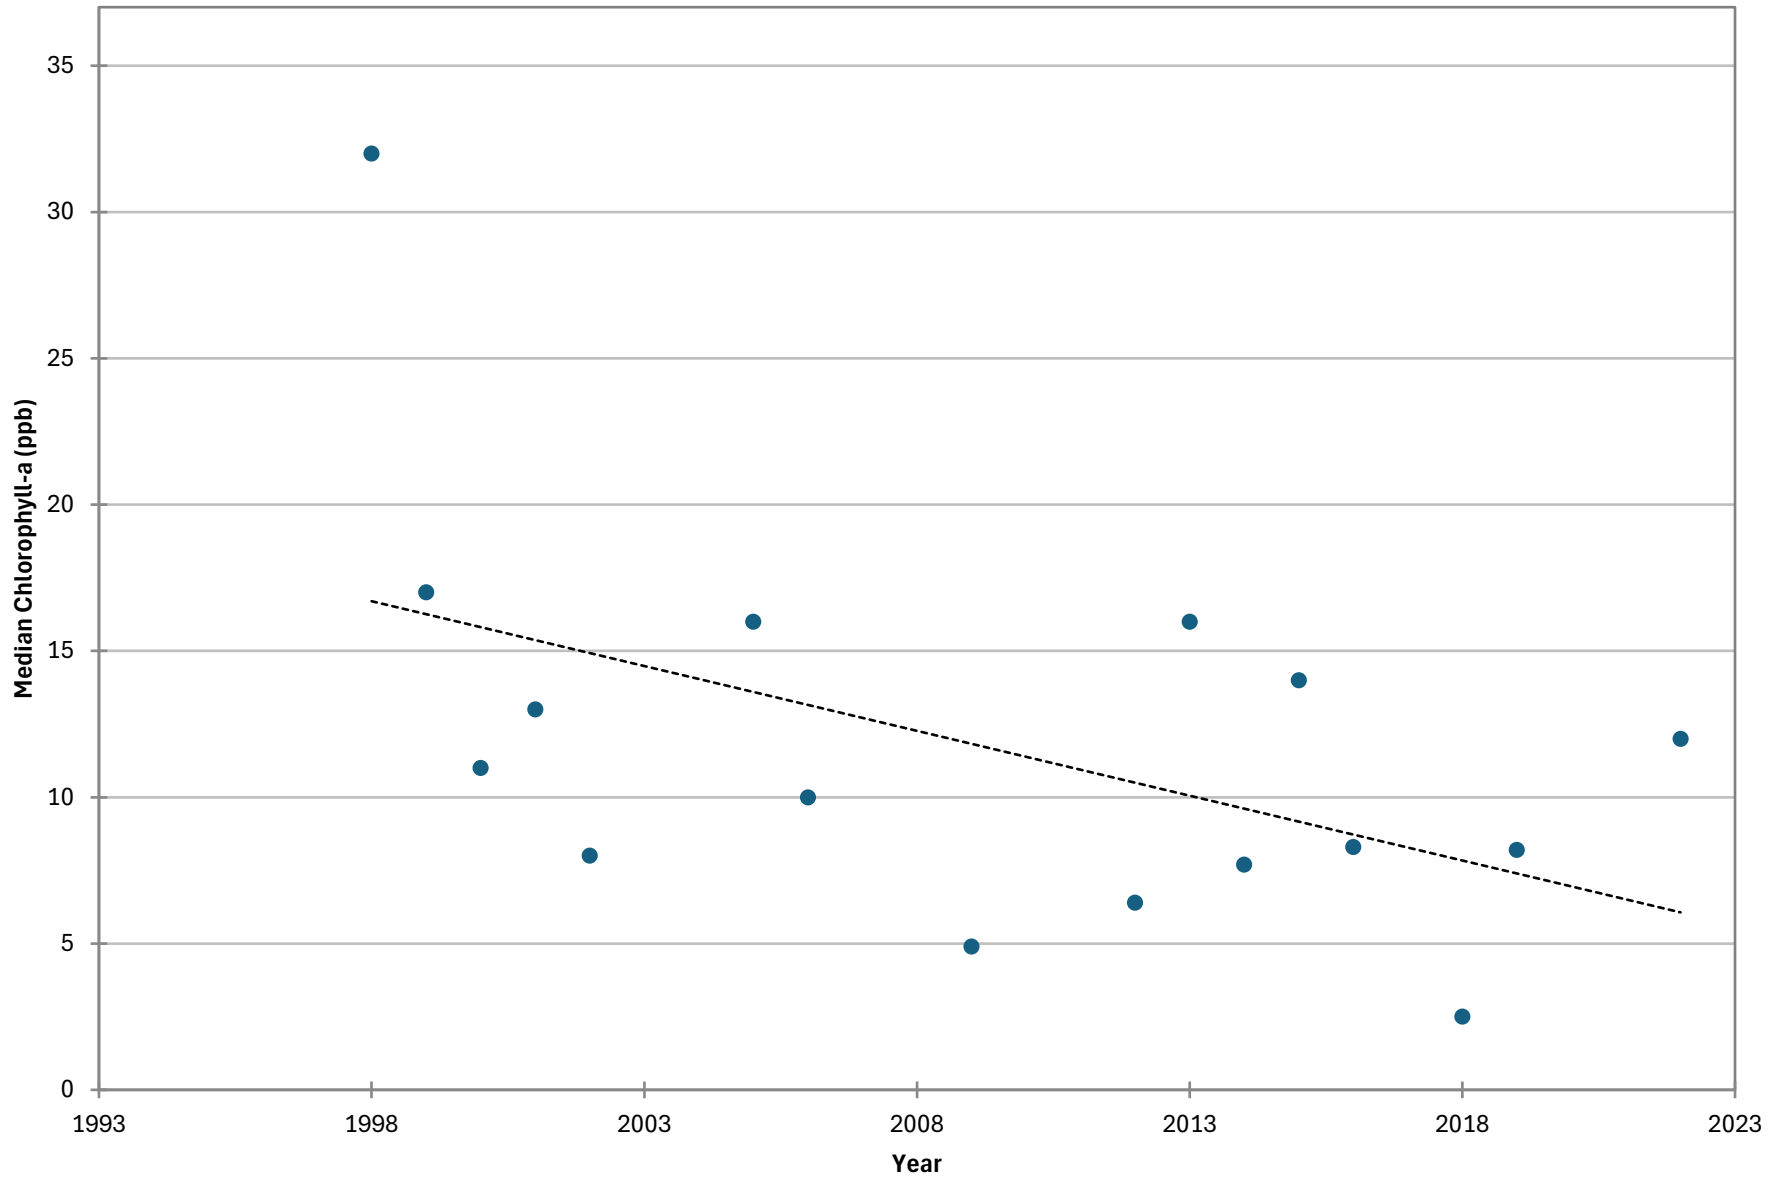
COOPERATIVE LAKES MONITORING PROGRAM
SUMMER MEDIAN CHLOROPHYLL-A

Painter Lake (Cass Co.), 140108

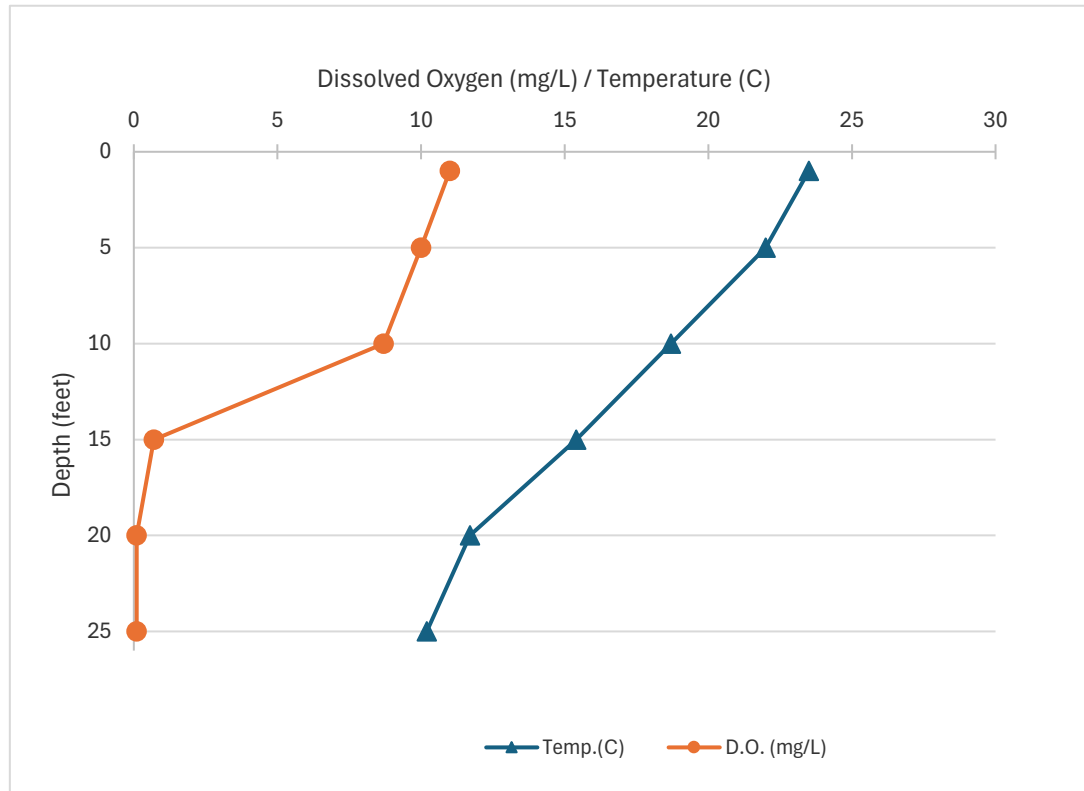
6/13/2022

Dissolved Oxygen and Temperature Profile

Depth (ft)	Temp.(C)	D.O. (mg/L)
1	23.5	11
5	22	10
10	18.7	8.7
15	15.4	0.7
20	11.7	0.1
25	10.2	0.1

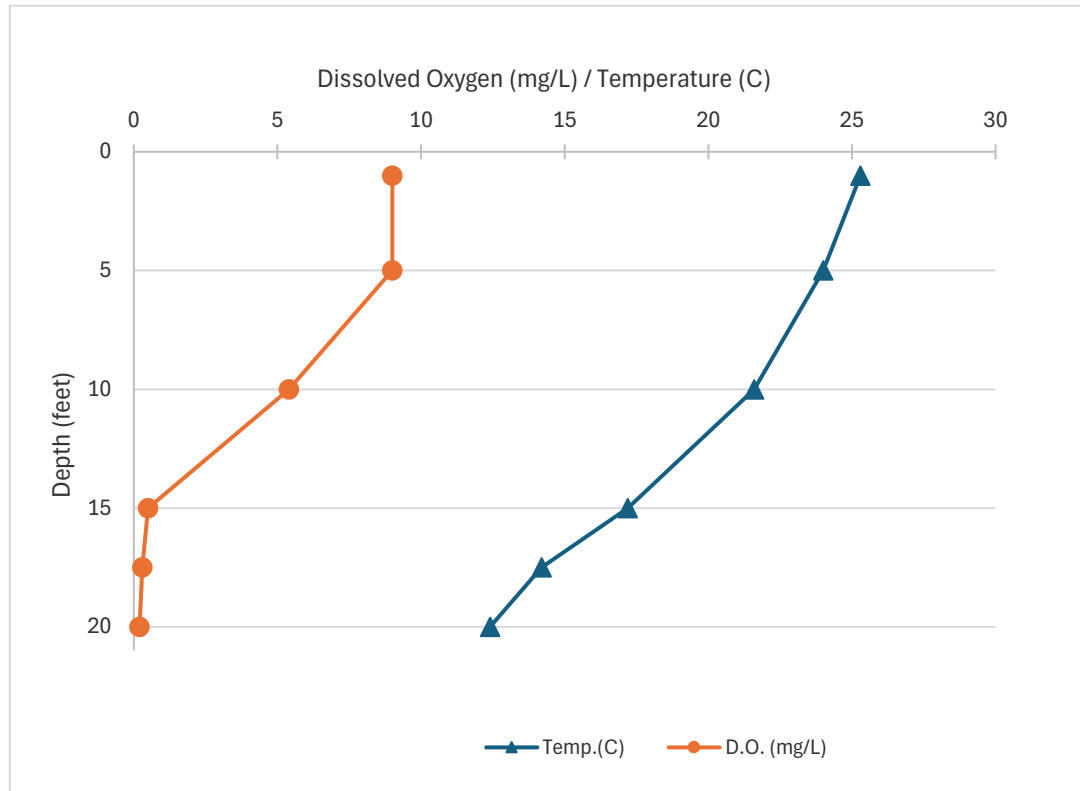
7/2/2022

Dissolved Oxygen and Temperature Profile

Depth (ft)	Temp.(C)	D.O. (mg/L)
1	25.3	9
5	24	9
10	21.6	5.4
15	17.2	0.5
17.5	14.2	0.3
20	12.4	0.2

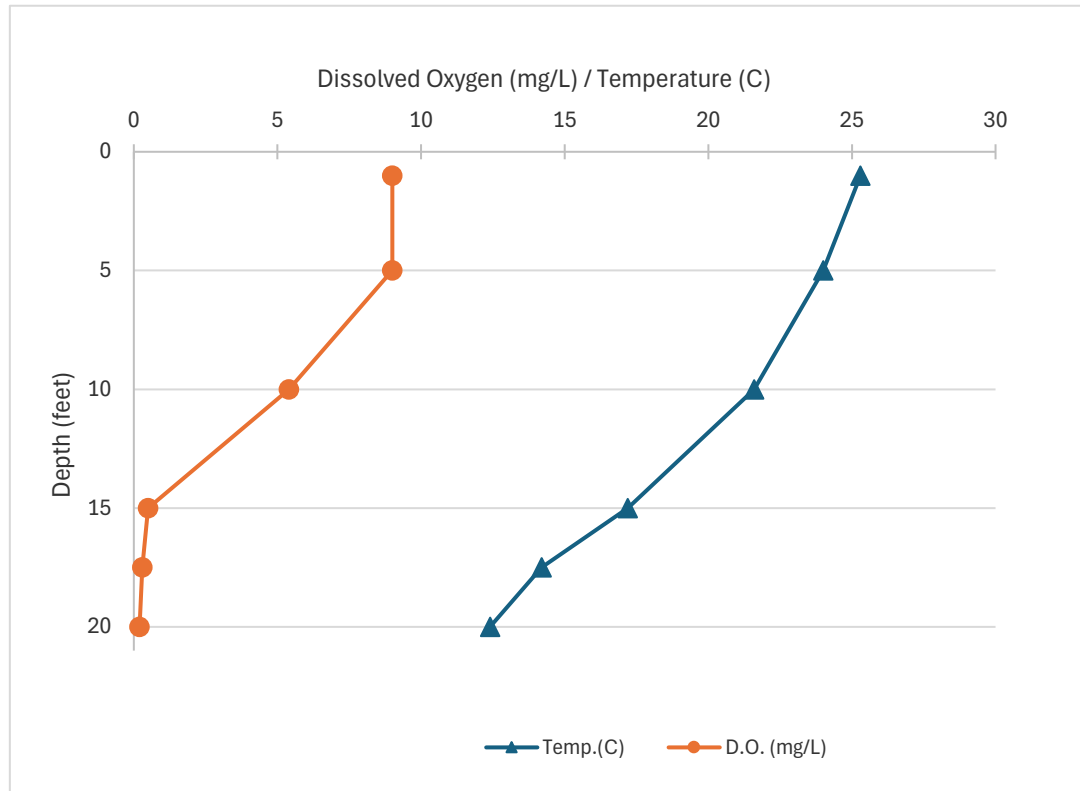
7/7/2022

Dissolved Oxygen and Temperature Profile

Depth (ft)	Temp.(C)	D.O. (mg/L)
1	25.3	9
5	24	9
10	21.6	5.4
15	17.2	0.5
17.5	14.2	0.3
20	12.4	0.2

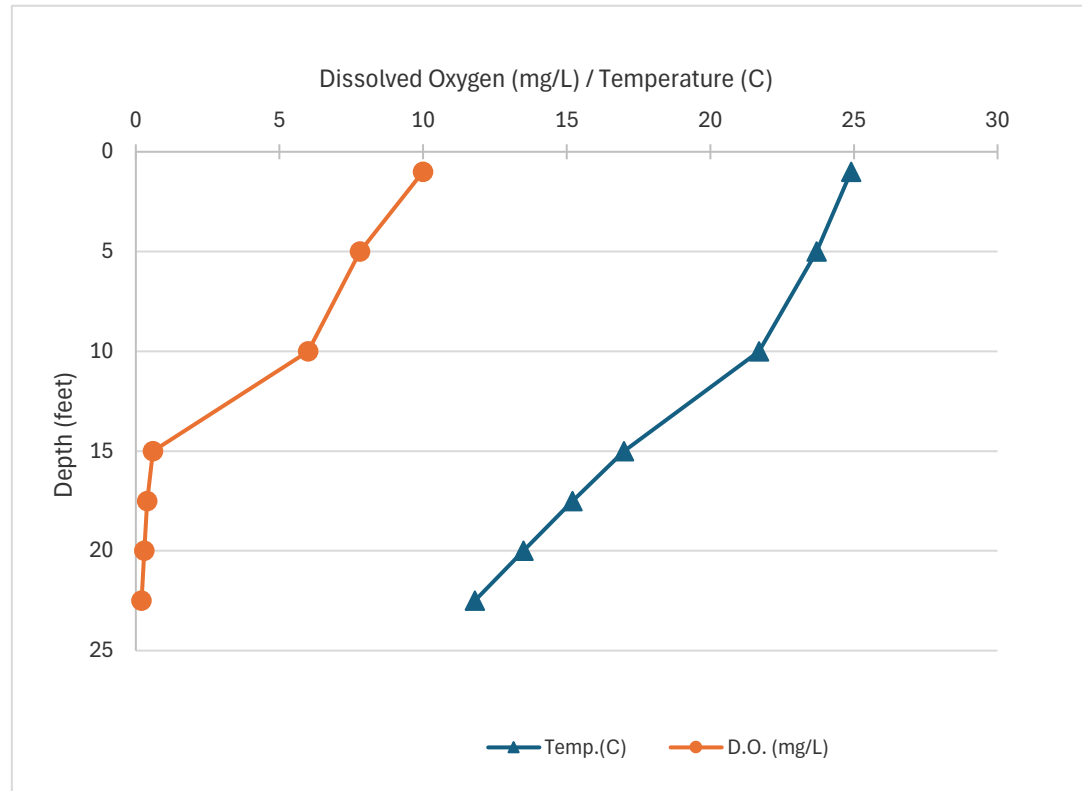
7/16/2022

Dissolved Oxygen and Temperature Profile

Depth (ft)	Temp.(C)	D.O. (mg/L)
1	24.9	10
5	23.7	7.8
10	21.7	6
15	17	0.6
17.5	15.2	0.4
20	13.5	0.3
22.5	11.8	0.2

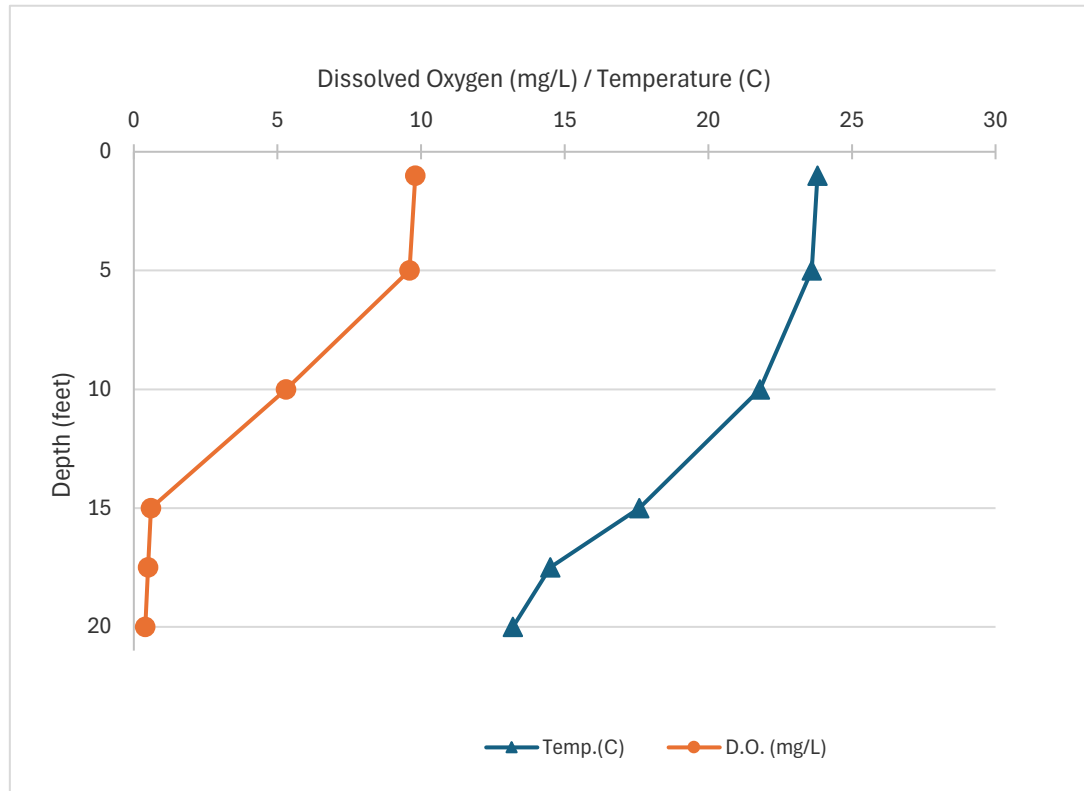
7/30/2022

Dissolved Oxygen and Temperature Profile

Depth (ft)	Temp.(C)	D.O. (mg/L)
1	23.8	9.8
5	23.6	9.6
10	21.8	5.3
15	17.6	0.6
17.5	14.5	0.5
20	13.2	0.4

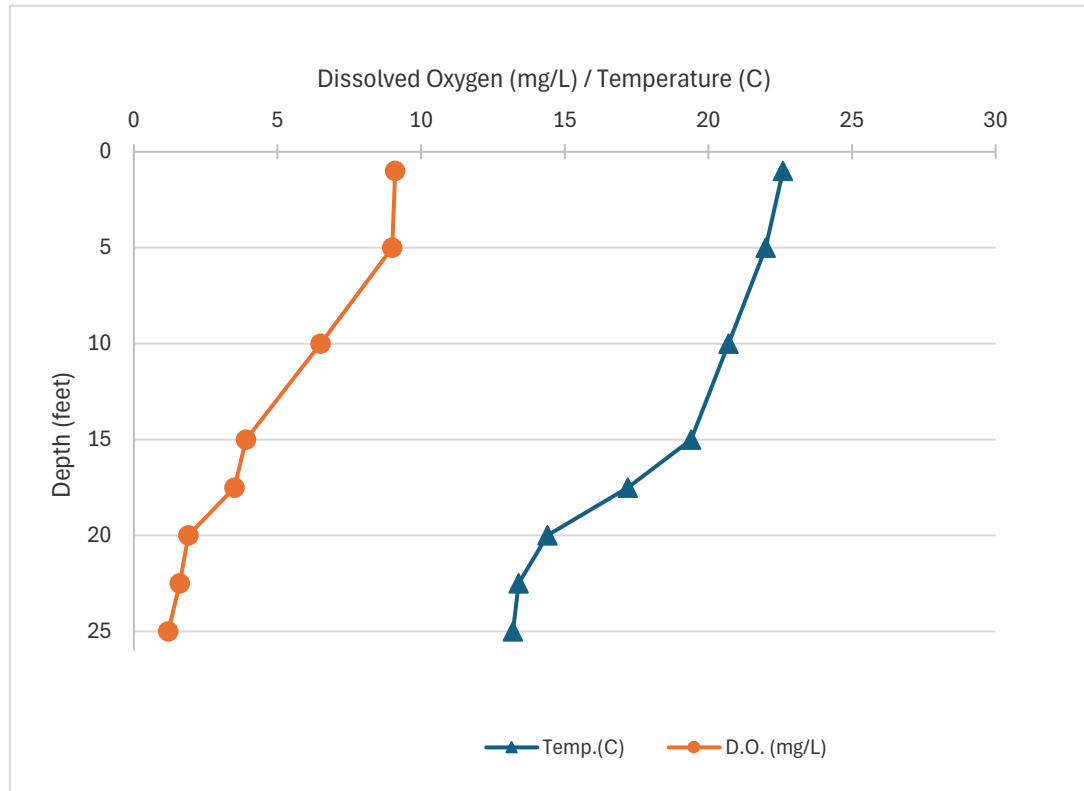
8/16/2022

Dissolved Oxygen and Temperature Profile

Depth (ft)	Temp.(C)	D.O. (mg/L)
1	22.6	9.1
5	22	9
10	20.7	6.5
15	19.4	3.9
17.5	17.2	3.5
20	14.4	1.9
22.5	13.4	1.6
25	13.2	1.2

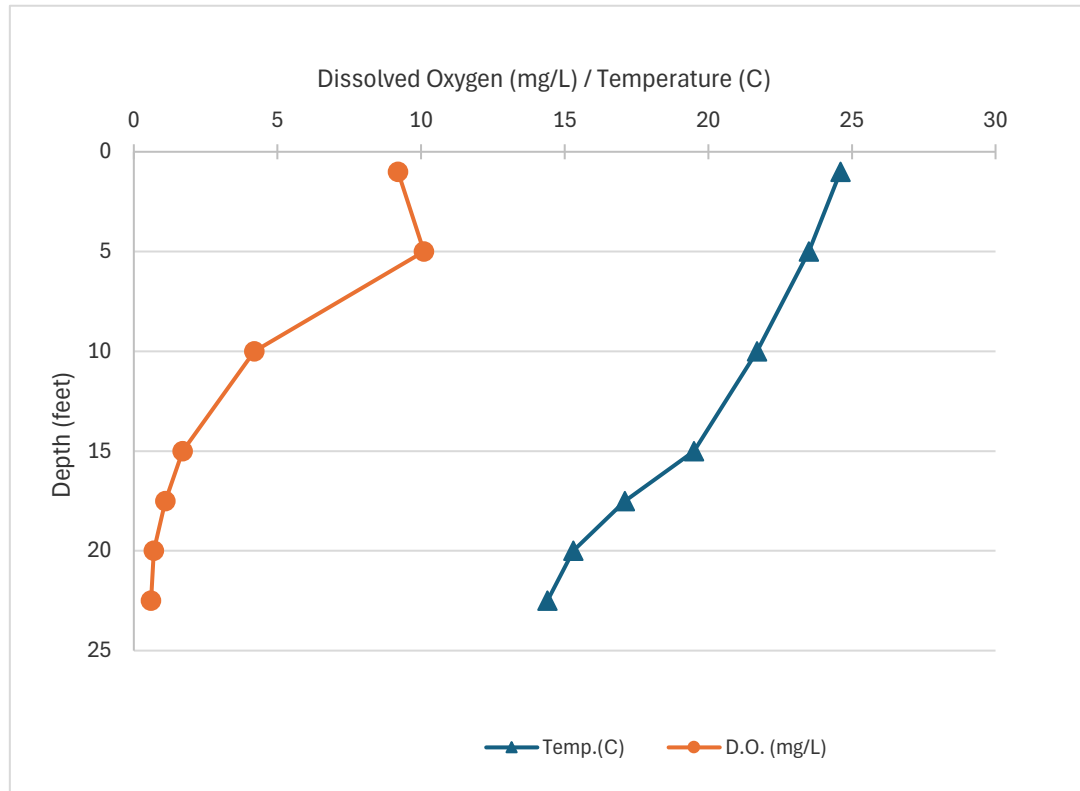
9/3/2022

Dissolved Oxygen and Temperature Profile

Depth (ft)	Temp.(C)	D.O. (mg/L)
1	24.6	9.2
5	23.5	10.1
10	21.7	4.2
15	19.5	1.7
17.5	17.1	1.1
20	15.3	0.7
22.5	14.4	0.6

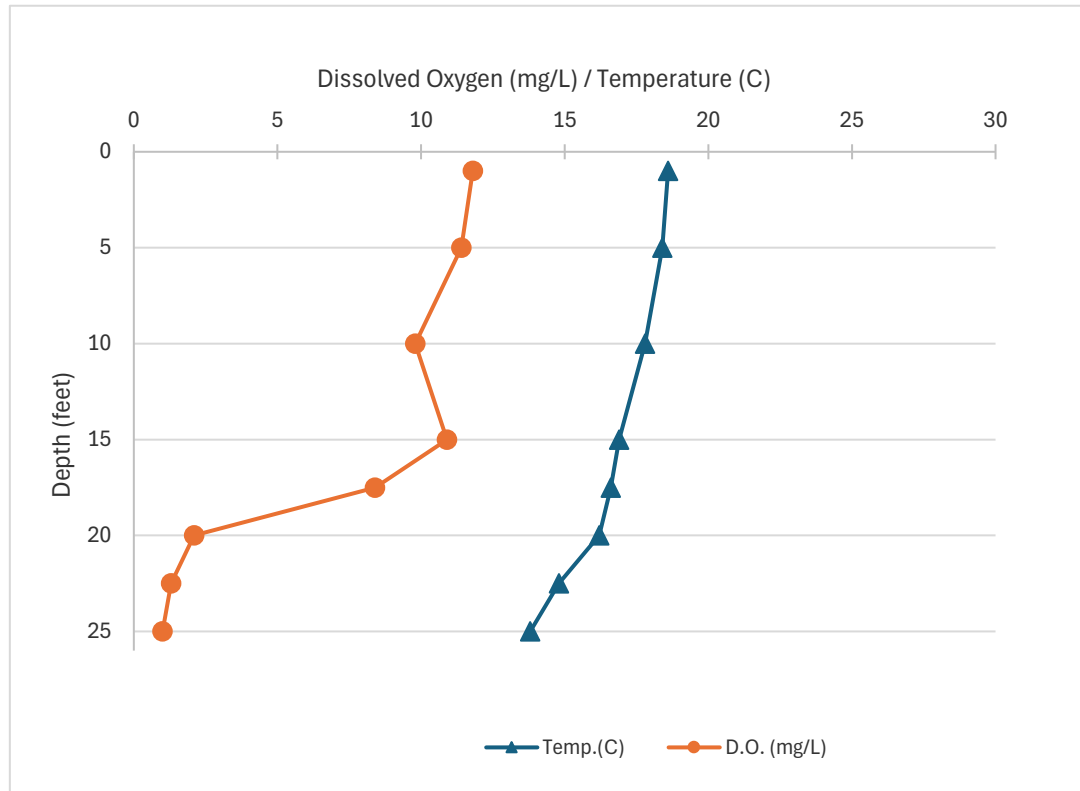
9/24/2022

Dissolved Oxygen and Temperature Profile

Depth (ft)	Temp.(C)	D.O. (mg/L)
1	18.6	11.8
5	18.4	11.4
10	17.8	9.8
15	16.9	10.9
17.5	16.6	8.4
20	16.2	2.1
22.5	14.8	1.3
25	13.8	1
