2023 Data Report for

Pentwater Lake, Oceana County

Site ID: 640089

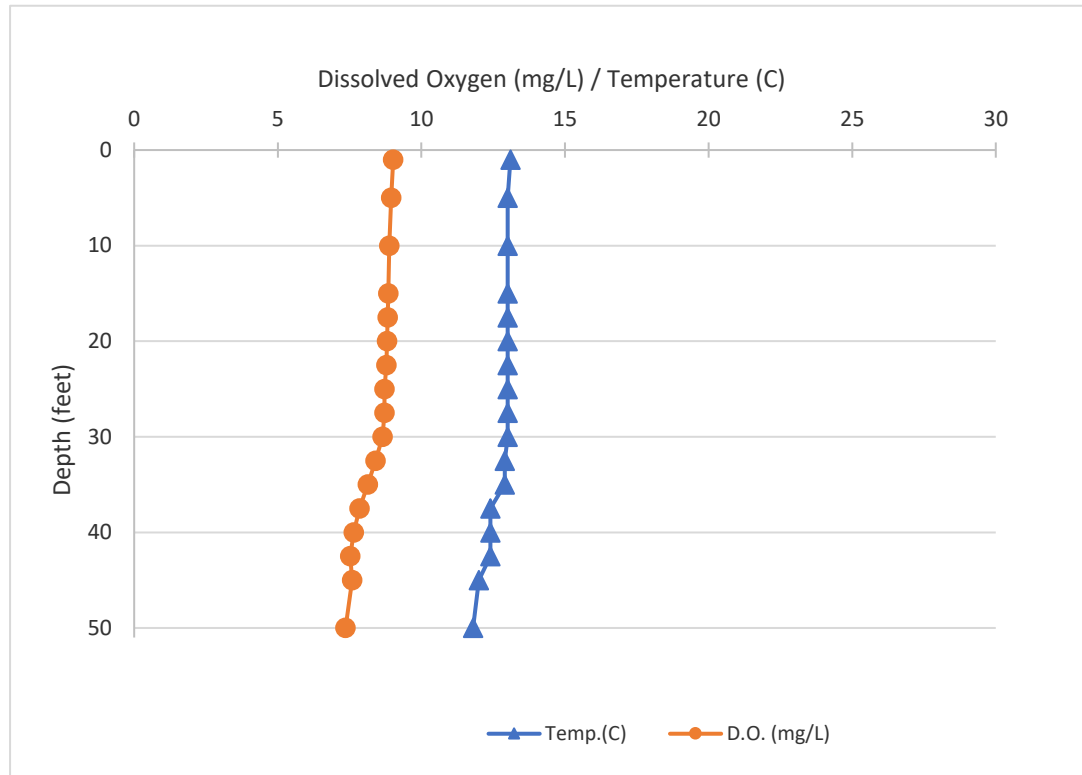
Name: Pentwater Lake
County: Oceana
Site ID: 640089
Date: 10/19/2023

Depth (ft)	Temp.(C)	D.O. (mg/L)
1	13.1	9.02
5	13	8.95
10	13	8.88
15	13	8.85
17.5	13	8.83
20	13	8.8
22.5	13	8.78
25	13	8.72
27.5	13	8.72
30	13	8.65
32.5	12.9	8.4
35	12.9	8.14
37.5	12.4	7.85
40	12.4	7.65
42.5	12.4	7.52
45	12	7.59
50	11.8	7.36
