2023 Data Report for

Rose Lake, Osceola County

Site ID: 670058

Rose Lake, Osceola County 2023 CLMP Results

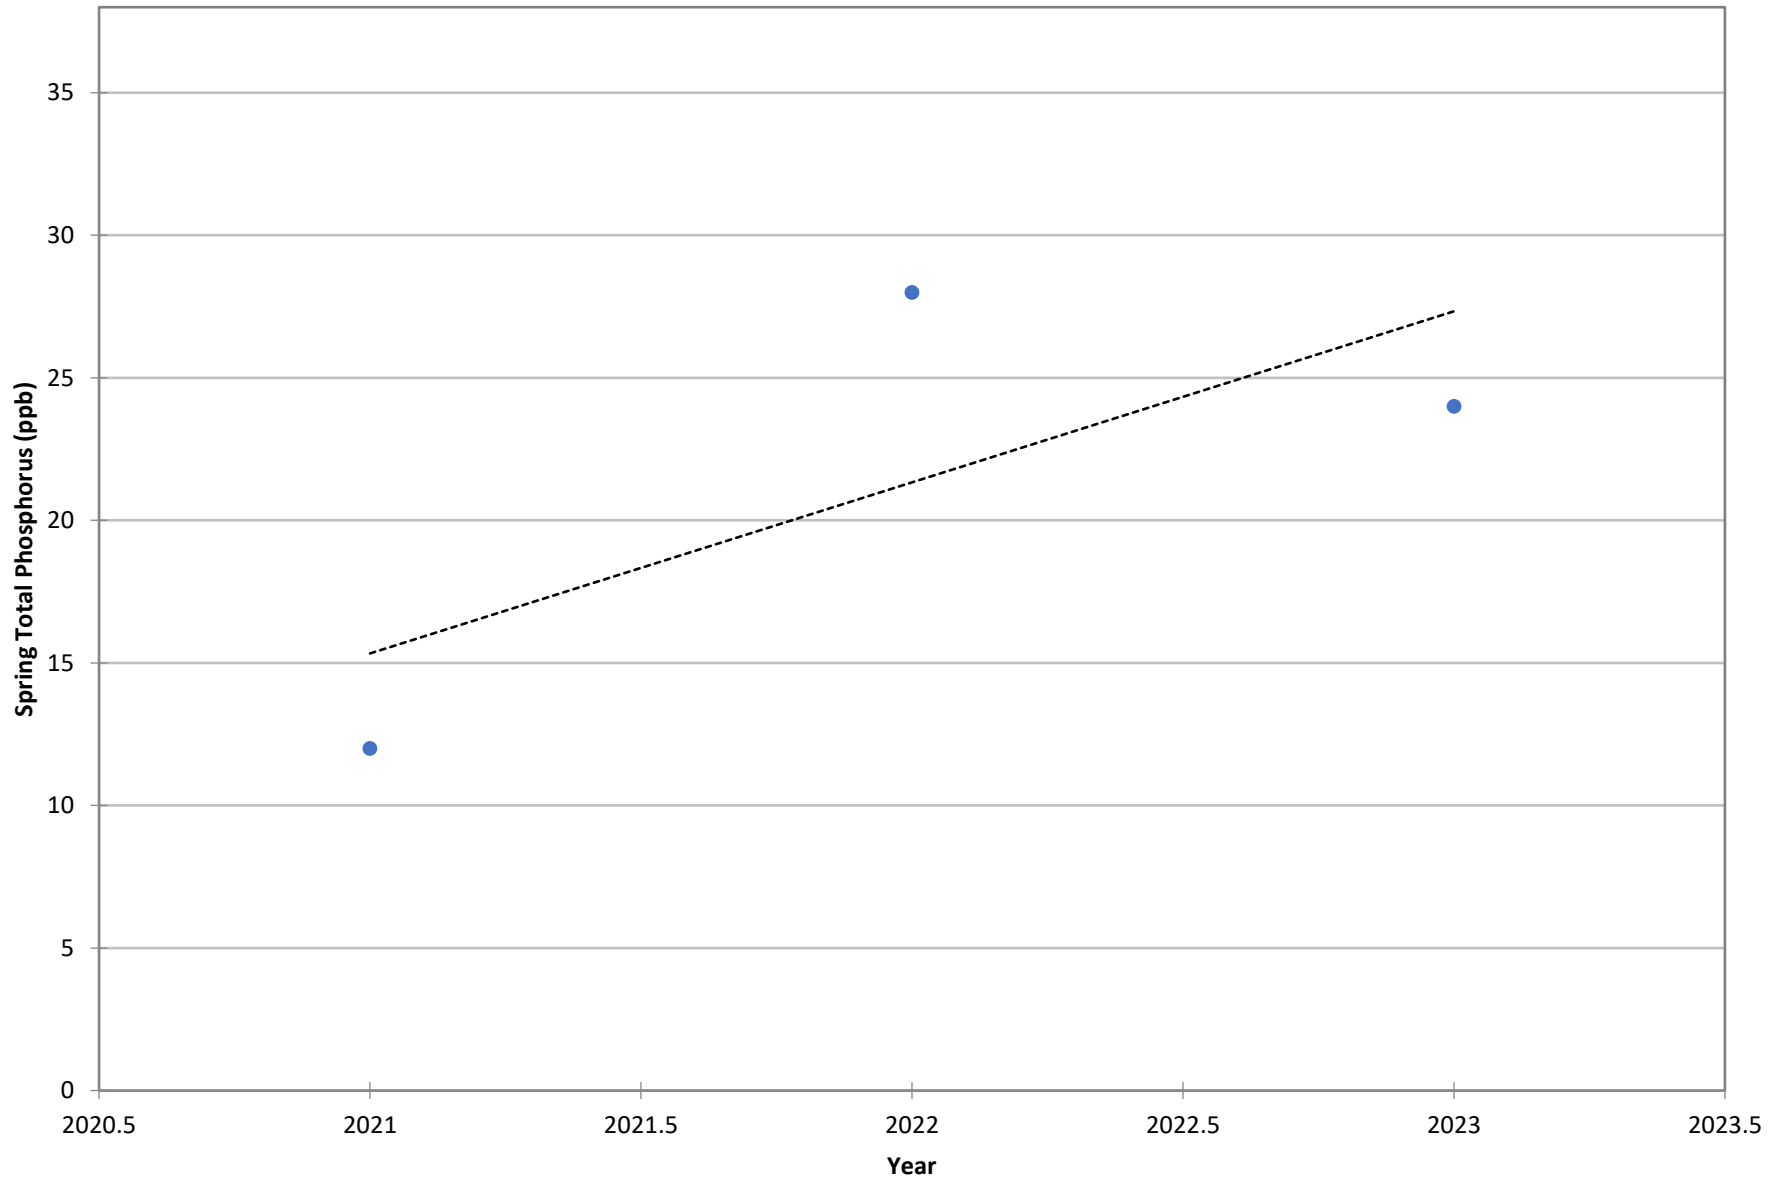
COOPERATIVE LAKES MONITORING PROGRAM
SPRING TOTAL PHOSPHORUS

Rose Lake (Osceola Co.), 670058

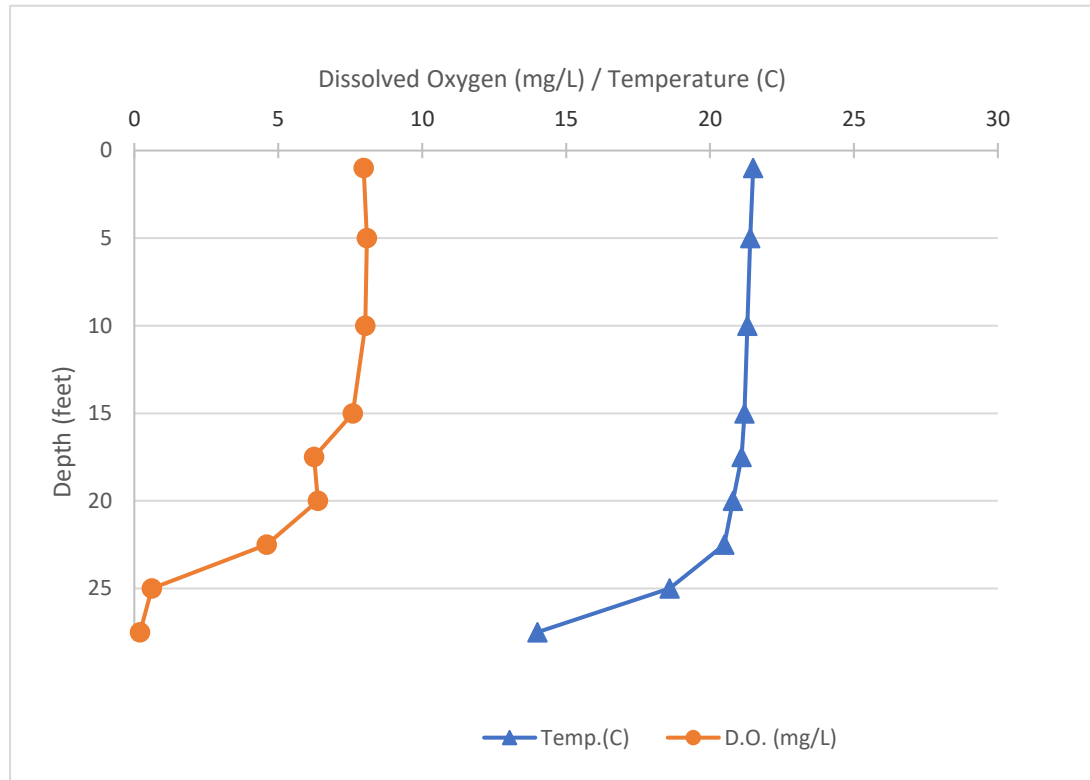
9/10/2023

Dissolved Oxygen and Temperature Profile

Depth (ft)	Temp.(C)	D.O. (mg/L)
1	21.5	7.97
5	21.4	8.08
10	21.3	8.02
15	21.2	7.59
17.5	21.1	6.24
20	20.8	6.38
22.5	20.5	4.6
25	18.6	0.61
27.5	14	0.2
