2023 Data Report for

Upper Herring Lake, Benzie County

Site ID: 100247

Upper Herring Lake, Benzie County 2023 CLMP Results

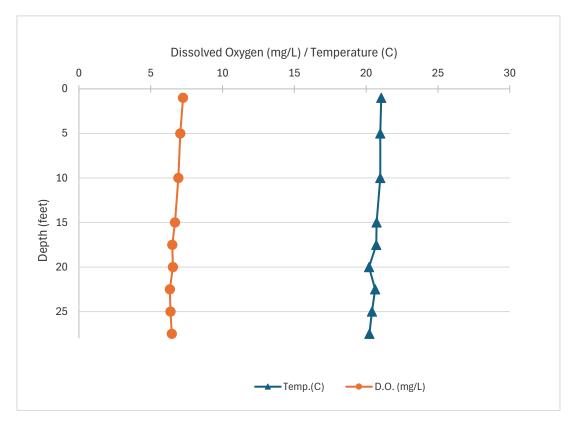
County: Benzie
Site ID: 100247
Date: 9/9/2021

Depth (ft)	Temp.(C)	D.O. (mg/L)
1	21.05	7.25
5	20.98	7.06
10	20.98	6.92
15	20.73	6.69
17.5	20.7	6.5
20	20.2	6.54
22.5	20.63	6.33
25	20.4	6.38
27.5	20.23	6.47
