# 2024 Data Report for

# **Blue Lake, Mecosta County**

Site ID: 540092

# Blue Lake, Mecosta County 2024 CLMP Results

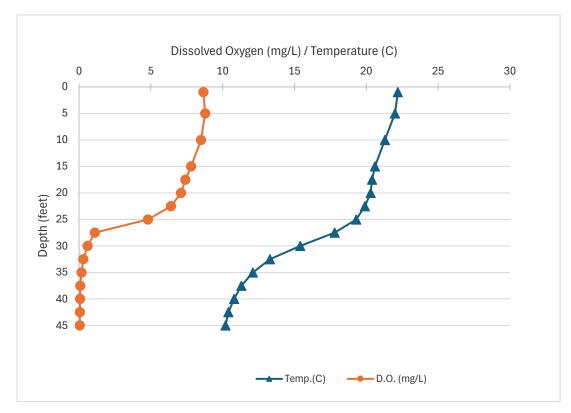
Name: Blue Lake County: Mecosta Site ID: 540092 Date: 9/15/2024

Depth (ft)	Temp.(C)	D.O. (mg/L)
1	22.2	8.66
5	22	8.78
10	21.3	8.5
15	20.6	7.8
17.5	20.4	7.4
20	20.3	7.1
22.5	19.9	6.4
25	19.3	4.8
27.5	17.8	1.1
30	15.4	0.6
32.5	13.3	0.3
35	12.1	0.17
37.5	11.3	0.08
40	10.8	0.07
42.5	10.4	0.06
45	10.2	0.05
