2024 Data Report for Klinger Lake, St. Joseph County

Site ID: 750136

2024 CLMP Results

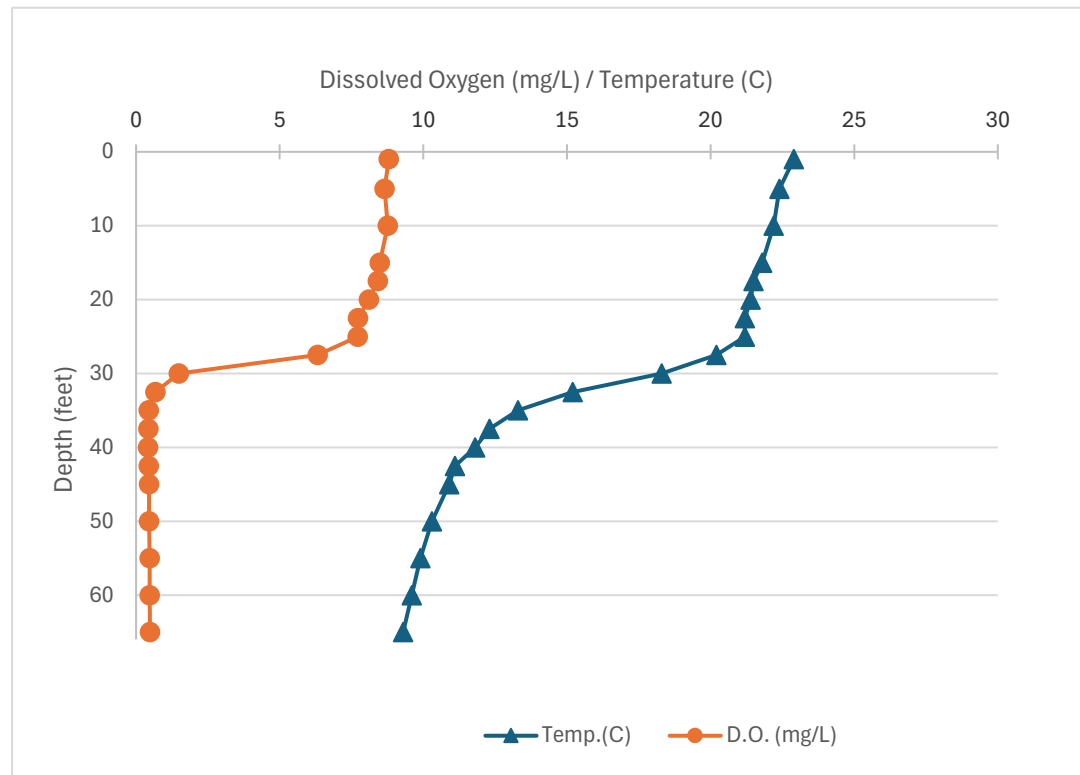
9/11/2019

Dissolved Oxygen and Temperature Profile

Depth (ft)	Temp.(C)	D.O. (mg/L)
1	22.9	8.8
5	22.4	8.65
10	22.2	8.76
15	21.8	8.48
17.5	21.5	8.42
20	21.4	8.1
22.5	21.2	7.73
25	21.2	7.71
27.5	20.2	6.32
30	18.3	1.49
32.5	15.2	0.68
35	13.3	0.44
37.5	12.3	0.43
40	11.8	0.42
42.5	11.1	0.44
45	10.9	0.45
50	10.3	0.45
55	9.9	0.47
60	9.6	0.47
65	9.3	0.48
