# 2024 Data Report for

# Big Pine Island Lake, Kent County

Site ID: 410437

# Big Pine Island Lake, Kent County 2024 CLMP Results

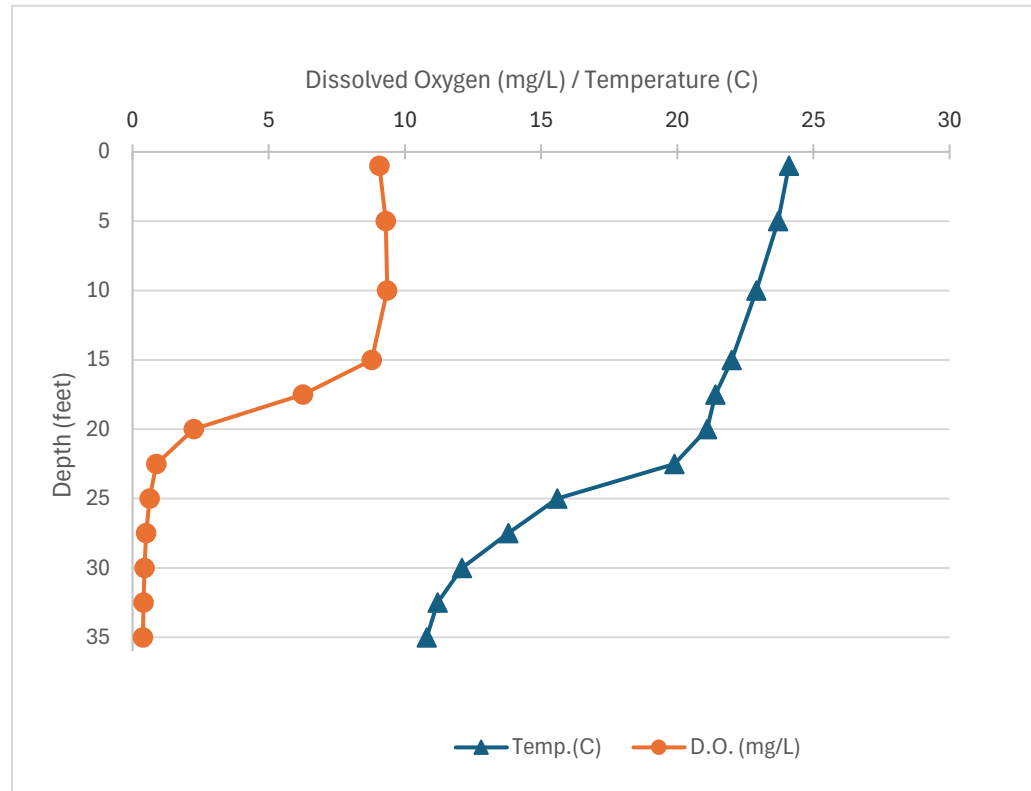
### Dissolved Oxygen and Temperature Profile

Depth (ft)	Temp.(C)	D.O. (mg/L)
1	24.1	9.06
5	23.7	9.3
10	22.9	9.35
15	22	8.78
17.5	21.4	6.25
20	21.1	2.25
22.5	19.9	0.88
25	15.6	0.63
27.5	13.8	0.5
30	12.1	0.44
32.5	11.2	0.41
35	10.8	0.38
