2024 Data Report for Big Bass Lake, Lake County

Site ID: 430029

2024 CLMP Results

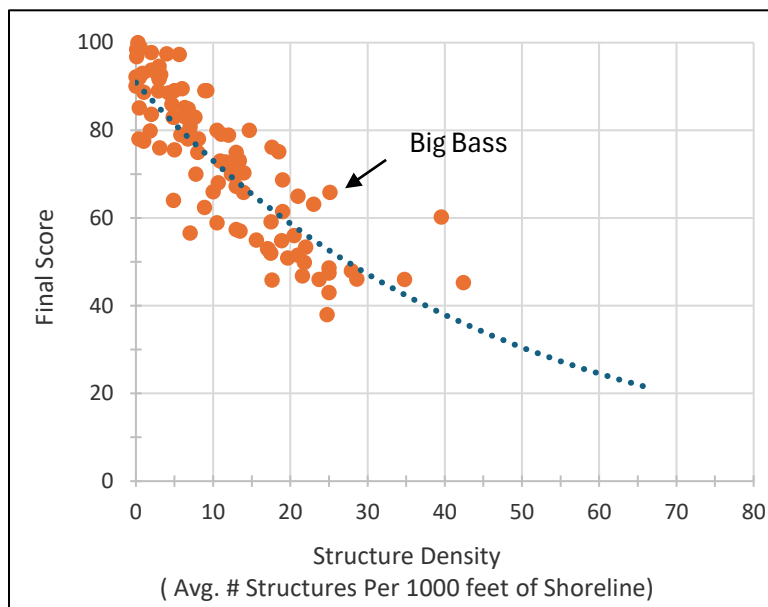
How does your lake compare to others in the program?

Big Bass Lake	
Number of Sections:	36
Number of Structures:	904
Structure Density:	25
Final Score:	65.9

All 97 Participating Lakes from 2015-2022:	
Avg. Number of Sections:	16
Avg. Number of Structures:	228
Avg. Structure Density:	12
Avg. Final Score:	73

Note about graph to the left: The dotted line sets your average expectation of the score of your lake. If your lake is lower than the dotted line, then your shoreline health is lower than average compared to lakes with similar amount of shoreline development. And vice-versa in regards to a lake above the dotted line.

Overall, the lakeshore habitat of Big Bass Lake scored quite a bit better than could be expected when compared to other lakes in the program with similar amount of development. Most of the 1000 foot sections scored either Fair or Good (18 fair and 12 good), while six sections scored Poor. While Big Bass is doing well compared to other similar lakes, given the six poor sections, there is plenty of room for improvement.

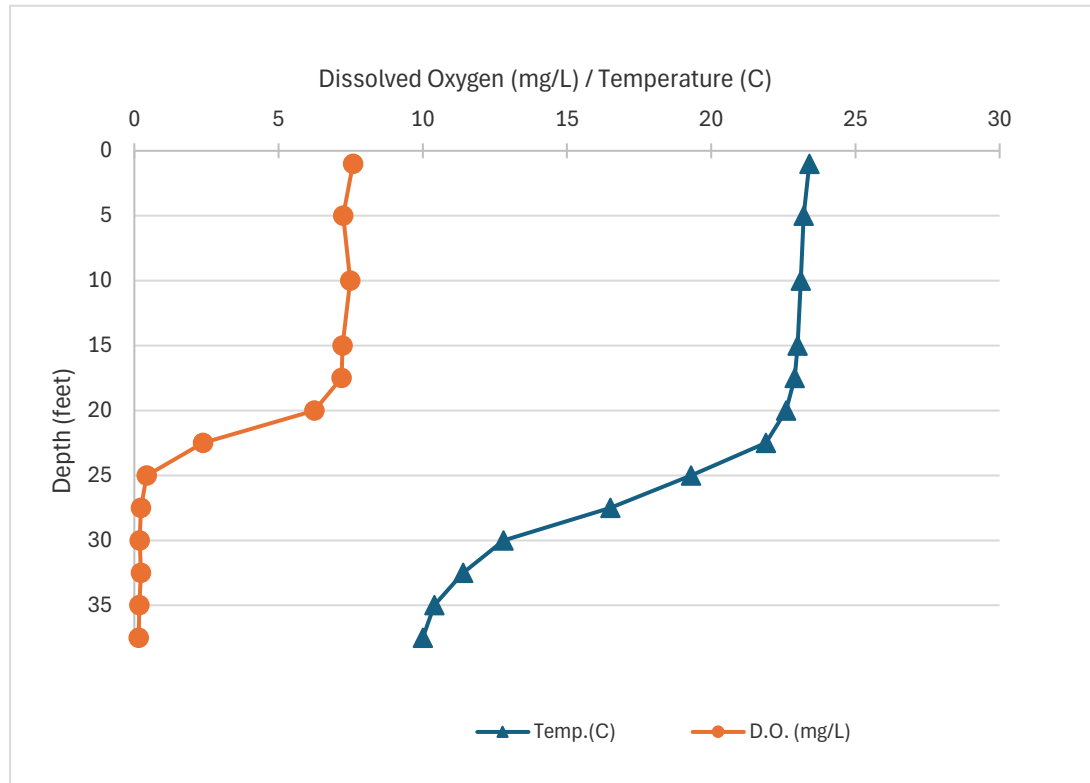
Name: Big Bass Lake
County: Lake
Site ID: 430029
Date: 9/5/2024

Dissolved Oxygen and Temperature Profile

Depth (ft)	Temp.(C)	D.O. (mg/L)
1	23.4	7.58
5	23.2	7.24
10	23.1	7.49
15	23	7.22
17.5	22.9	7.19
20	22.6	6.24
22.5	21.9	2.38
25	19.3	0.43
27.5	16.5	0.23
30	12.8	0.19
32.5	11.4	0.23
35	10.4	0.17
37.5	10	0.15
