2024 Data Report for Lake Christiana, Cass County

Site ID: 140055

2024 CLMP Results

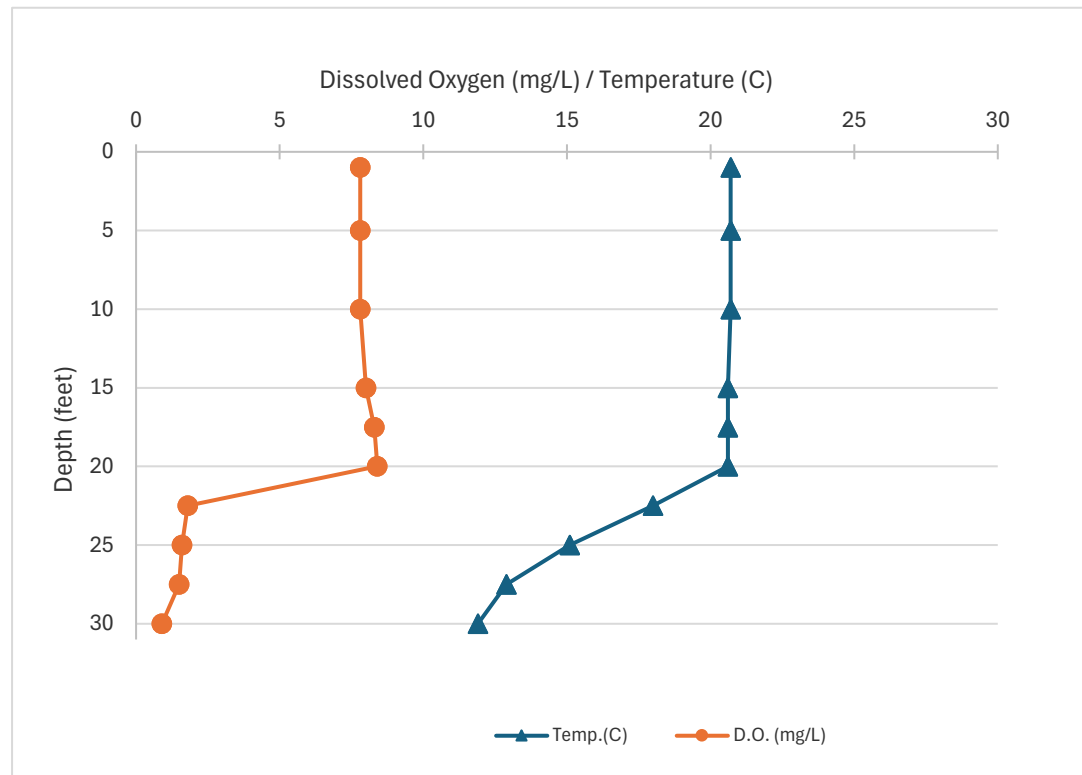
Name: Lake Christiana
County: Cass
Site ID: 140055
Date: 9/24/2022

Dissolved Oxygen and Temperature Profile

Depth (ft)	Temp.(C)	D.O. (mg/L)
1	20.7	7.8
1	20.7	7.8
5	20.7	7.8
5	20.7	7.8
10	20.7	7.8
10	20.7	7.8
15	20.6	8
15	20.6	8
17.5	20.6	8.3
17.5	20.6	8.3
20	20.6	8.4
20	20.6	8.4
22.5	18	1.8
22.5	18	1.8
25	15.1	1.6
25	15.1	1.6
27.5	12.9	1.5
27.5	12.9	1.5
30	11.9	0.9
30	11.9	0.9
