2024 Data Report for

Crockery Lake, Ottawa County

Site ID: 700422

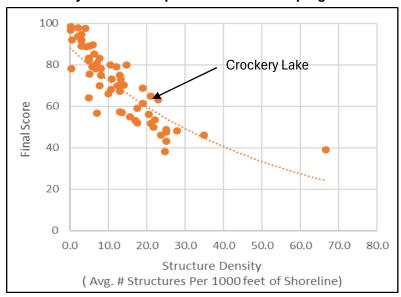
This assessment involves rating 1000 foot sections of shoreline for aquatic vegetation, shoreline vegetation, erosion, and erosion control practices (like sea walls). Each shoreline section is given three scores ranging from 0-100 for the categories of Littoral, Riparian, and Erosion Management. The three scores are averaged to produce a average section score. Then a total score is given to the entire lake by averaging all of the average section scores. A score of 0 indicates a shoreline that has been extremely disturbed by human impacts and no natural shoreline remains. A score of 100 indicates a shoreline that is nearly pristine.

How does your lake compare to others in the program?

Overall, the lakeshore habitat of Crockery Lake scored lower when average when compared to other lakes in the program, but probably scored exactly as expected considering the amount of development along the shores.

The lake sections scored highest for erosion control, with an average of 78, meaning that there are a low amount of sea walls, rock rip-rap, and other shoreline erosion structures.

The riparian zone was the weak point in Crockery's score (scoring an average of 46). There is certainly room for improvement; reduce the amount of mowed grass and increase the amount of unmowed native vegetation along the lakeshore to boost this aspect of the shoreline habitat.

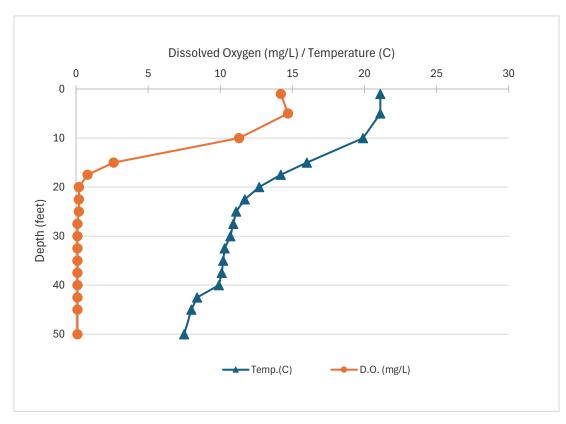
Dissolved Oxygen and Temperature Profile

County: Ottawa Site ID: 700422 Date: 5/21/2024

Depth (ft)	Temp.(C)	D.O. (mg/L)
1	21.1	14.2
5	21.1	14.7
10	19.9	11.3
15	16	2.6
17.5	14.2	0.8
20	12.7	0.2
22.5	11.7	0.2
25	11.1	0.2
27.5	10.9	0.1
30	10.7	0.1
32.5	10.3	0.1
35	10.2	0.1
37.5	10.1	0.1
40	9.9	0.1
42.5	8.4	0.1
45	8	0.1
50	7.5	0.1

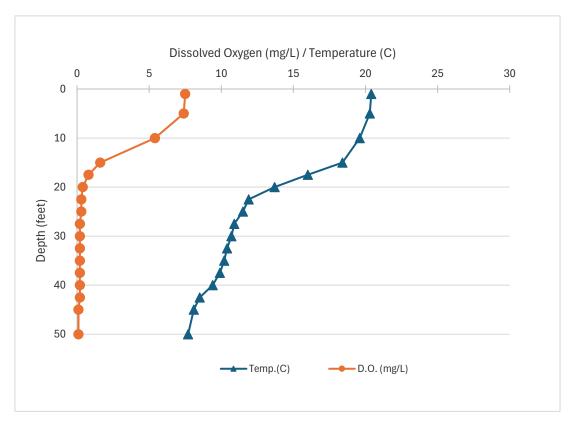
Dissolved Oxygen and Temperature Profile

County: Ottawa Site ID: 700422 Date: 5/28/2024

Depth (ft)	Temp.(C)	D.O. (mg/L)
1	20.4	7.5
5	20.3	7.4
10	19.6	5.4
15	18.4	1.6
17.5	16	0.8
20	13.7	0.4
22.5	11.9	0.3
25	11.5	0.3
27.5	10.9	0.2
30	10.7	0.2
32.5	10.4	0.2
35	10.2	0.2
37.5	9.9	0.2
40	9.4	0.2
42.5	8.5	0.2
45	8.1	0.1
50	7.7	0.1

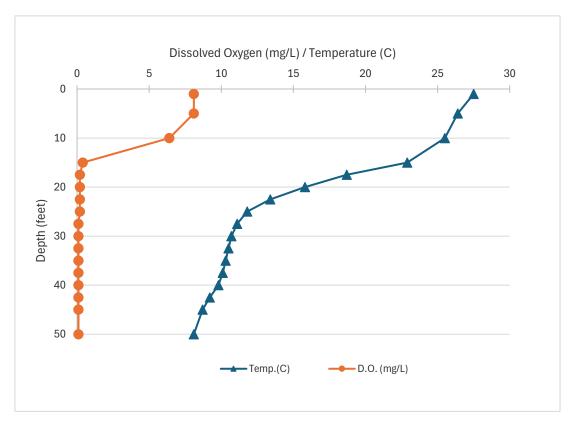
Dissolved Oxygen and Temperature Profile

County: Ottawa Site ID: 700422 Date: 6/24/2024

Depth (ft)	Temp.(C)	D.O. (mg/L)
1	27.5	8.1
5	26.4	8.1
10	25.5	6.4
15	22.9	0.4
17.5	18.7	0.2
20	15.8	0.2
22.5	13.4	0.2
25	11.8	0.2
27.5	11.1	0.1
30	10.7	0.1
32.5	10.5	0.1
35	10.3	0.1
37.5	10.1	0.1
40	9.8	0.1
42.5	9.2	0.1
45	8.7	0.1
50	8.1	0.1

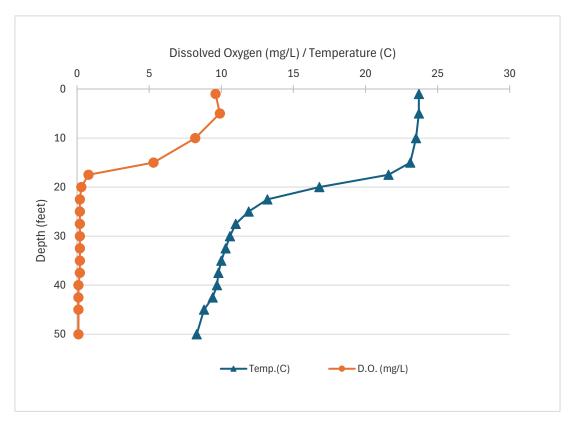
Dissolved Oxygen and Temperature Profile

County: Ottawa Site ID: 700422 Date: 7/2/2024

Depth (ft)	Temp.(C)	D.O. (mg/L)
1	23.7	9.6
5	23.7	9.9
10	23.5	8.2
15	23.1	5.3
17.5	21.6	0.8
20	16.8	0.3
22.5	13.2	0.2
25	11.9	0.2
27.5	11	0.2
30	10.6	0.2
32.5	10.3	0.2
35	10	0.2
37.5	9.8	0.2
40	9.7	0.1
42.5	9.4	0.1
45	8.8	0.1
50	8.3	0.1

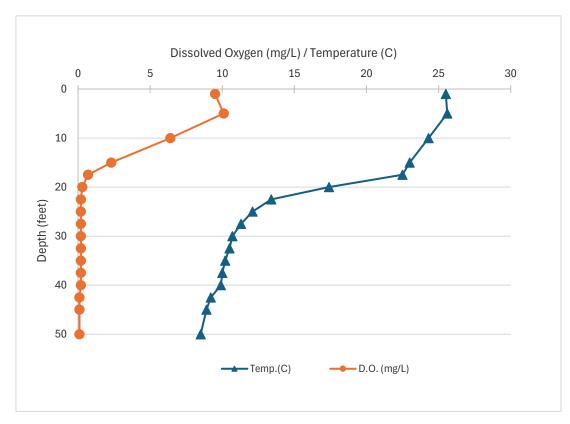
Dissolved Oxygen and Temperature Profile

County: Ottawa Site ID: 700422 Date: 7/9/2024

Depth (ft) Temp.(C) D.O. (mg/L) 9.5 25.5 5 25.6 10.1 10 24.3 6.4 15 23 2.3 17.5 22.5 0.7 20 17.4 0.3 22.5 13.4 0.2 25 12.1 0.2 27.5 11.3 0.2 30 10.7 0.2 32.5 10.5 0.2 35 10.2 0.2 37.5 10 0.2 40 9.9 0.2 42.5 9.2 0.1 45 8.9 0.1 50 8.5 0.1

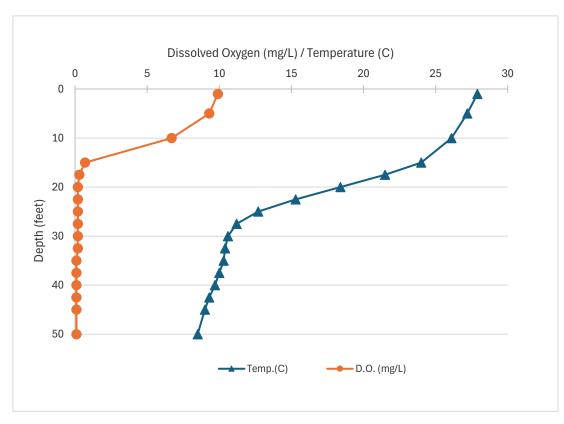
Dissolved Oxygen and Temperature Profile

County: Ottawa Site ID: 700422 Date: 7/15/2024

Depth (ft)	Temp.(C)	D.O. (mg/L)
1	27.9	9.9
5	27.2	9.3
10	26.1	6.7
15	24	0.7
17.5	21.5	0.3
20	18.4	0.2
22.5	15.3	0.2
25	12.7	0.2
27.5	11.2	0.2
30	10.6	0.2
32.5	10.4	0.2
35	10.3	0.1
37.5	10	0.1
40	9.7	0.1
42.5	9.3	0.1
45	9	0.1
50	8.5	0.1

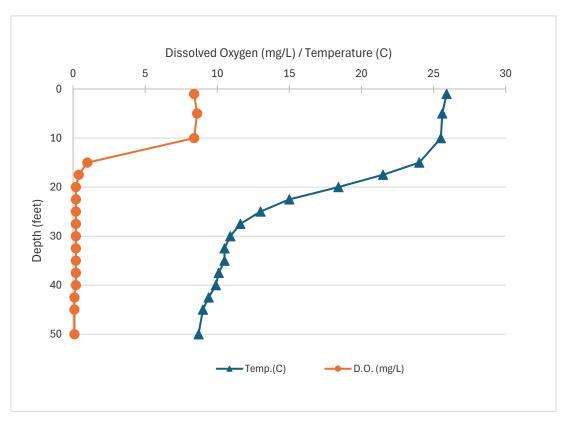
Dissolved Oxygen and Temperature Profile

County: Ottawa
Site ID: 700422
Date: 7/22/2024

Depth (ft)	Temp.(C)	D.O. (mg/L)
1	25.9	8.4
5	25.6	8.6
10	25.5	8.4
15	24	1
17.5	21.5	0.4
20	18.4	0.2
22.5	15	0.2
25	13	0.2
27.5	11.6	0.2
30	10.9	0.2
32.5	10.5	0.2
35	10.5	0.2
37.5	10.1	0.2
40	9.9	0.2
42.5	9.4	0.1
45	9	0.1
50	8.7	0.1

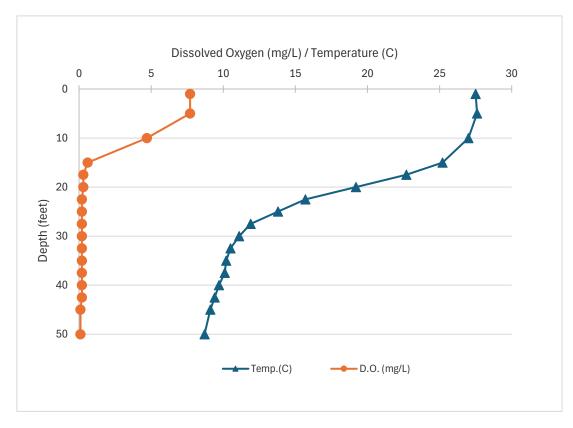
Dissolved Oxygen and Temperature Profile

County: Ottawa Site ID: 700422 Date: 8/4/2024

Depth (ft)	Temp.(C)	D.O. (mg/L)
1	27.5	7.7
5	27.6	7.7
10	27	4.7
15	25.2	0.6
17.5	22.7	0.3
20	19.2	0.3
22.5	15.7	0.2
25	13.8	0.2
27.5	11.9	0.2
30	11.1	0.2
32.5	10.5	0.2
35	10.2	0.2
37.5	10.1	0.2
40	9.7	0.2
42.5	9.4	0.2
45	9.1	0.1
50	8.7	0.1

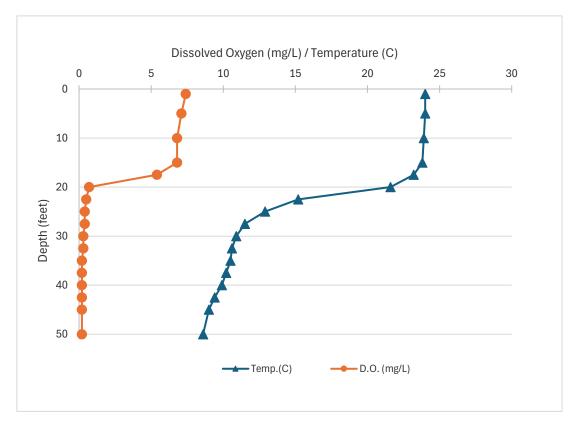
Dissolved Oxygen and Temperature Profile

County: Ottawa
Site ID: 700422
Date: 8/12/2024

Depth (ft)	Temp.(C)	D.O. (mg/L)
1	24	7.4
5	24	7.1
10	23.9	6.8
15	23.8	6.8
17.5	23.2	5.4
20	21.6	0.7
22.5	15.2	0.5
25	12.9	0.4
27.5	11.5	0.4
30	10.9	0.3
32.5	10.6	0.3
35	10.5	0.2
37.5	10.2	0.2
40	9.9	0.2
42.5	9.4	0.2
45	9	0.2
50	8.6	0.2

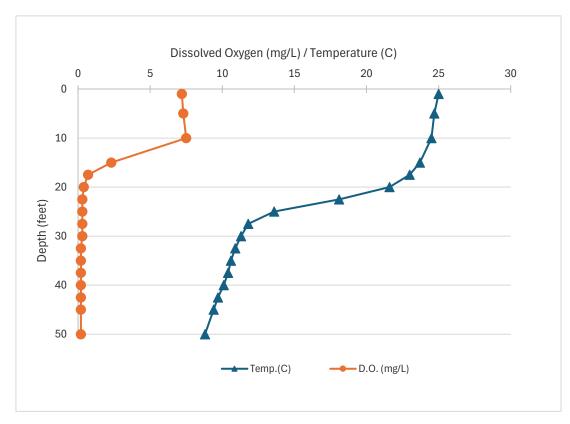
Dissolved Oxygen and Temperature Profile

County: Ottawa Site ID: 700422 Date: 9/2/2024

Depth (ft)	Temp.(C)	D.O. (mg/L)
1	25	7.2
5	24.7	7.3
10	24.5	7.5
15	23.7	2.3
17.5	23	0.7
20	21.6	0.4
22.5	18.1	0.3
25	13.6	0.3
27.5	11.8	0.3
30	11.3	0.3
32.5	10.9	0.2
35	10.6	0.2
37.5	10.4	0.2
40	10.1	0.2
42.5	9.7	0.2
45	9.4	0.2
50	8.8	0.2
