2024 Data Report for

Little Bass Lake, Lake County

Site ID: 430640

Little Bass Lake, Lake County 2024 CLMP Results

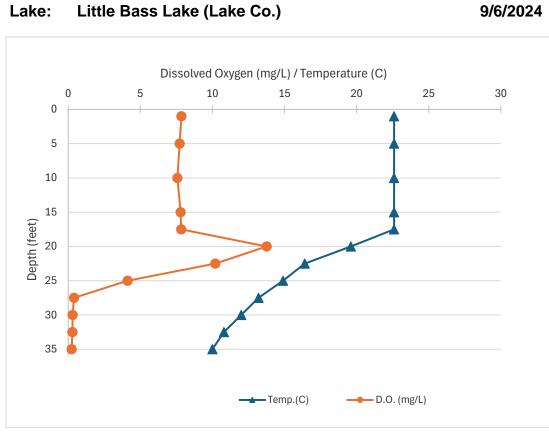
County: Lake Site ID: 430640 Date: 9/6/2024

Depth (ft)	Temp.(C)	D.O. (mg/L)
1	22.6	7.85
5	22.6	7.73
10	22.6	7.57
15	22.6	7.8
17.5	22.6	7.84
20	19.6	13.76
22.5	16.4	10.2
25	14.9	4.12
27.5	13.2	0.41
30	12	0.31
32.5	10.8	0.3
35	10	0.24

Dissolved Oxygen and Temperature Profile
