2024 Data Report for

Oneida Lake, Livingston County

Site ID: 470593

Oneida Lake, Livingston County 2024 CLMP Results

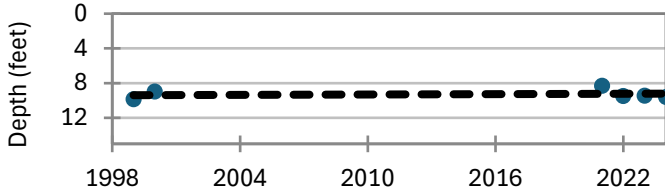
Secchi Disk Transparency (feet)

Year	# Readings	Min	Max	Average	Std. Dev	Carlson TSI
2024	18	7.5	13.5	9.6	1.4	44
2019-2023	45	6.0	14.5	9.1	1.8	45
1999-2018	37	6.0	14.0	9.4	1.8	45
2024 All CLMP Lakes	3348	0.5	85.0	11.7	6.2	43

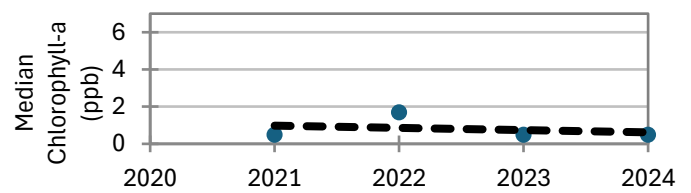
Chlorophyll-a (parts per billion)

Year	# Samples	Min	Max	Median	Std. Dev	Carlson TSI
2024	4	<1.0	<1.0	<1.0	0.0	31
2021-2023	14	<1.0	3.0	<1.0	0.6	31
2024 All CLMP Lakes	708	< 1.0	63.0	2.8	7.3	41

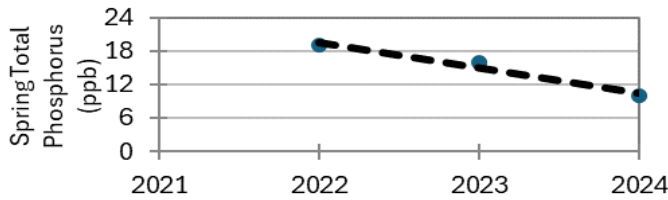
Spring Phosphorus (parts per billion)

Year	# Samples	Min	Max	Average	Std. Dev	Carlson TSI
2024	1	10.0	10.0	10.0	NA	37
2022-2023	2	16.0	19.0	17.5	2.1	44
2024 All CLMP Lakes	259	<= 5	140.0	14.3	39.7	43

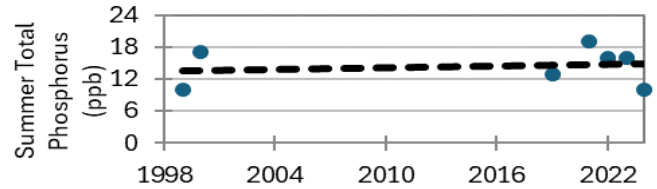
Summer Phosphorus (parts per billion)

Year	# Samples	Min	Max	Average	Std. Dev	Carlson TSI
2024	1	10.0	10.0	10.0	NA	37
2019-2023	4	13.0	19.0	16.0	2.4	44
1999-2018	2	10.0	17.0	13.5	4.9	41
2024 All CLMP Lakes	261	<= 5	140.0	14.6	11.9	43

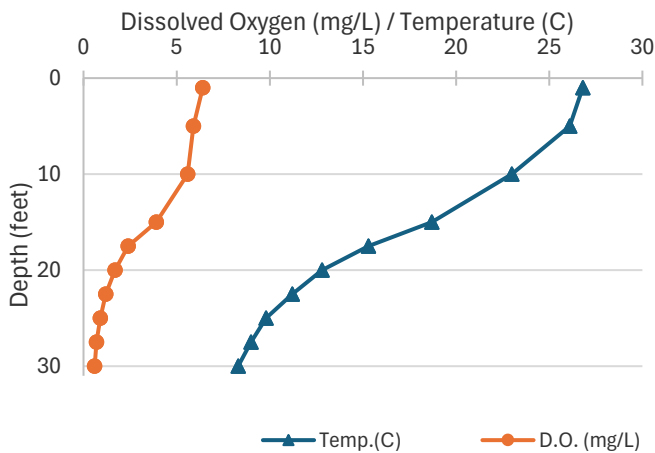
7/17/2024

Dissolved Oxygen and Temperature Profile

This lake displays a normal stratification pattern. The lake maintains some dissolved oxygen in the bottom waters through early summer. By mid-summer, the lake has stratified and the bottom water is devoid of oxygen.

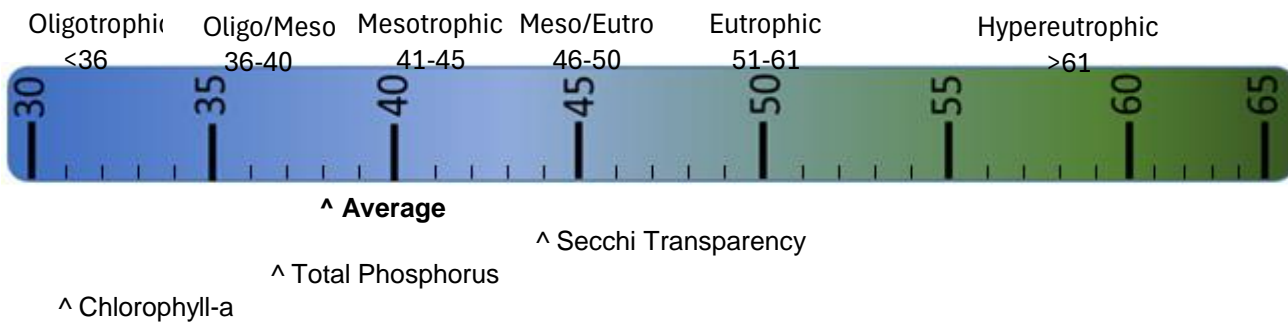
With an average TSI score of 38 based on 2024 Secchi transparency, chlorophyll-a, and summer total phosphorus data, this lake is rated between the oligotrophic and mesotrophic classification.

TSI for Oneida Lake in 2024	
Average	38
Secchi Disk	44
Summer TP	37
Chlorophyll-a	31

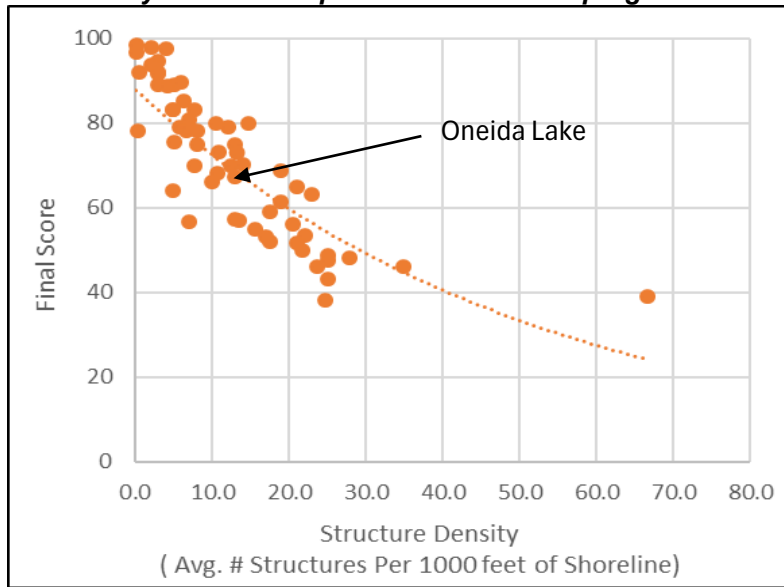
How does your lake compare to others in the program?

Oneida Lake:	
Number of Sections:	7
Number of Structures:	93
Structure Density:	13
Final Score:	67

All 62 Participating Lakes from 2015-2019:	
Avg. Number of Sections:	16
Avg. Number of Structures:	228
Avg. Structure Density:	12.6
Avg. Final Score:	71

Overall, the lakeshore habitat of Oneida Lake right around average when compared to other lakes in the program. All of the 1000 foot sections scored either Fair or Good: 6 fair, and 1 good.

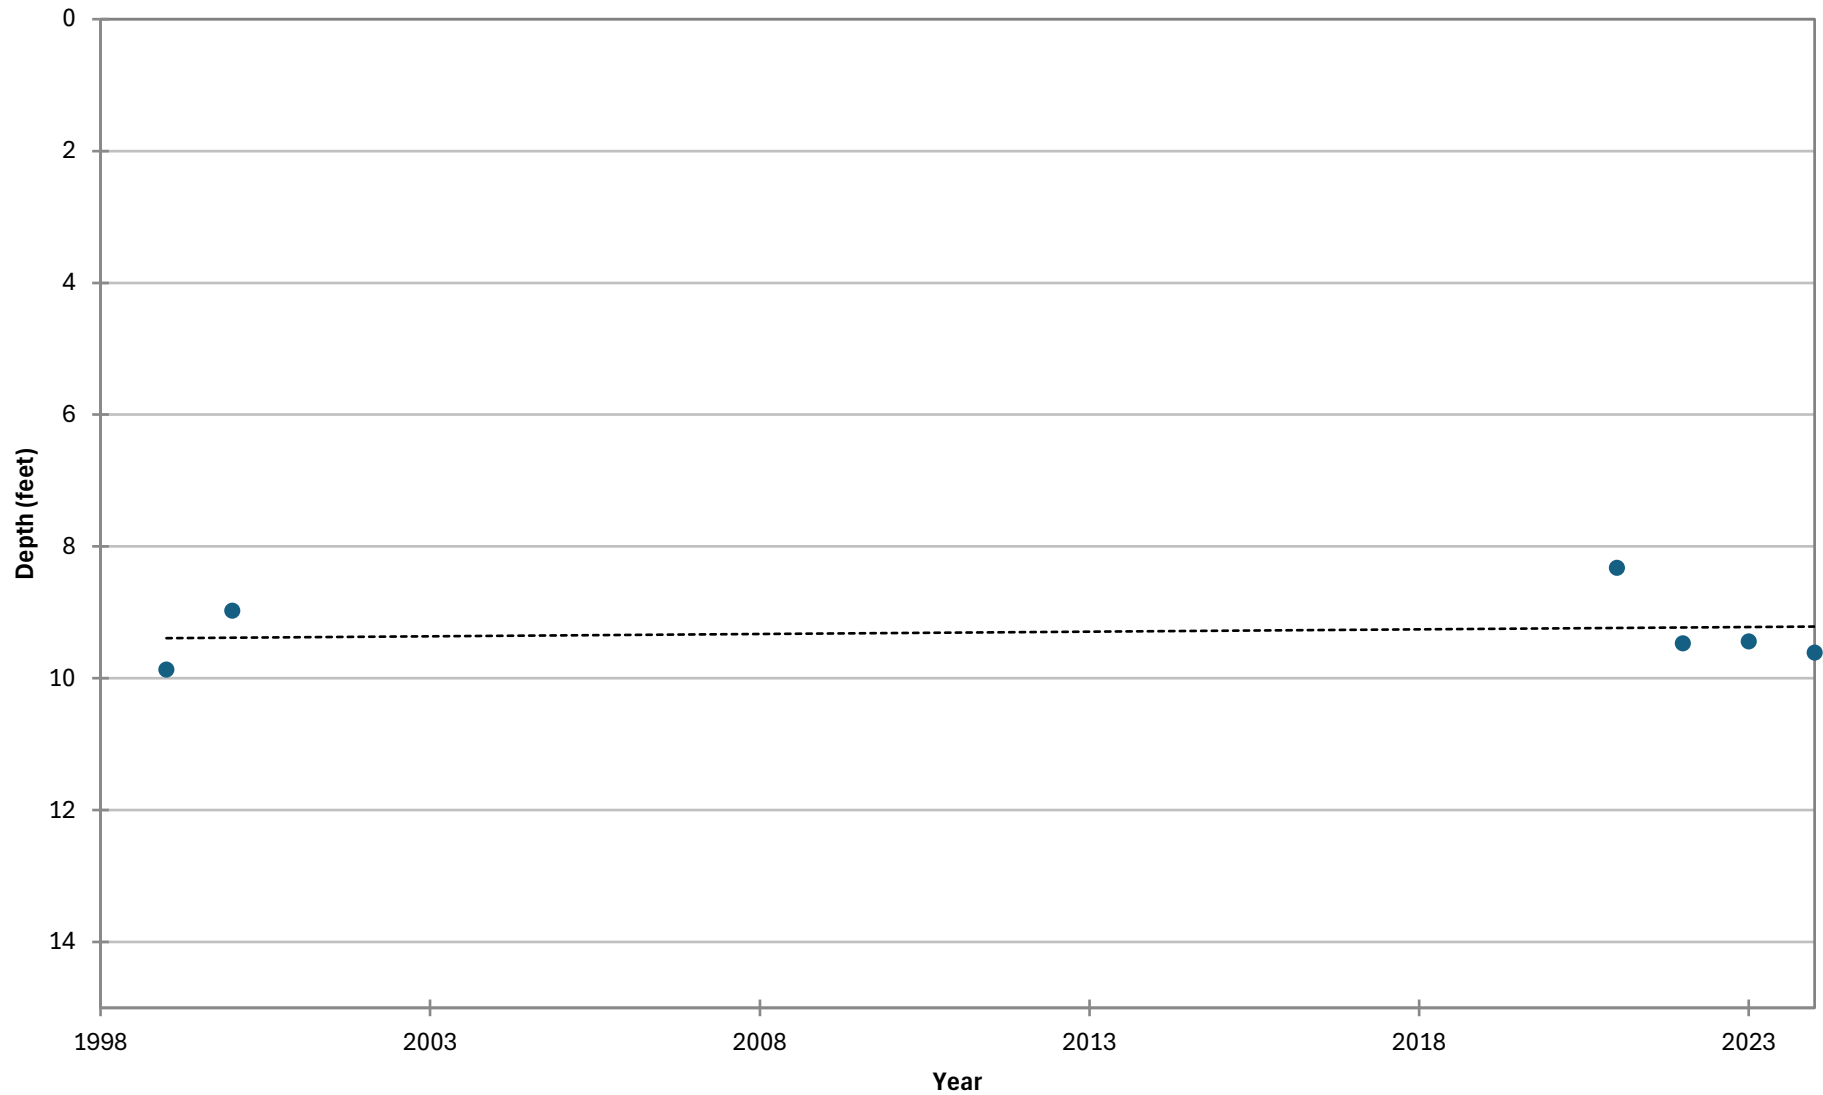
Oneida Lake (Livingston Co.), 470593

COOPERATIVE LAKES MONITORING PROGRAM
SUMMER MEAN TRANSPARENCY

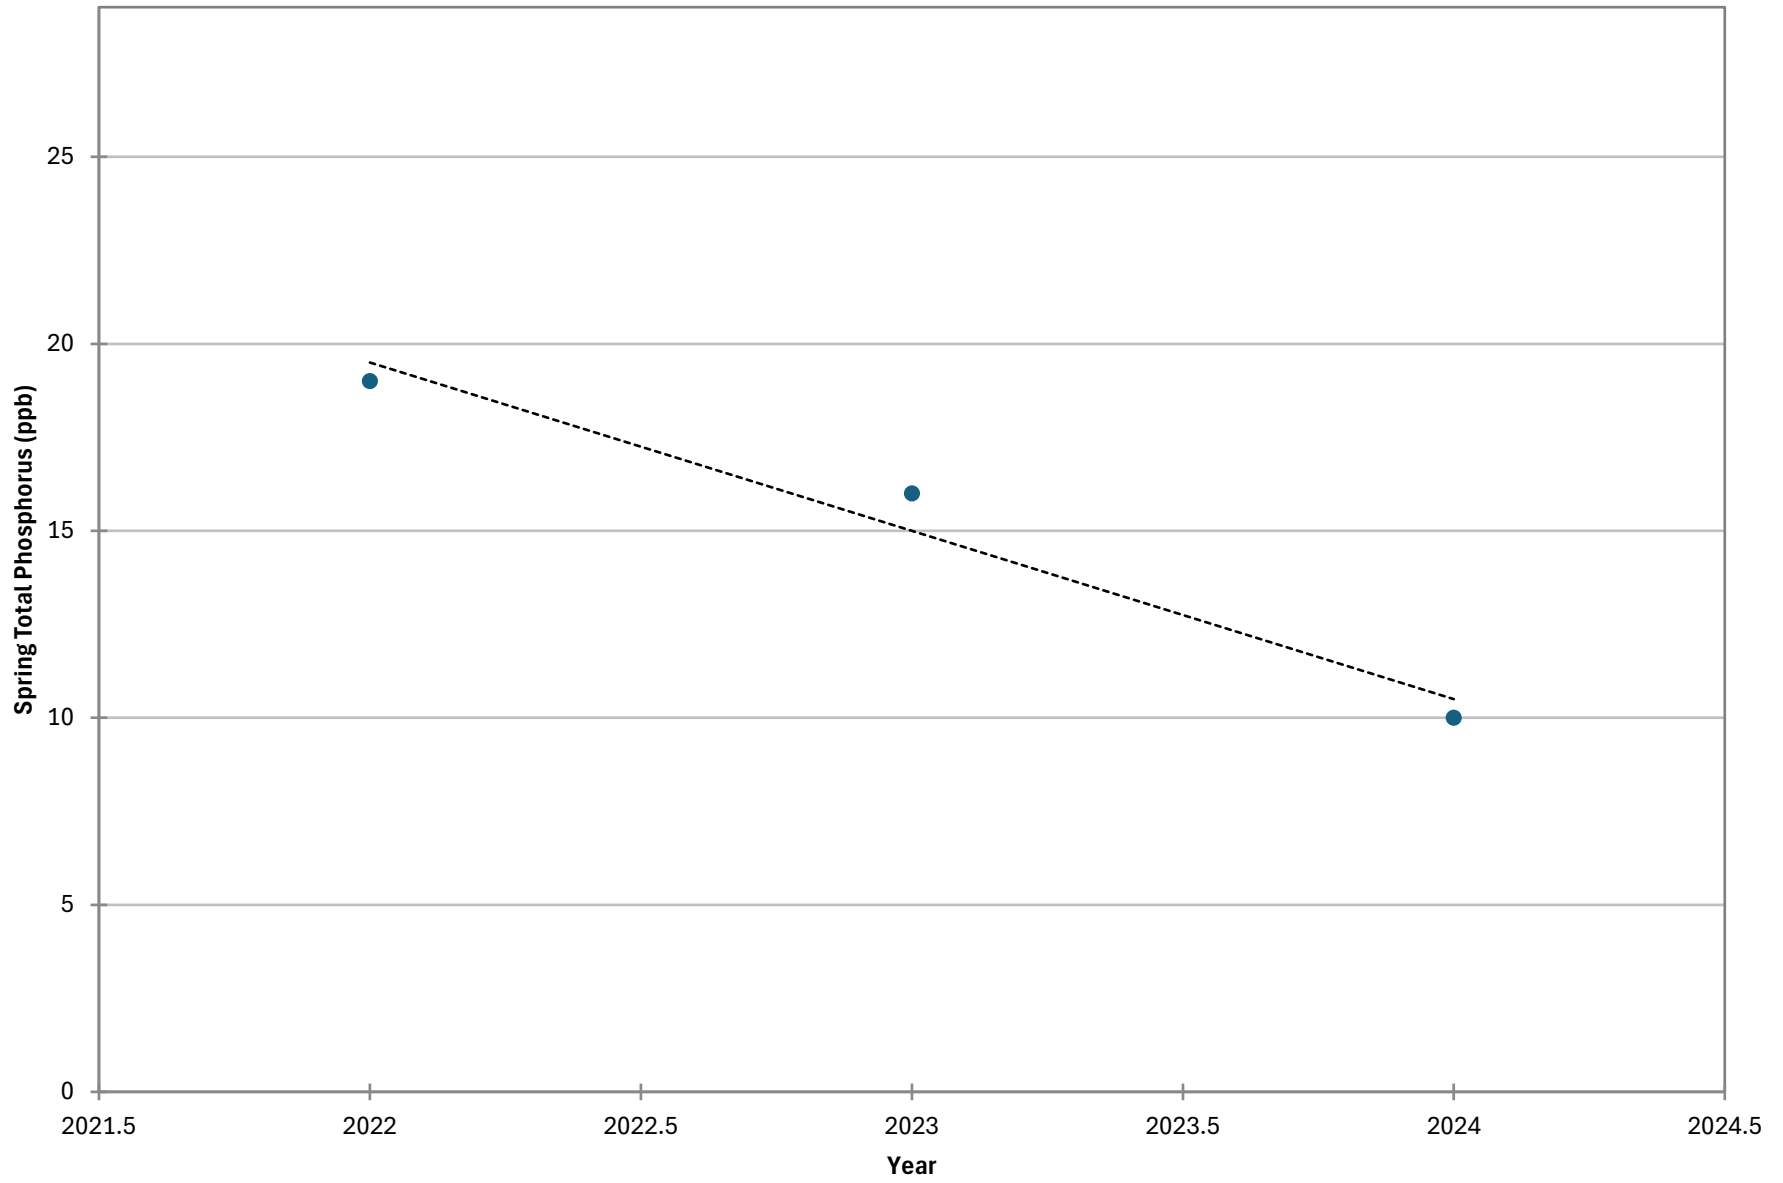
Oneida Lake (Livingston Co.), 470593

COOPERATIVE LAKES MONITORING PROGRAM
SPRING TOTAL PHOSPHORUS

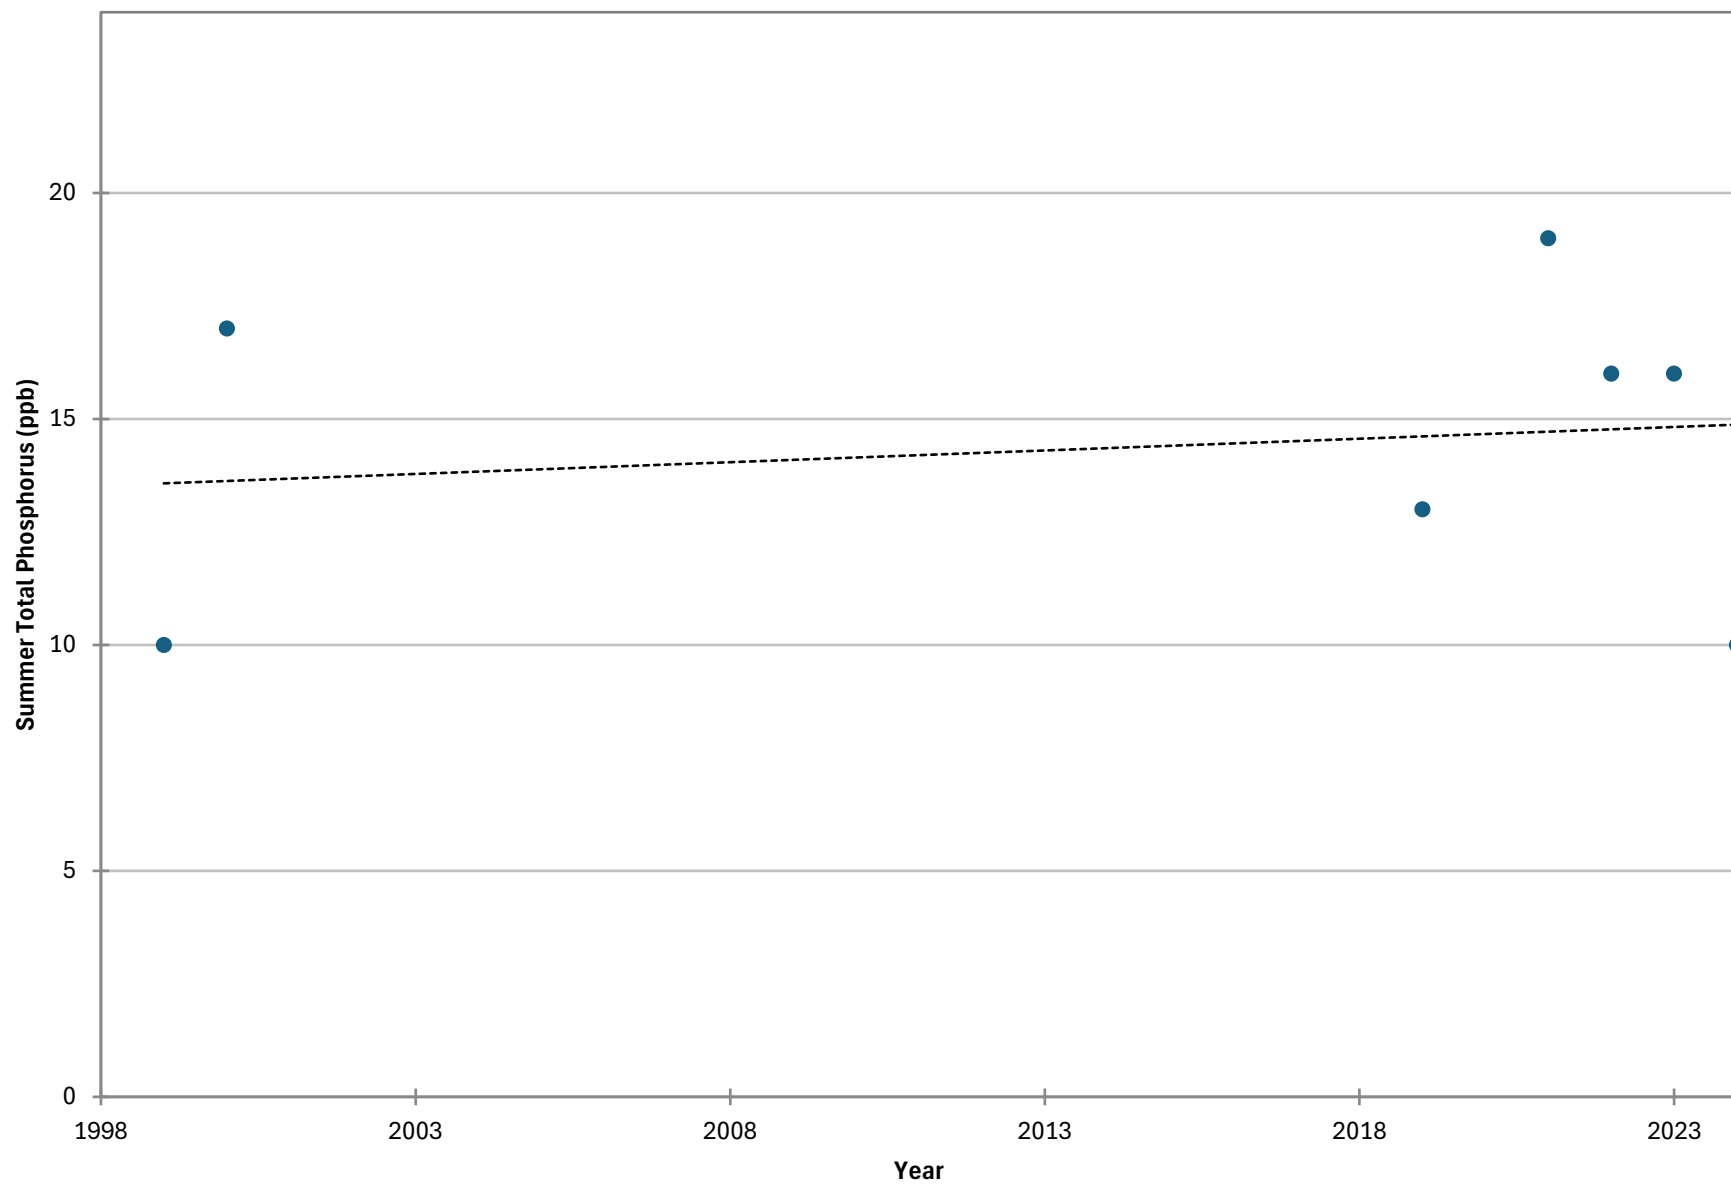
Oneida Lake (Livingston Co.), 470593

COOPERATIVE LAKES MONITORING PROGRAM
SUMMER TOTAL PHOSPHORUS

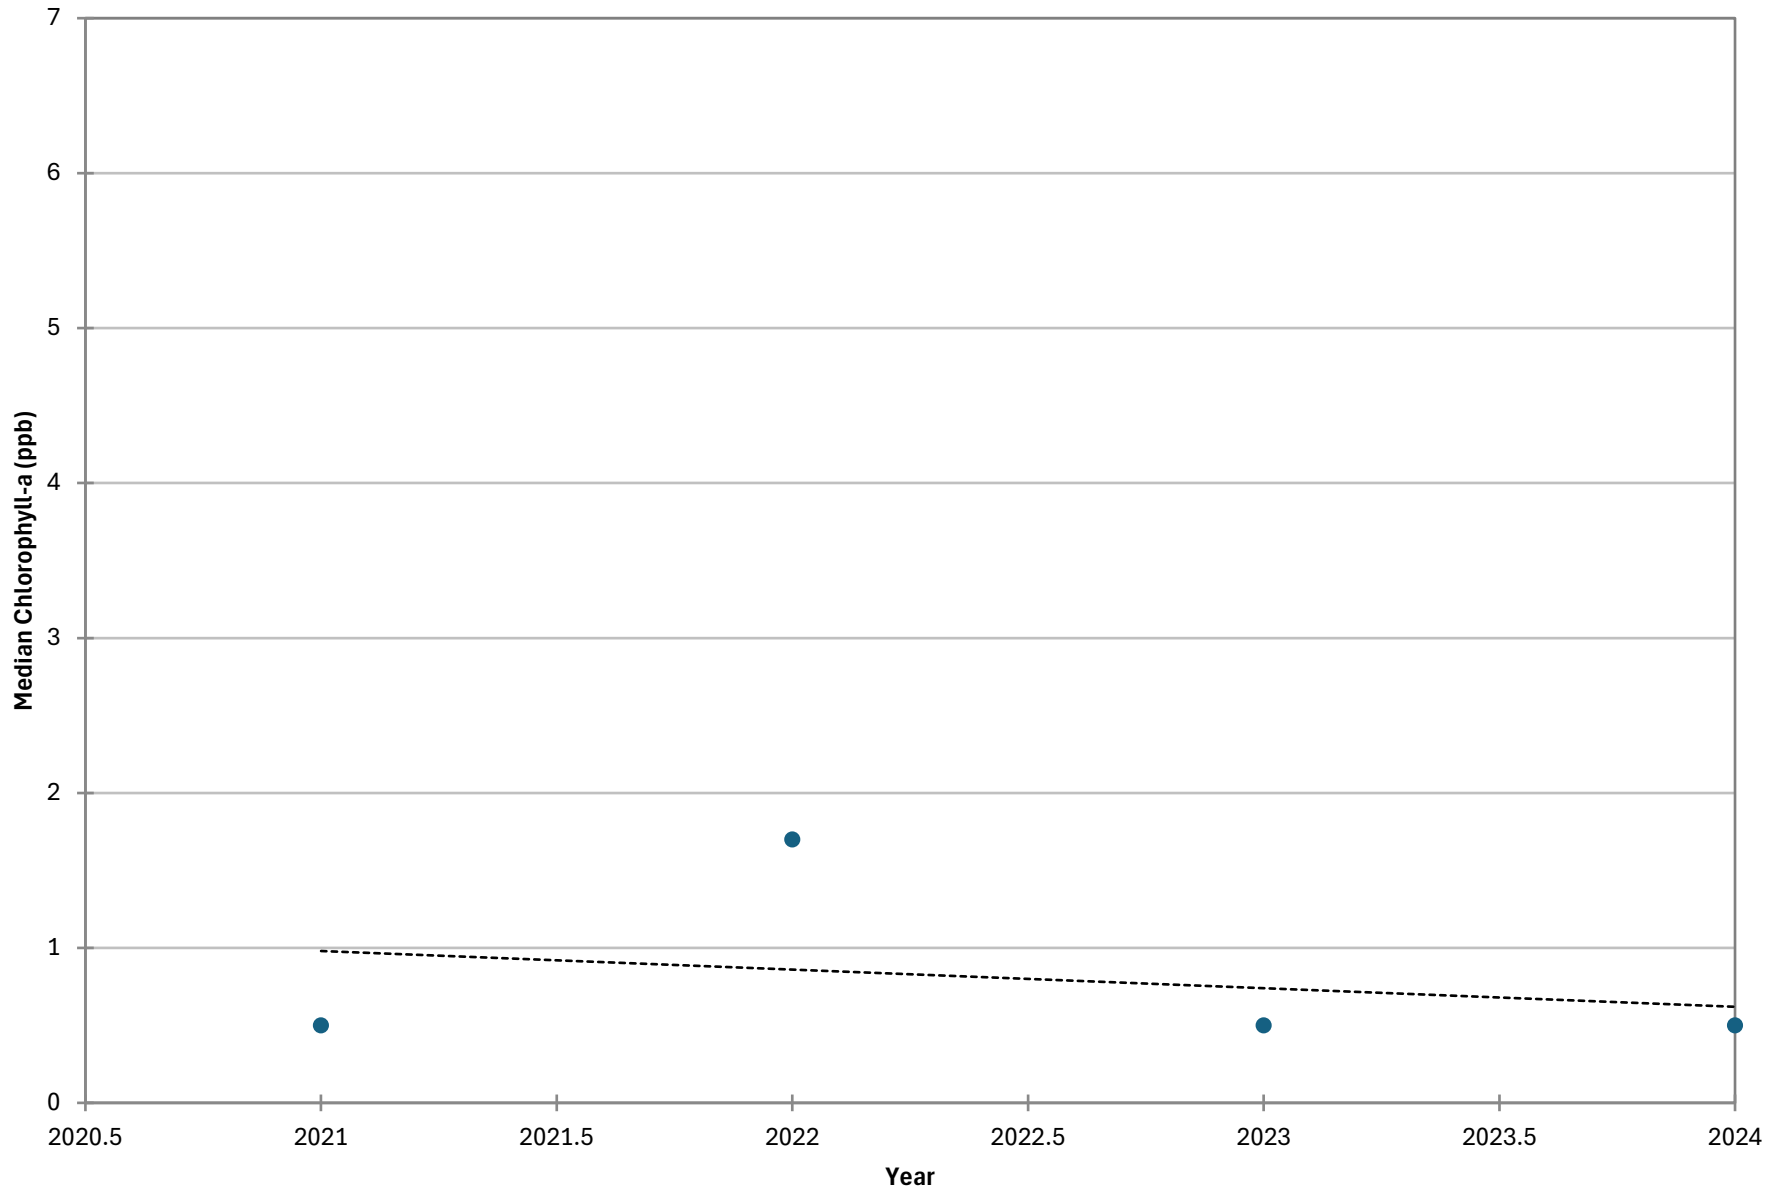
Oneida Lake (Livingston Co.), 470593

COOPERATIVE LAKES MONITORING PROGRAM
SUMMER MEDIAN CHLOROPHYLL-A

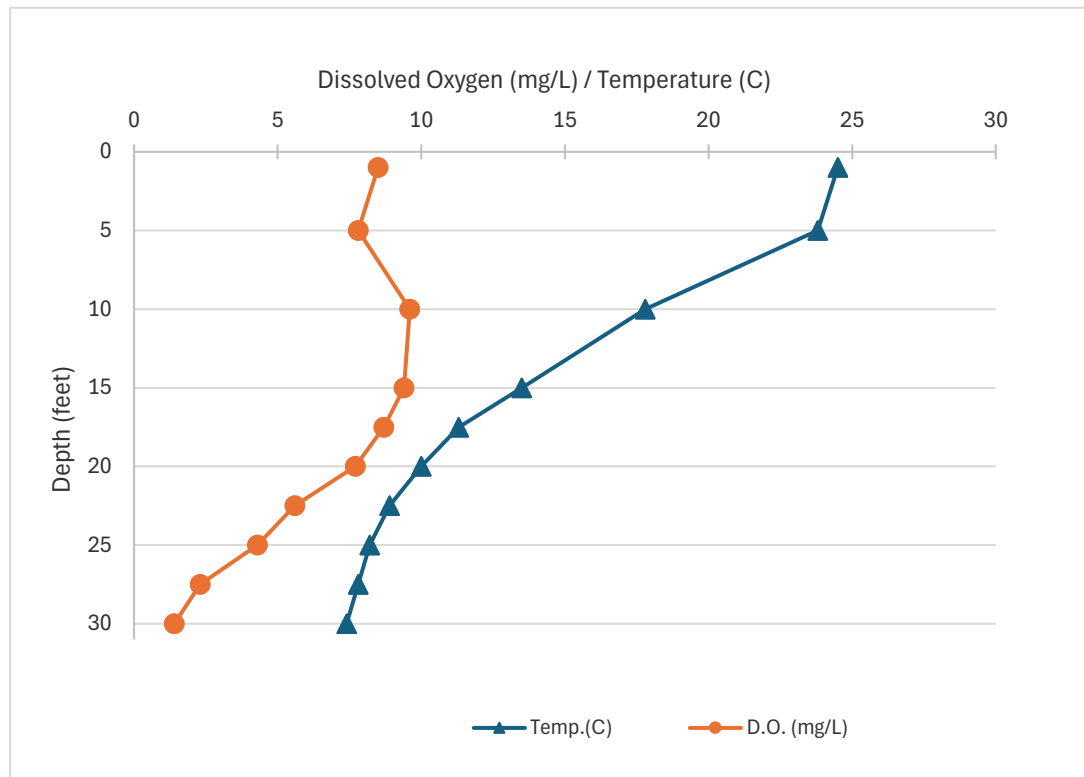
5/24/2024

Dissolved Oxygen and Temperature Profile

Depth (ft)	Temp.(C)	D.O. (mg/L)
1	24.5	8.5
1	24.5	8.5
5	23.8	7.8
5	23.8	7.8
10	17.8	9.6
10	17.8	9.6
15	13.5	9.4
15	13.5	9.4
17.5	11.3	8.7
17.5	11.3	8.7
20	10	7.7
20	10	7.7
22.5	8.9	5.6
22.5	8.9	5.6
25	8.2	4.3
25	8.2	4.3
27.5	7.8	2.3
27.5	7.8	2.3
30	7.4	1.4
30	7.4	1.4

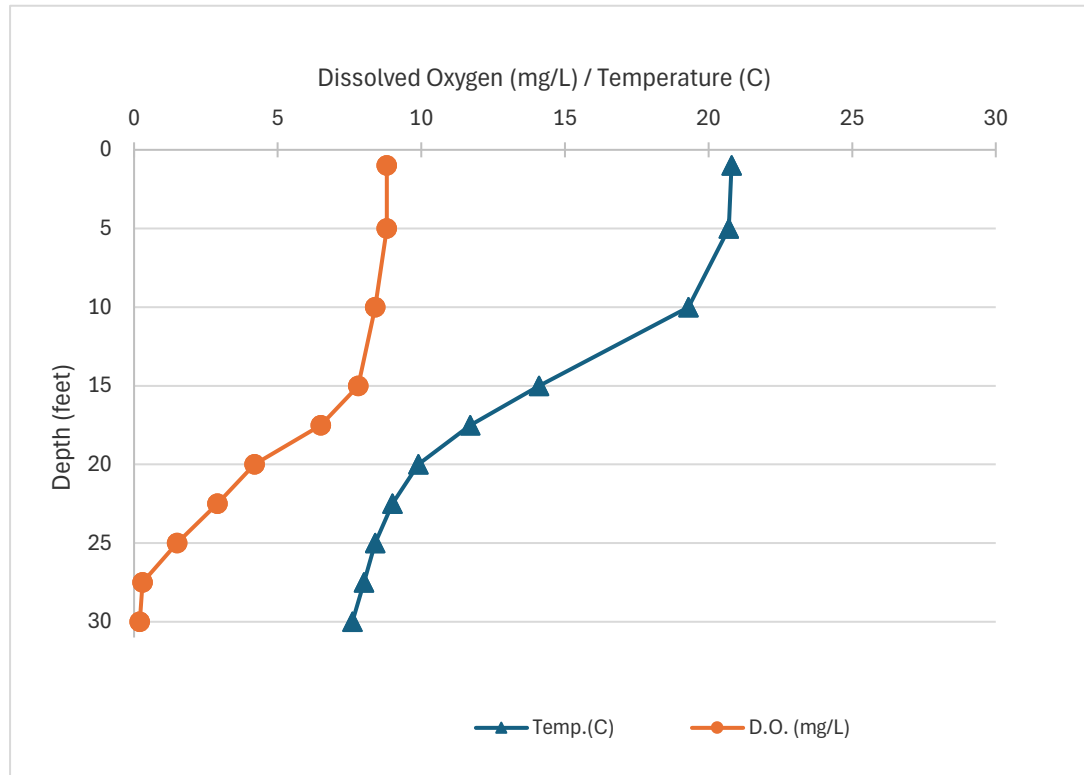
6/9/2024

Dissolved Oxygen and Temperature Profile

Depth (ft)	Temp.(C)	D.O. (mg/L)
1	20.8	8.8
1	20.8	8.8
5	20.7	8.8
5	20.7	8.8
10	19.3	8.4
10	19.3	8.4
15	14.1	7.8
15	14.1	7.8
17.5	11.7	6.5
17.5	11.7	6.5
20	9.9	4.2
20	9.9	4.2
22.5	9	2.9
22.5	9	2.9
25	8.4	1.5
25	8.4	1.5
27.5	8	0.3
27.5	8	0.3
30	7.6	0.2
30	7.6	0.2

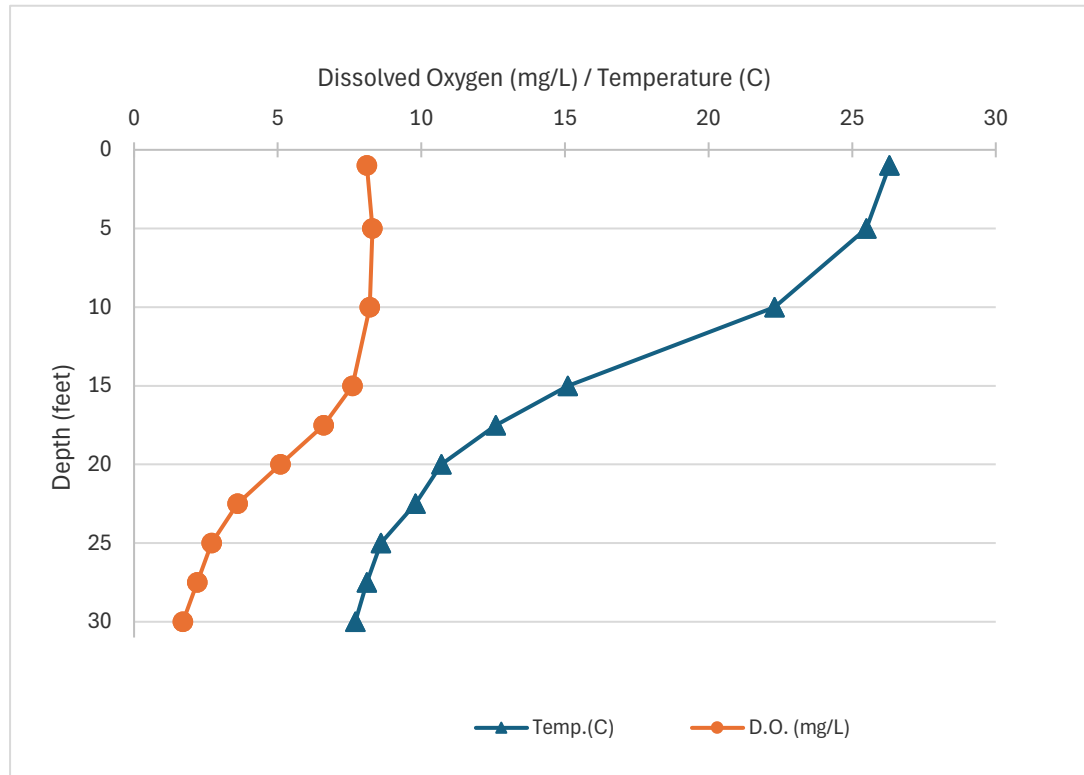
6/27/2024

Dissolved Oxygen and Temperature Profile

Depth (ft)	Temp.(C)	D.O. (mg/L)
1	26.3	8.1
1	26.3	8.1
5	25.5	8.3
5	25.5	8.3
10	22.3	8.2
10	22.3	8.2
15	15.1	7.6
15	15.1	7.6
17.5	12.6	6.6
17.5	12.6	6.6
20	10.7	5.1
20	10.7	5.1
22.5	9.8	3.6
22.5	9.8	3.6
25	8.6	2.7
25	8.6	2.7
27.5	8.1	2.2
27.5	8.1	2.2
30	7.7	1.7
30	7.7	1.7

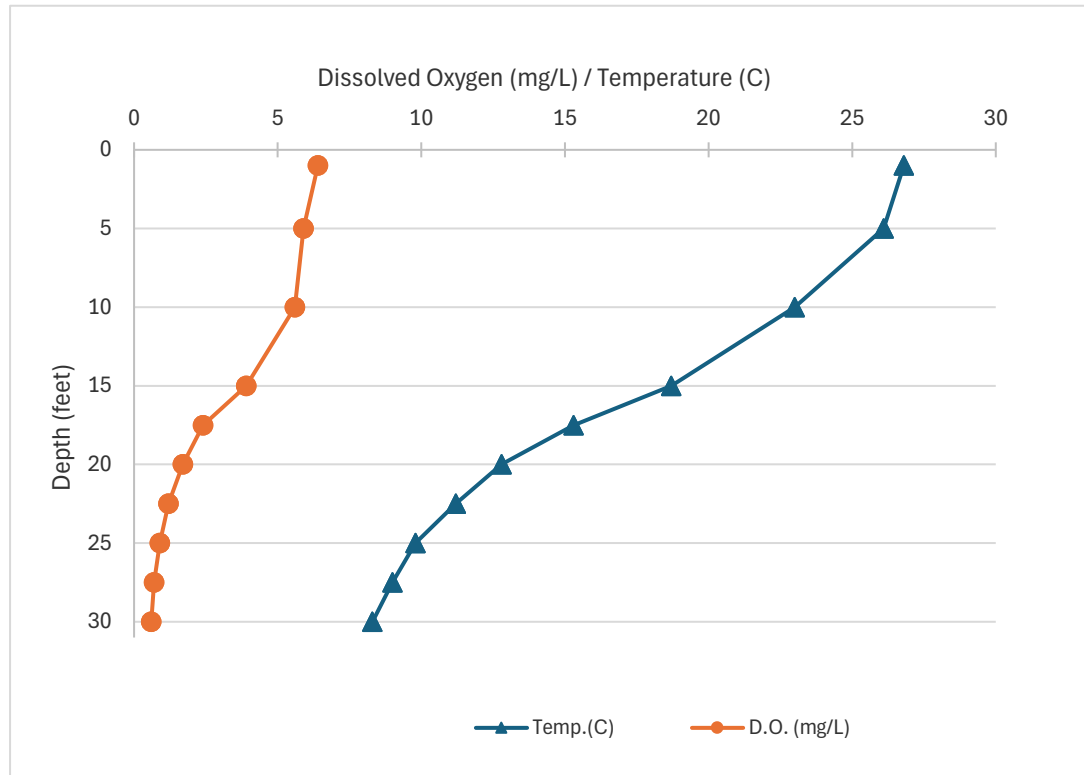
7/17/2024

Dissolved Oxygen and Temperature Profile

Depth (ft)	Temp.(C)	D.O. (mg/L)
1	26.8	6.4
1	26.8	6.4
5	26.1	5.9
5	26.1	5.9
10	23	5.6
10	23	5.6
15	18.7	3.9
15	18.7	3.9
17.5	15.3	2.4
17.5	15.3	2.4
20	12.8	1.7
20	12.8	1.7
22.5	11.2	1.2
22.5	11.2	1.2
25	9.8	0.9
25	9.8	0.9
27.5	9	0.7
27.5	9	0.7
30	8.3	0.6
30	8.3	0.6

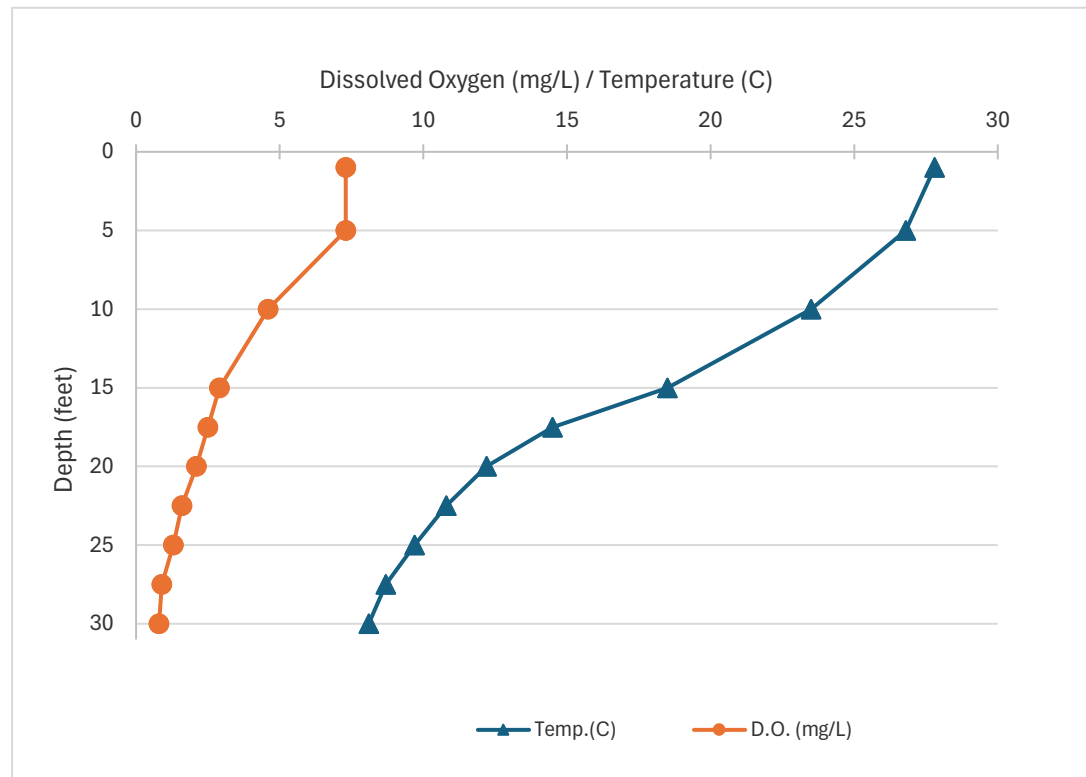
8/3/2024

Dissolved Oxygen and Temperature Profile

Depth (ft)	Temp.(C)	D.O. (mg/L)
1	27.8	7.3
1	27.8	7.3
5	26.8	7.3
5	26.8	7.3
10	23.5	4.6
10	23.5	4.6
15	18.5	2.9
15	18.5	2.9
17.5	14.5	2.5
17.5	14.5	2.5
20	12.2	2.1
20	12.2	2.1
22.5	10.8	1.6
22.5	10.8	1.6
25	9.7	1.3
25	9.7	1.3
27.5	8.7	0.9
27.5	8.7	0.9
30	8.1	0.8
30	8.1	0.8

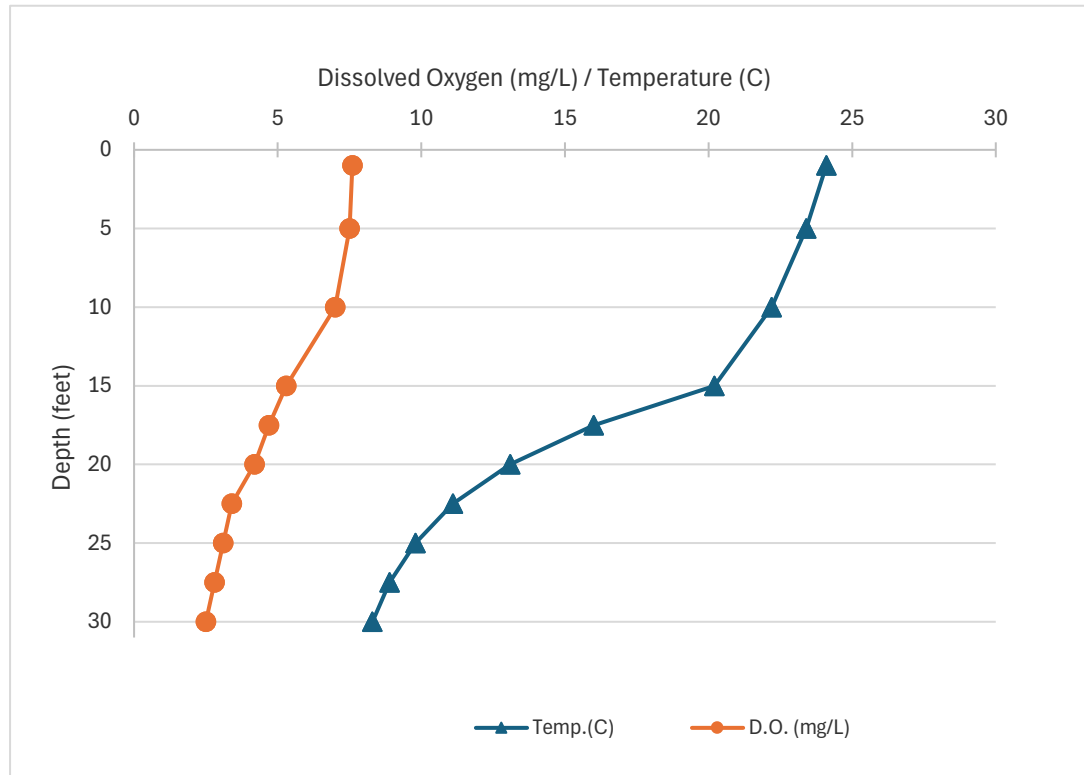
8/14/2024

Dissolved Oxygen and Temperature Profile

Depth (ft)	Temp.(C)	D.O. (mg/L)
1	24.1	7.6
1	24.1	7.6
5	23.4	7.5
5	23.4	7.5
10	22.2	7
10	22.2	7
15	20.2	5.3
15	20.2	5.3
17.5	16	4.7
17.5	16	4.7
20	13.1	4.2
20	13.1	4.2
22.5	11.1	3.4
22.5	11.1	3.4
25	9.8	3.1
25	9.8	3.1
27.5	8.9	2.8
27.5	8.9	2.8
30	8.3	2.5
30	8.3	2.5

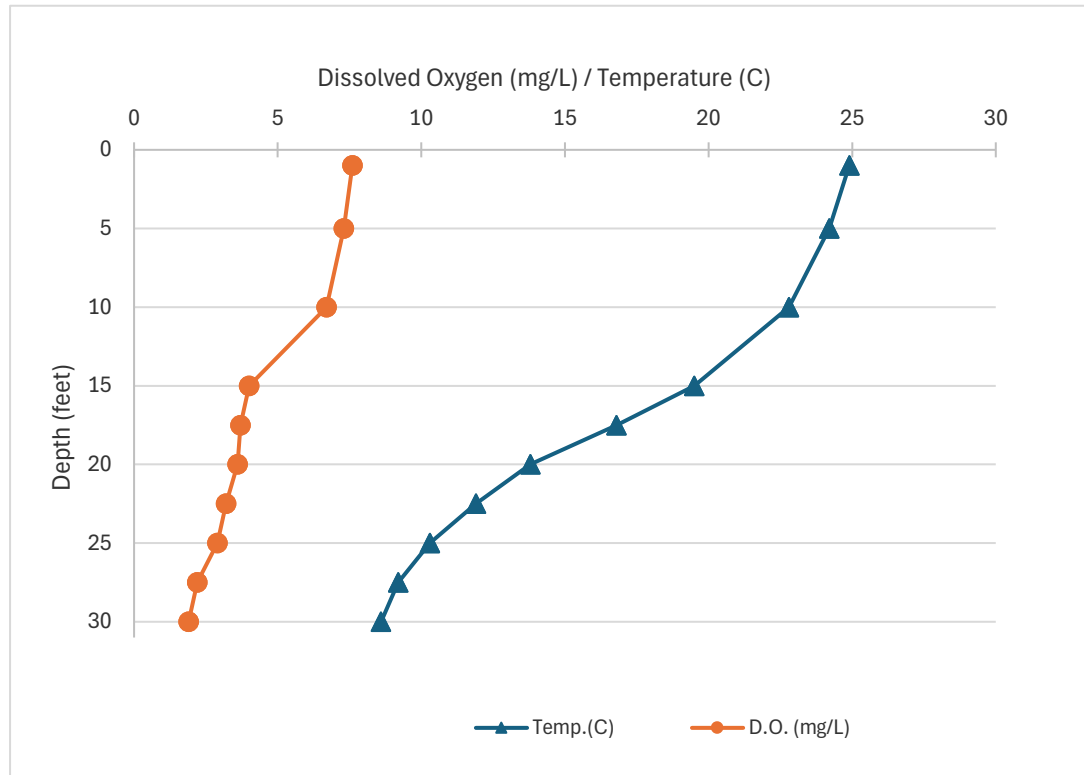
9/1/2024

Dissolved Oxygen and Temperature Profile

Depth (ft)	Temp.(C)	D.O. (mg/L)
1	24.9	7.6
1	24.9	7.6
5	24.2	7.3
5	24.2	7.3
10	22.8	6.7
10	22.8	6.7
15	19.5	4
15	19.5	4
17.5	16.8	3.7
17.5	16.8	3.7
20	13.8	3.6
20	13.8	3.6
22.5	11.9	3.2
22.5	11.9	3.2
25	10.3	2.9
25	10.3	2.9
27.5	9.2	2.2
27.5	9.2	2.2
30	8.6	1.9
30	8.6	1.9

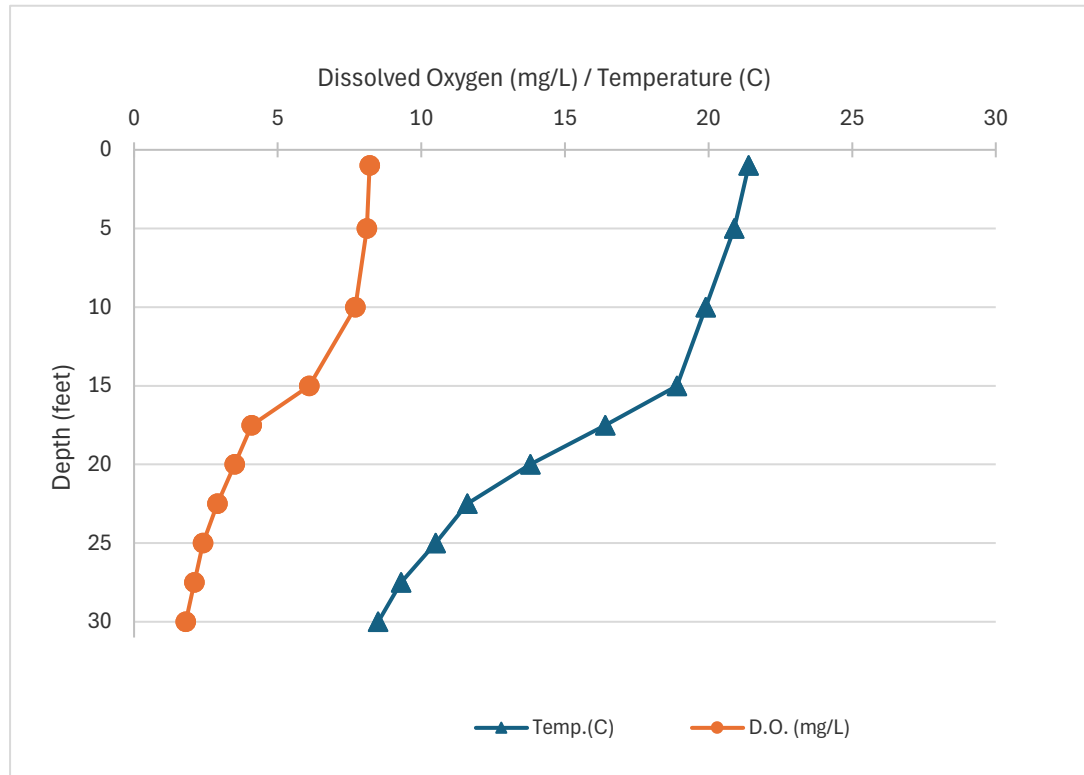
9/12/2024

Dissolved Oxygen and Temperature Profile

Depth (ft)	Temp.(C)	D.O. (mg/L)
1	21.4	8.2
1	21.4	8.2
5	20.9	8.1
5	20.9	8.1
10	19.9	7.7
10	19.9	7.7
15	18.9	6.1
15	18.9	6.1
17.5	16.4	4.1
17.5	16.4	4.1
20	13.8	3.5
20	13.8	3.5
22.5	11.6	2.9
22.5	11.6	2.9
25	10.5	2.4
25	10.5	2.4
27.5	9.3	2.1
27.5	9.3	2.1
30	8.5	1.8
30	8.5	1.8
