2017 Data Report for

Chippewa Lake, Mecosta County

Site ID: 540050

Chippewa Lake, Mecosta County 2017 CLMP Results

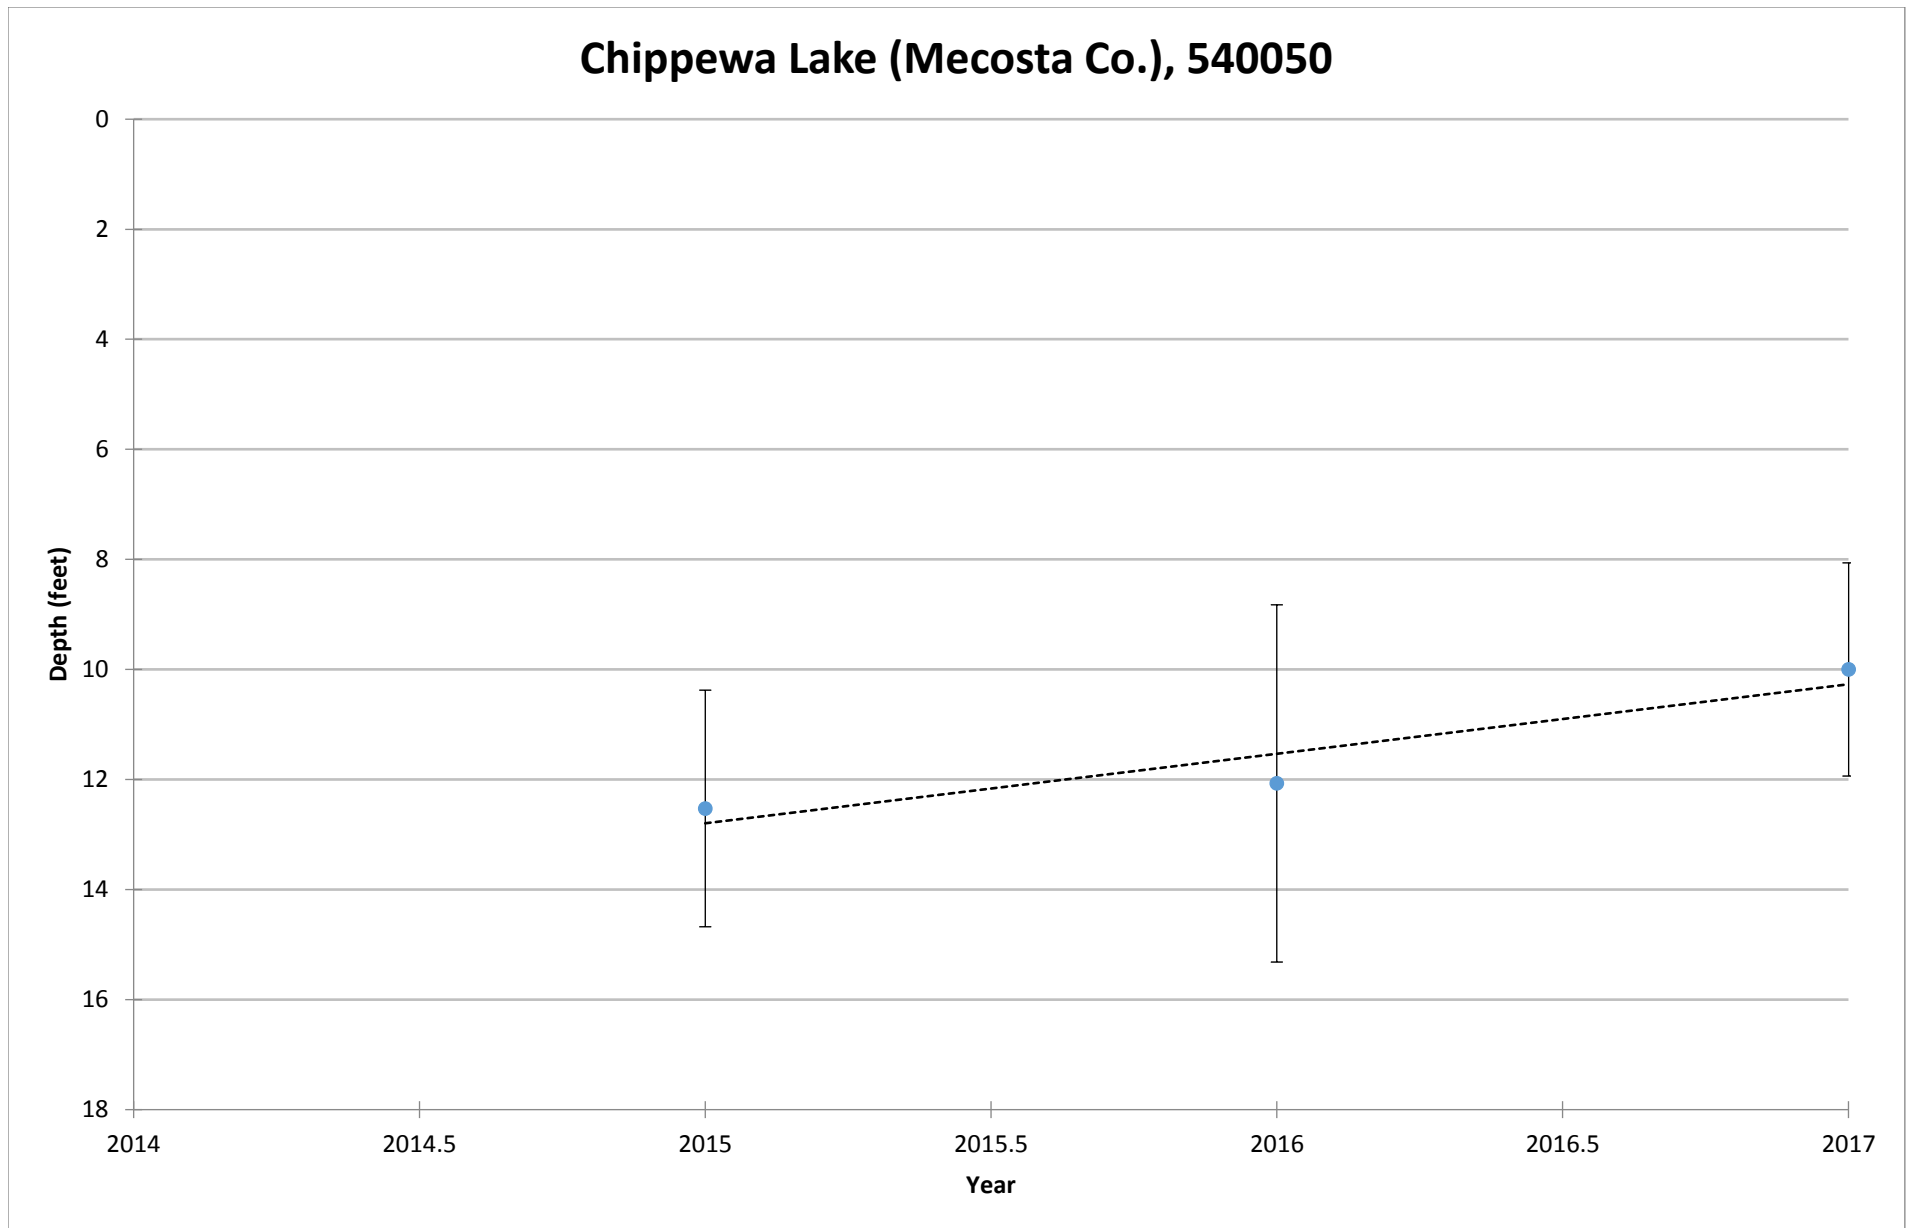
COOPERATIVE LAKES MONITORING PROGRAM
SUMMER MEAN TRANSPARENCY

Vertical bars indicate standard deviation

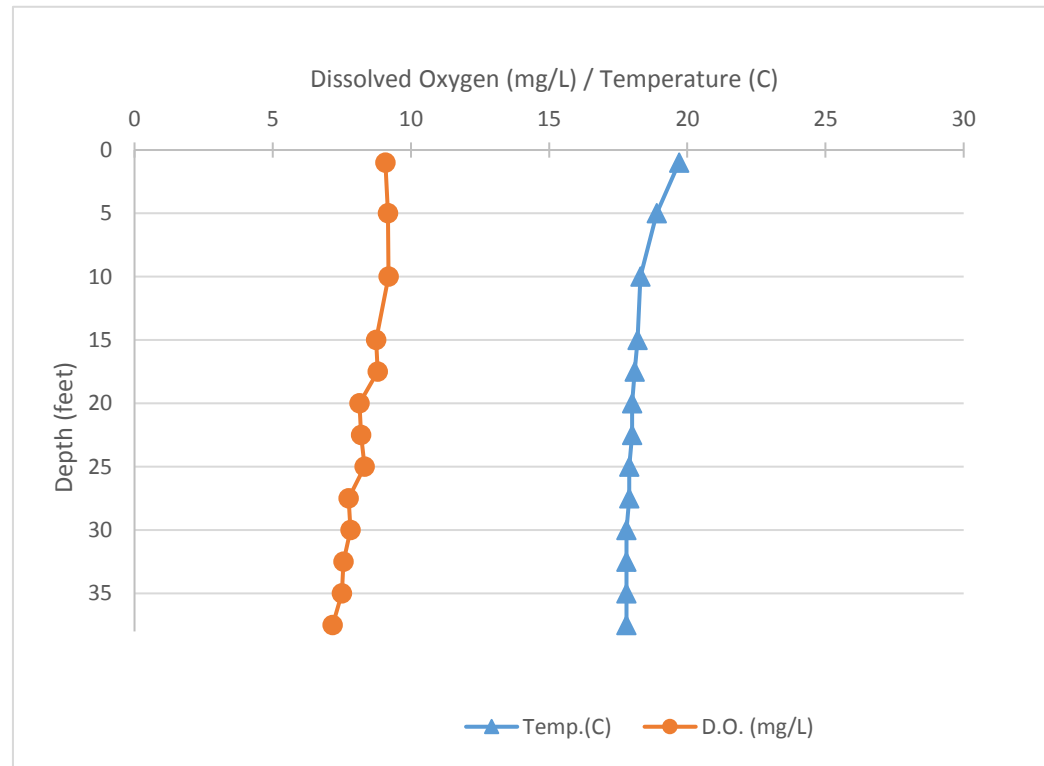
9/10/2017

Depth (ft)	Temp.(C)	D.O. (mg/L)
1	19.7	9.08
5	18.9	9.17
10	18.3	9.19
15	18.2	8.74
17.5	18.1	8.8
20	18	8.14
22.5	18	8.2
25	17.9	8.32
27.5	17.9	7.75
30	17.8	7.81
32.5	17.8	7.56
35	17.8	7.5
37.5	17.8	7.17
