**2017 Data Report
for
Deer Lake, Oakland County**

Site ID: 631128

Deer Lake, Oakland County 2017 CLMP Results

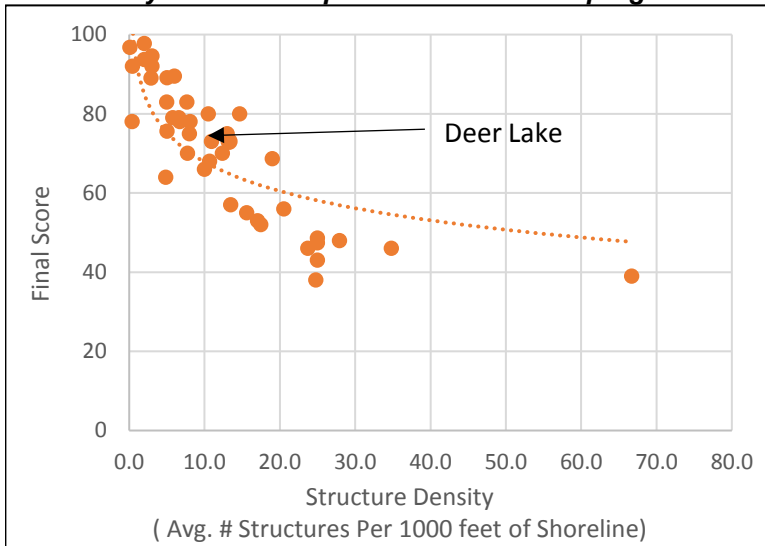
How does your lake compare to others in the program?

Deer Lake:	
Number of Sections:	13
Number of Structures:	142
Structure Density:	10.9
Final Score:	73

All 42 Participating Lakes from 2015-2017:	
Avg. Number of Sections:	16.3
Avg. Number of Structures:	248.5
Avg. Structure Density:	15.2
Avg. Final Score:	70.5

There is a very tight relationship between Final Score and Structure Density. It will be interesting to see if and how this changes as more lakes go through this scoring process.

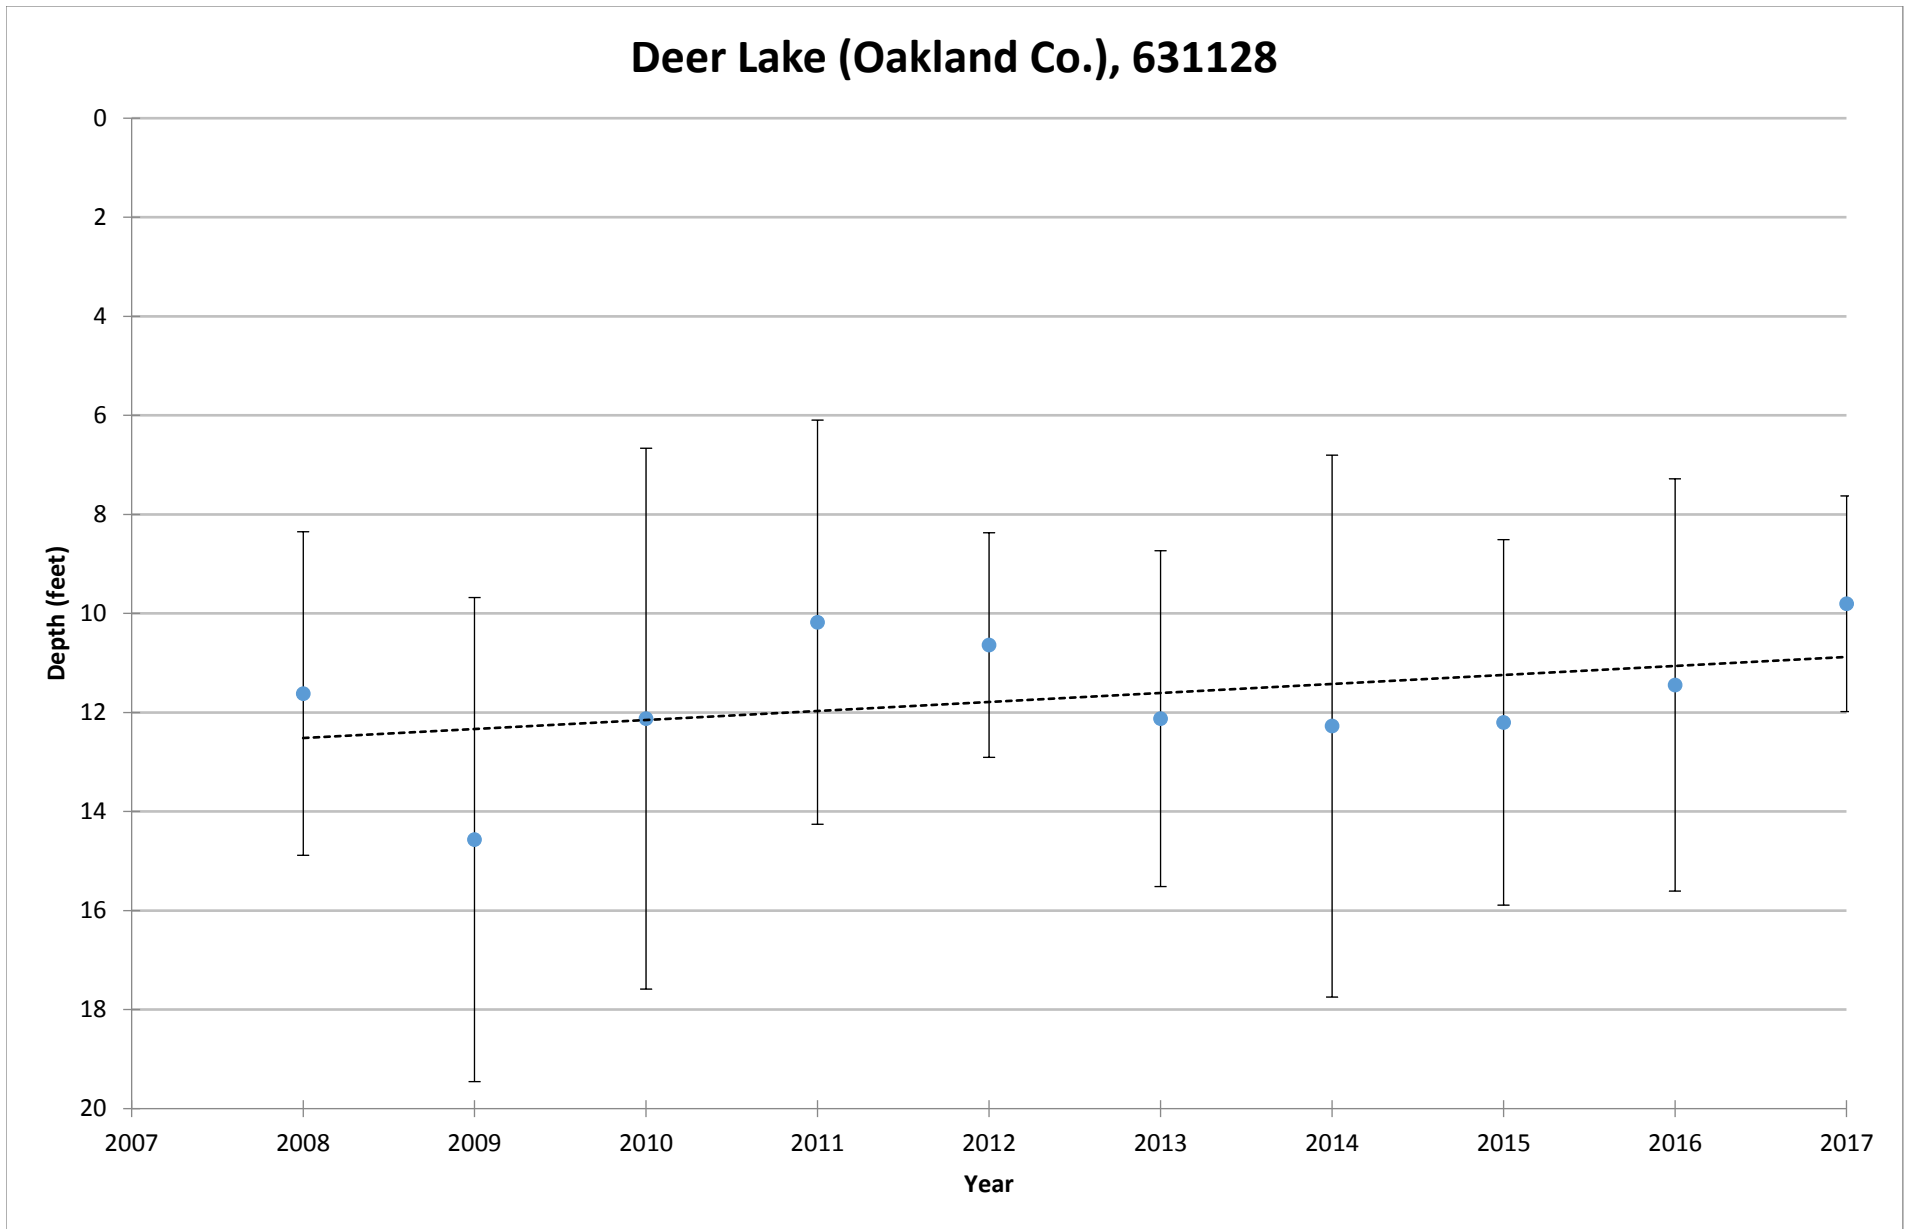
COOPERATIVE LAKES MONITORING PROGRAM
SUMMER MEAN TRANSPARENCY

Deer Lake (Oakland Co.), 631128

Vertical bars indicate standard deviation

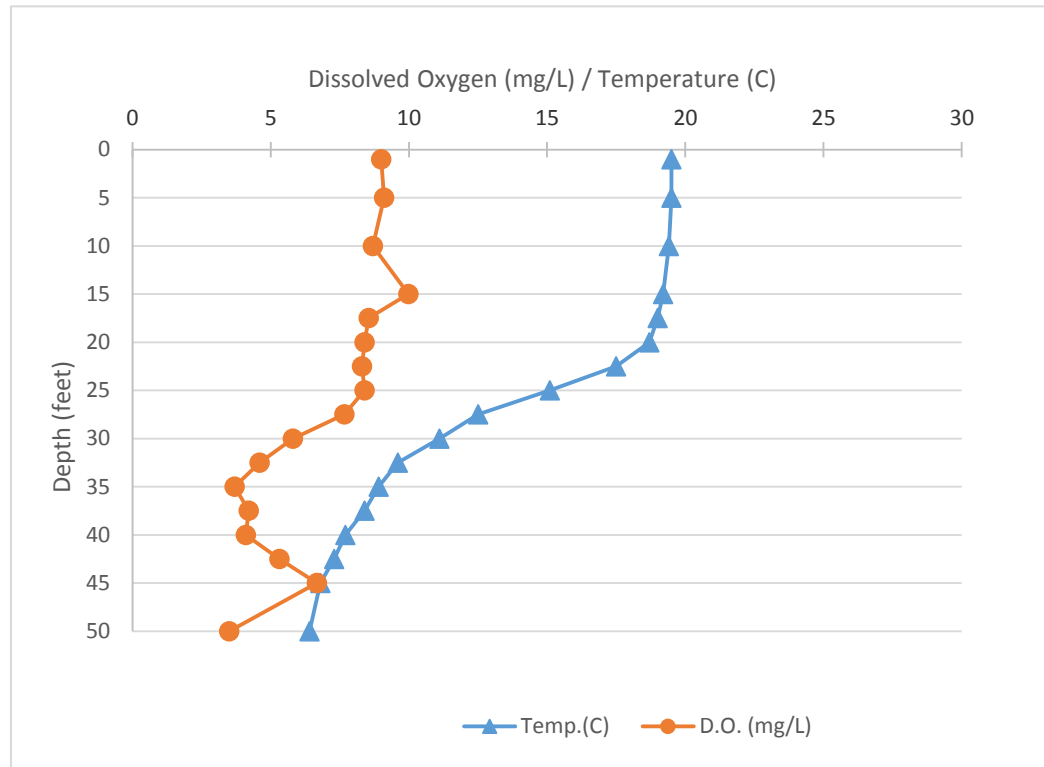
9/13/2017

Dissolved Oxygen and Temperature Profile

Depth (ft)	Temp.(C)	D.O. (mg/L)
1	19.5	9
5	19.5	9.1
10	19.4	8.7
15	19.2	9.98
17.5	19	8.55
20	18.7	8.4
22.5	17.5	8.3
25	15.1	8.4
27.5	12.5	7.66
30	11.1	5.8
32.5	9.6	4.6
35	8.9	3.7
37.5	8.4	4.2
40	7.7	4.1
42.5	7.3	5.31
45	6.8	6.67
50	6.4	3.5
