**2017 Data Report
for
Dorner Lake, Manistee County**

Site ID: 510272

Dorner Lake, Manistee County 2017 CLMP Results

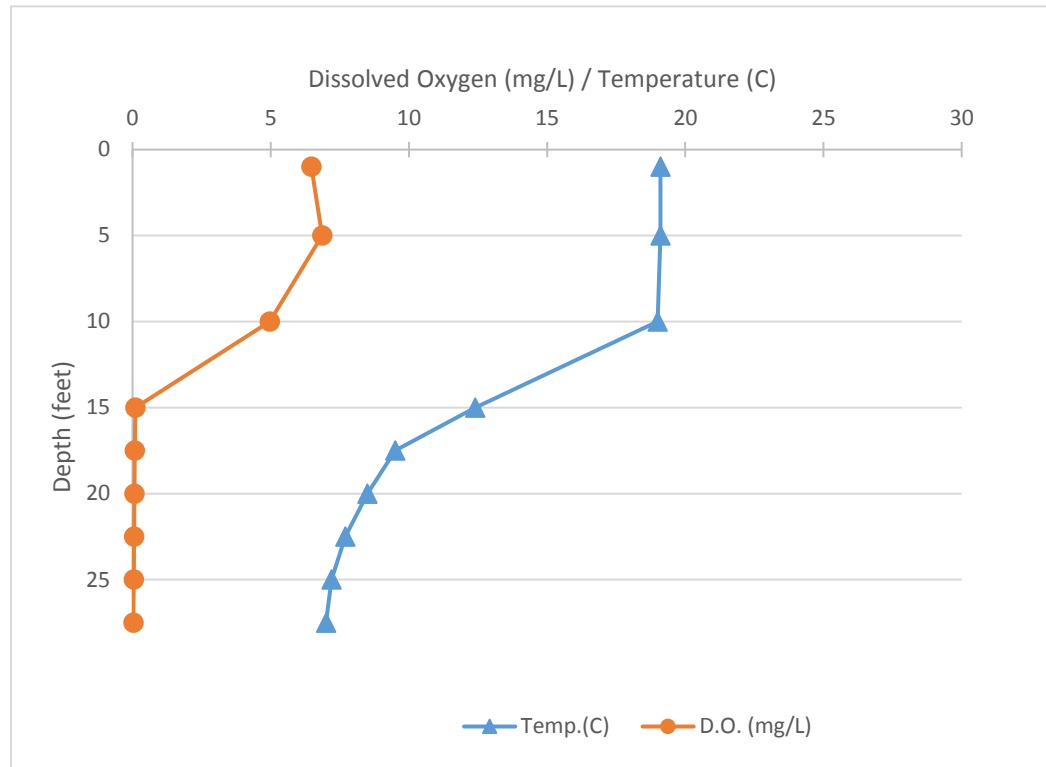
9/7/2017

Depth (ft)	Temp.(C)	D.O. (mg/L)
1	19.1	6.47
5	19.1	6.86
10	19	4.97
15	12.4	0.11
17.5	9.5	0.08
20	8.5	0.07
22.5	7.7	0.06
25	7.2	0.05
27.5	7	0.03
