2017 Data Report for Stony Lake, Oceana County

Site ID: 640049

Stony Lake, Oceana County 2017 CLMP Results

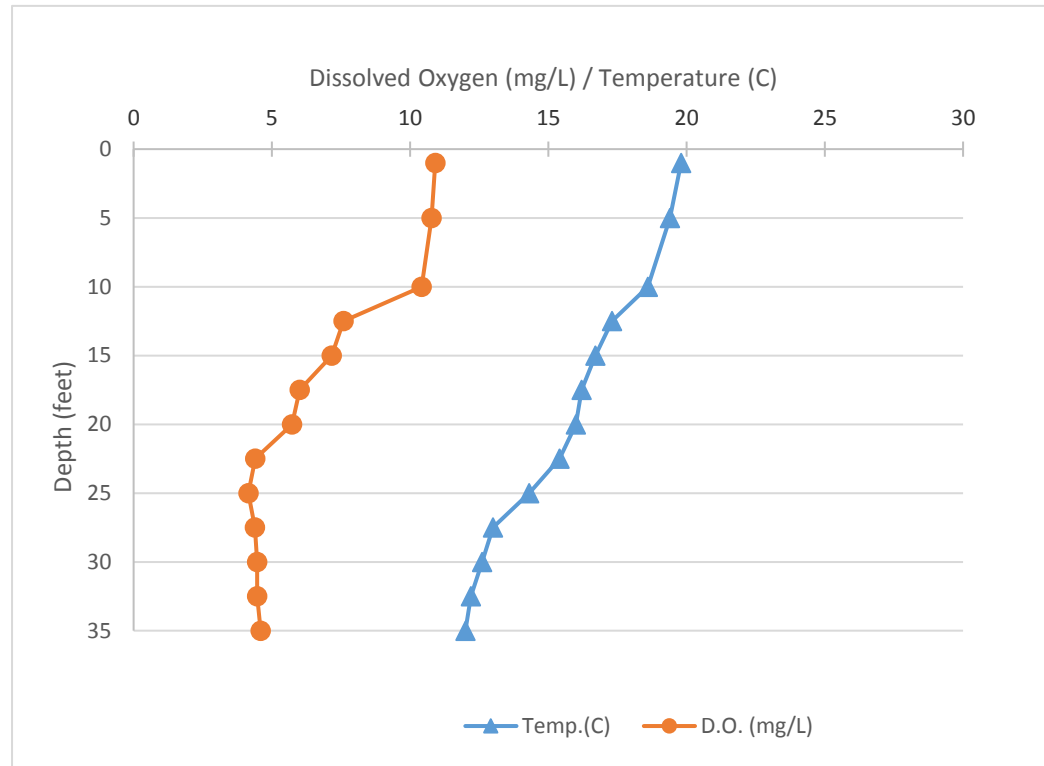
9/13/2017

Depth (ft)	Temp.(C)	D.O. (mg/L)
1	19.8	10.91
5	19.4	10.78
10	18.6	10.42
12.5	17.3	7.59
15	16.7	7.16
17.5	16.2	6.01
20	16	5.73
22.5	15.4	4.4
25	14.3	4.15
27.5	13	4.39
30	12.6	4.47
32.5	12.2	4.47
35	12	4.6
