2017 Data Report for Timmerman Lake, Manistee County

Site ID: 510275

Timmerman Lake, Manistee County 2017 CLMP Results

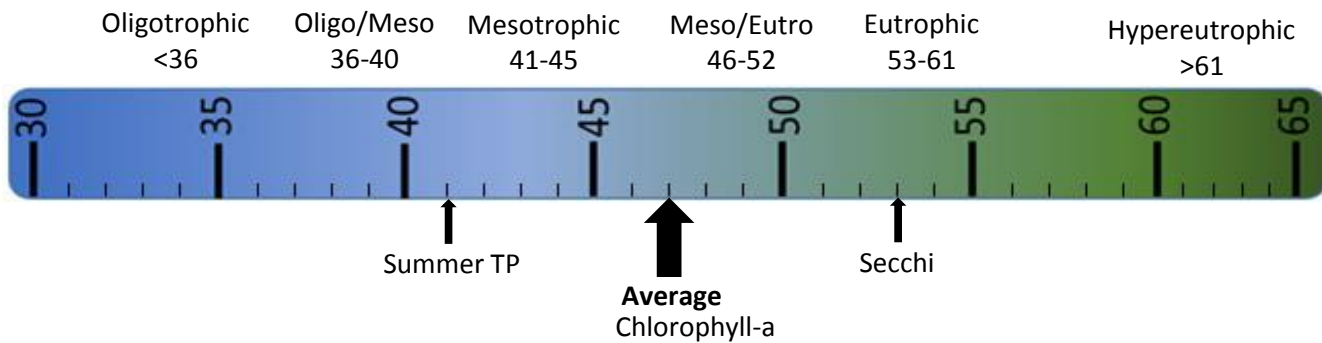
With an average TSI score of 47 based on 2017 Secchi transparency, chlorophyll-a, and summer total phosphorus data, this lake is rated between the mesotrophic and eutrophic lake classification. The lake leans slightly more mesotrophic than eutrotrophic.

TSI for Timmerman Lake in 2017	
Average	47
Secchi Disk	53
Summer TP	41
Chlorophyll-a	47

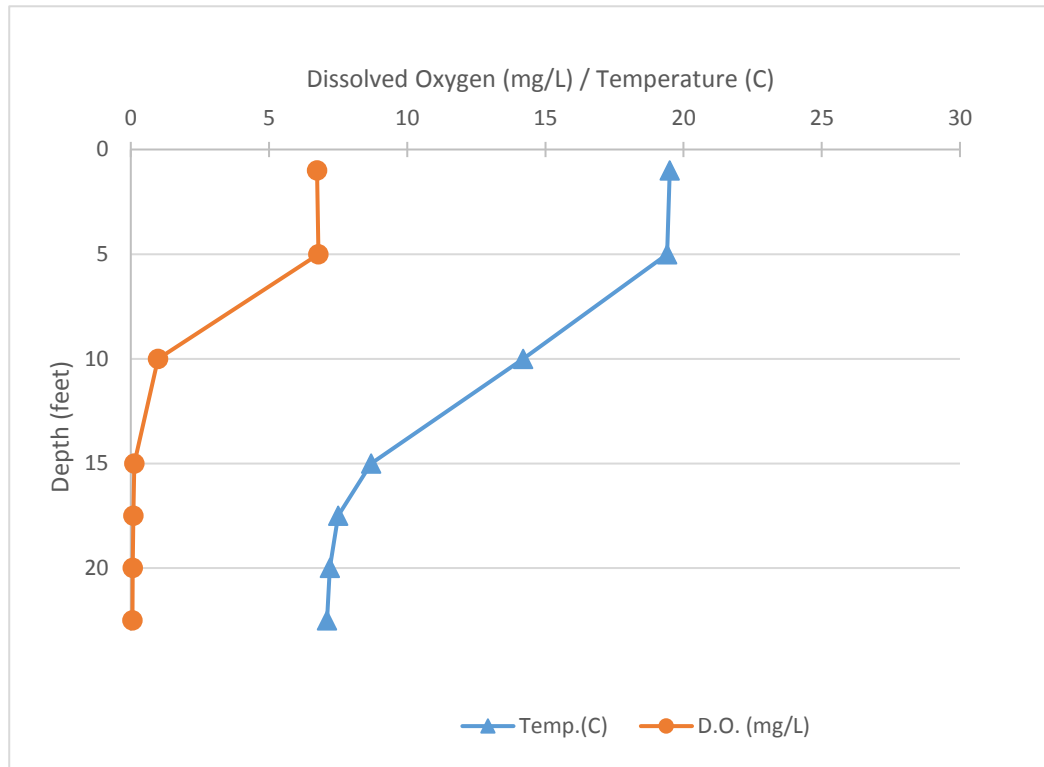
Name: Timmerman Lake
County: Manistee
Site ID: 510275
Date: 9/5/2017

Depth (ft)	Temp.(C)	D.O. (mg/L)
1	19.5	6.74
5	19.4	6.79
10	14.2	0.99
15	8.7	0.13
17.5	7.5	0.09
20	7.2	0.07
22.5	7.1	0.06
