2023 Data Report for

Eagle Lake, Van Buren County

Site ID: 800261

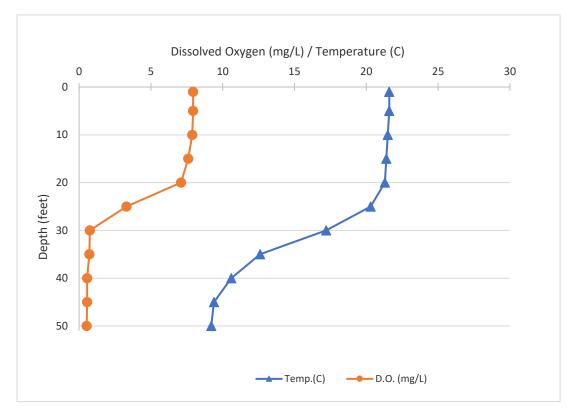
Name: Eagle Lake County: Van Buren Site ID: 800261 Date: 9/25/2023

Depth (ft)	Temp.(C)	D.O. (mg/L)
1	21.6	7.94
5	21.6	7.94
10	21.5	7.88
15	21.4	7.6
20	21.3	7.1
25	20.3	3.3
30	17.2	0.75
35	12.6	0.71
40	10.6	0.56
45	9.4	0.56
50	9.2	0.53
