**2016 Data Report
for
Hanbury Lake, Dickinson County**

Site ID: 220151

Hanbury Lake, Dickinson County 2016 CLMP Results

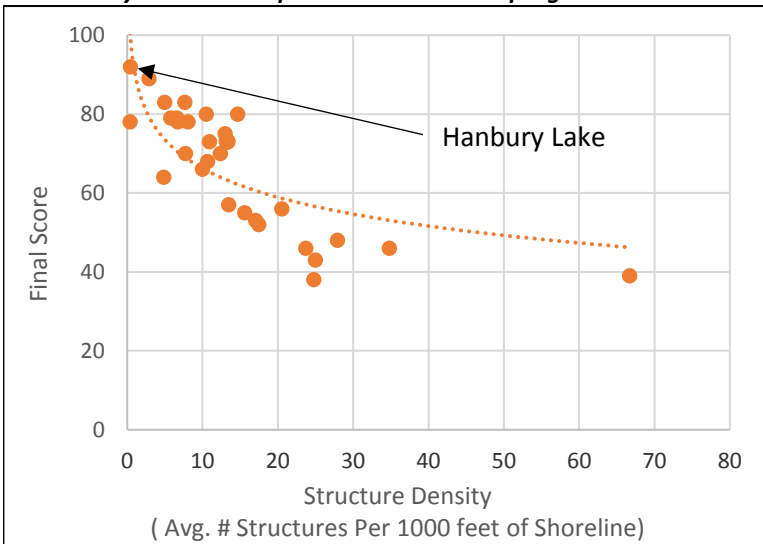
How does your lake compare to others in the program?

Hanbury Lake:	
Number of Sections:	7
Number of Structures:	3
Structure Density:	0.4
Final Score:	92

All 31 Participating Lakes in 2015 and 2016:	
Avg. Number of Sections:	16
Avg. Number of Structures:	233
Avg. Structure Density:	14.6
Avg. Final Score:	66

There is a very tight relationship between Final Score and Structure Density. It will be interesting to see if and how this changes as more lakes go through this scoring process.

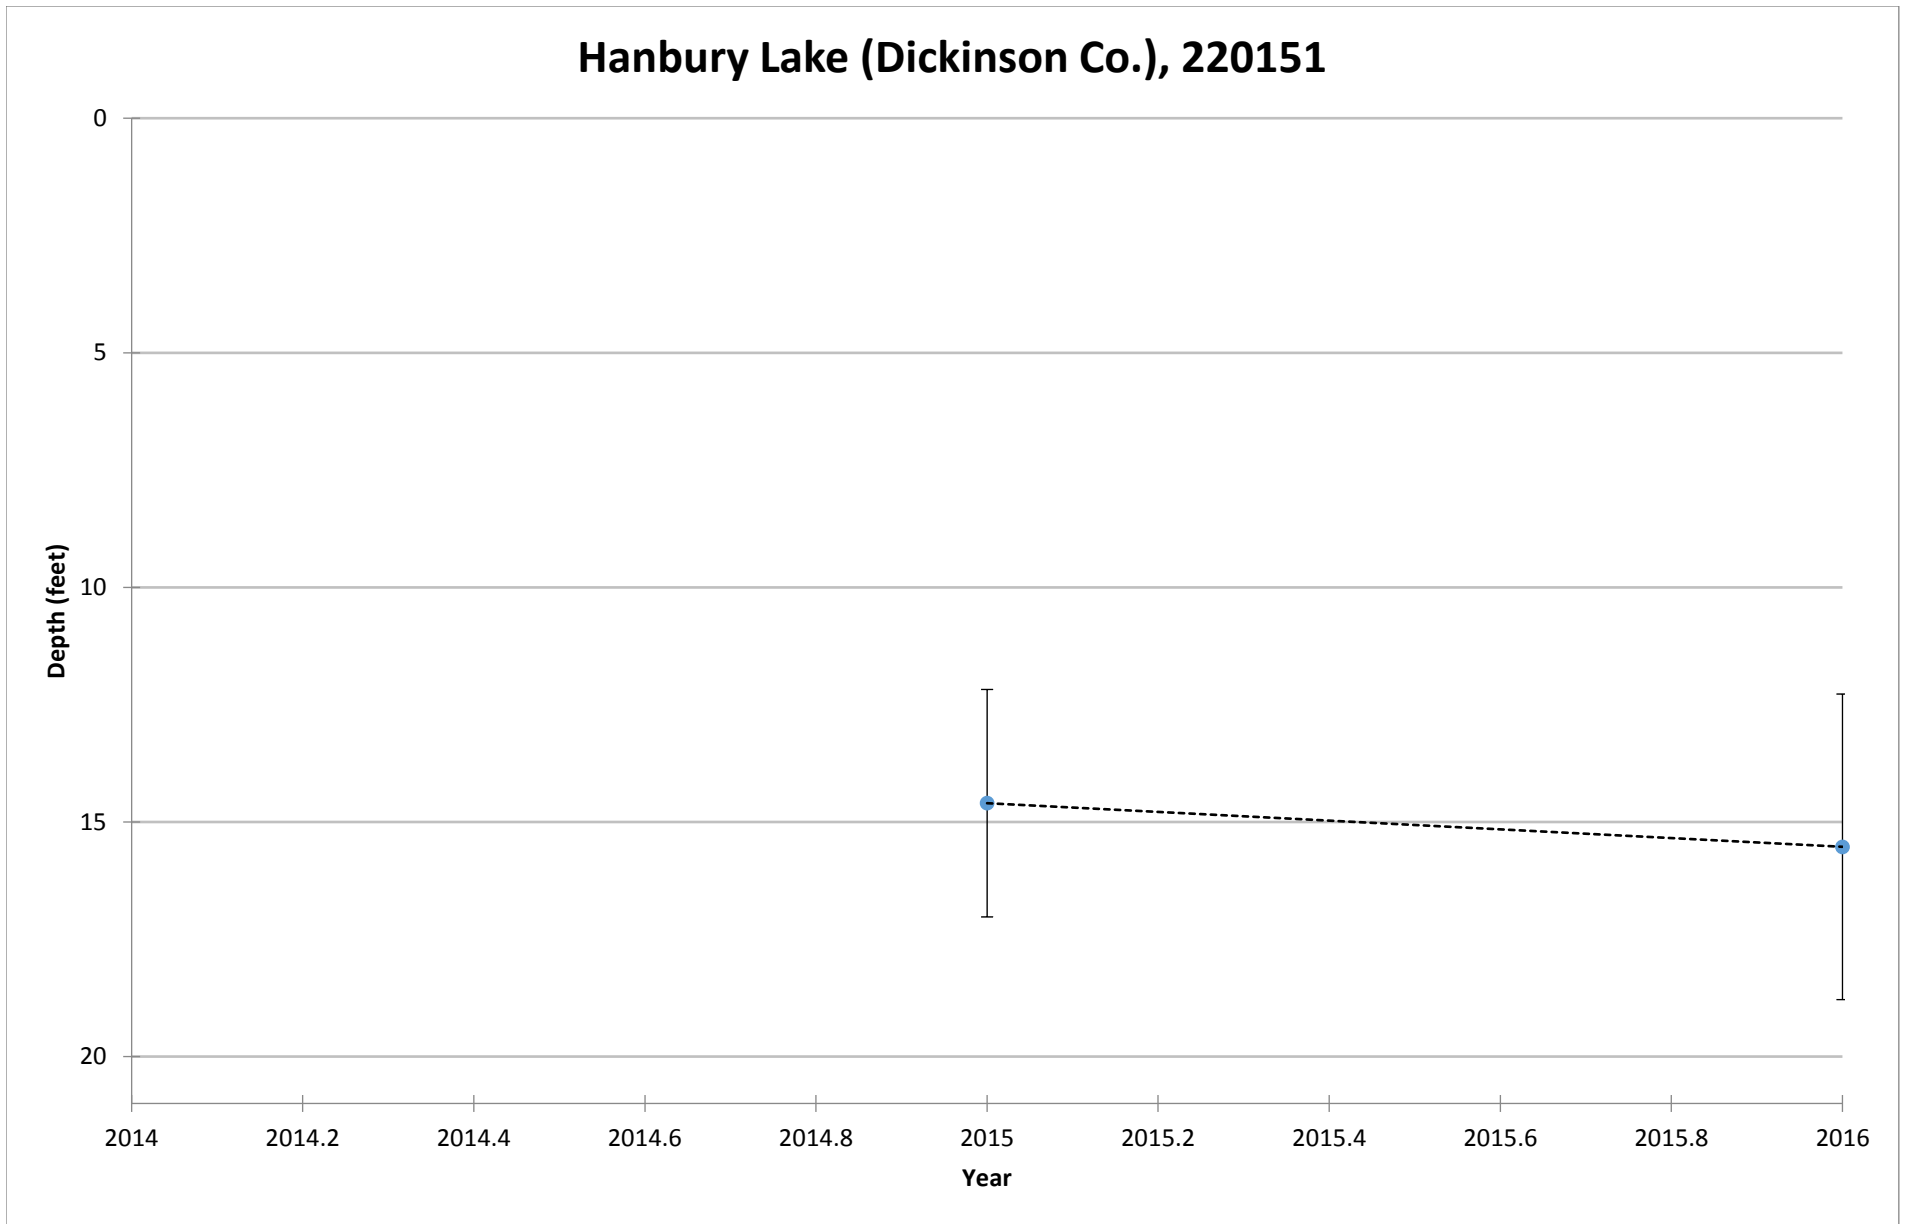
COOPERATIVE LAKES MONITORING PROGRAM
SUMMER MEAN TRANSPARENCY

Hanbury Lake (Dickinson Co.), 220151

Vertical bars indicate standard deviation
