**2018 Data Report
for
Elbow Lake, Lake County**

Site ID: 430637

Elbow Lake, Lake County 2018 CLMP Results

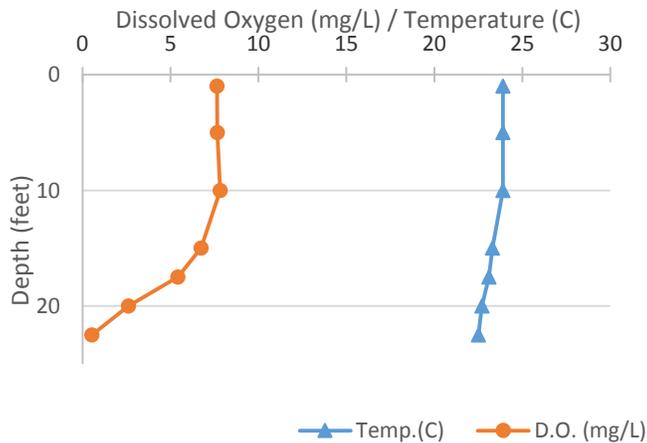
8/20/2017

Dissolved Oxygen and Temperature Profile

If you enrolled in Dissolved Oxygen/Temperature, the summary page will have a graph of one of the profiles taken during the late summer (typically August or September). If your lake stratifies, we will use a graph showing the earliest time of stratification, because identifying the timing of this condition and the depth at which it occurs is typically the most important use of dissolved oxygen measurements.

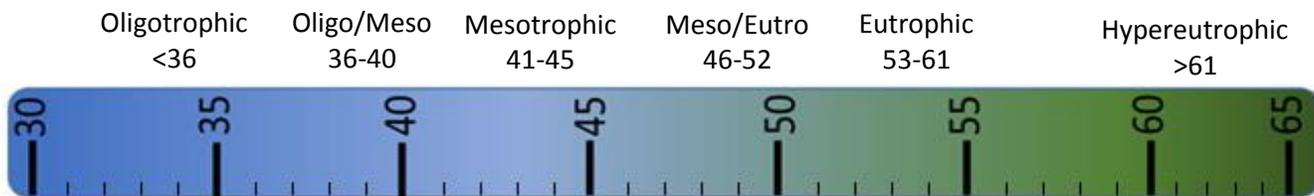
TSI for Elbow Lake in 2018	
Average	NA
Secchi Disk	NA
Summer TP	NA
Chlorophyll-a	NA

Oligotrophic: Generally deep and clear lakes with little aquatic plant or algae growth. These lakes maintain sufficient dissolved oxygen in the cool, deep-bottom waters during late summer to support cold water fish, such as trout and whitefish.

Mesotrophic: Lakes that fall between oligotrophic and eutrophic. Mid-ranged amounts of nutrients.

Eutrophic: Highly productive eutrophic lakes are generally shallow, turbid, and support abundant aquatic plant growth. In deep eutrophic lakes, the cool bottom waters usually contain little or no dissolved oxygen. Therefore, these lakes can only support warm water fish, such as bass and pike.

Hypereutrophic: A specialized category of eutrophic lakes. These lakes exhibit extremely high productivity, such as nuisance algae and weed growth.

In 1977, limnologist Dr. Robert Carlson developed a numerical scale (0-100) where the numbers indicate the level of nutrient enrichment. Using the proper equations, we can convert results from Summer Total Phosphorus, Secchi Depth, and Chlorophyll-a to this Trophic Status Index (TSI). The TSI numbers are furthermore grouped into general categories (oligotrophic, mesotrophic, eutrophic, and hypereutrophic), to quickly give us a way to understand the general nutrient level of any lake.

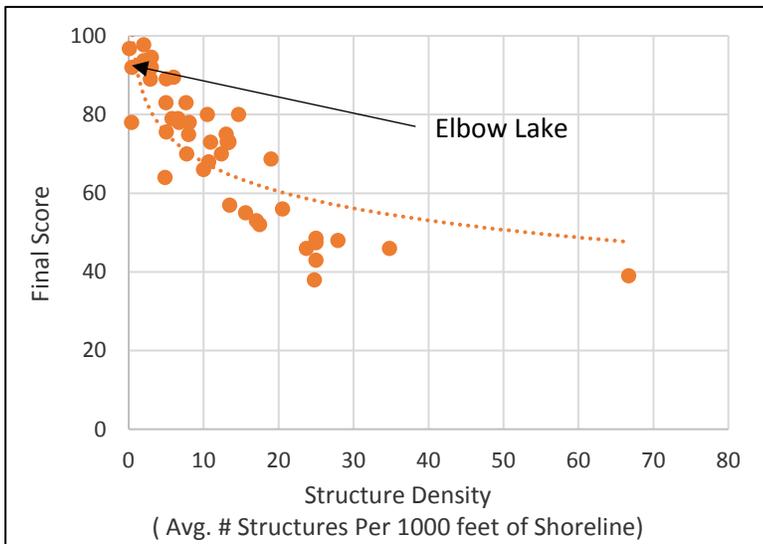
How does your lake compare to others in the program?

Elbow Lake:	
Number of Sections:	8
Number of Structures:	25
Structure Density:	3.1
Final Score:	92

All 42 Participating Lakes from 2015-2018:	
Avg. Number of Sections:	16.3
Avg. Number of Structures:	248.5
Avg. Structure Density:	15.2
Avg. Final Score:	70.5

There is a very tight relationship between Final Score and Structure Density. It will be interesting to see if and how this changes as more lakes go through this scoring process.
