# 2019 Data Report for Ann Lake, Benzie County

Site ID: 100082

# Ann Lake, Benzie County 2019 CLMP Results

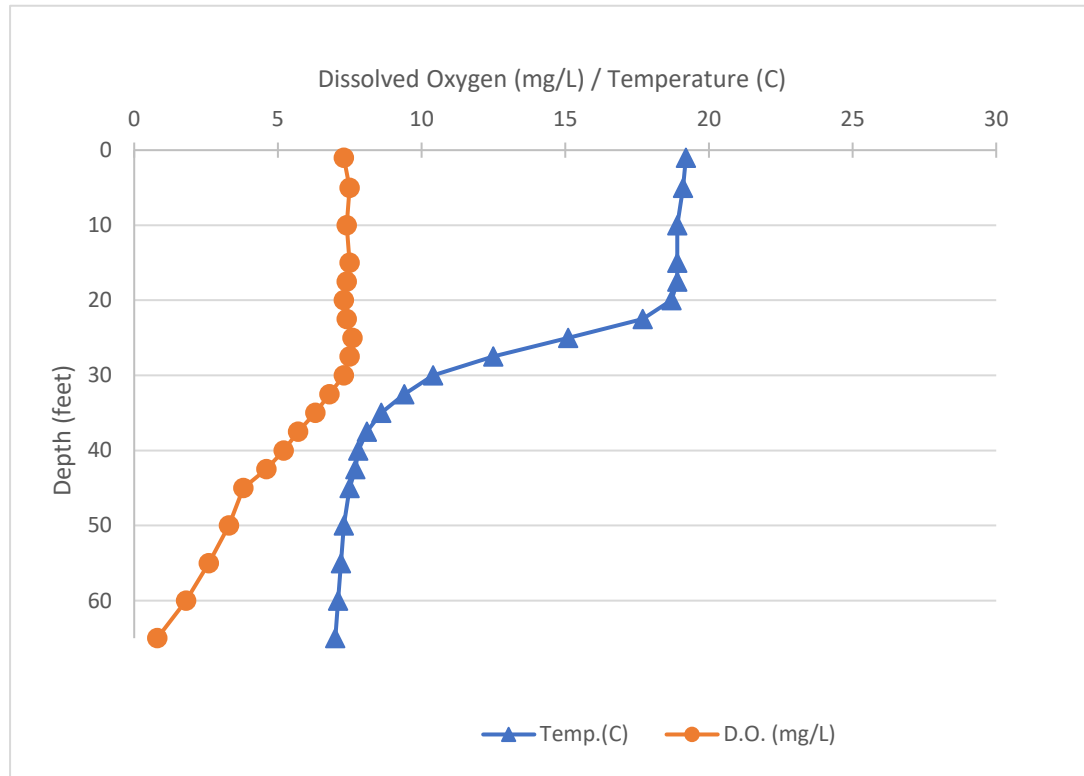
9/9/2019

### Dissolved Oxygen and Temperature Profile

Depth (ft)	Temp.(C)	D.O. (mg/L)
1	19.2	7.3
5	19.1	7.5
10	18.9	7.4
15	18.9	7.5
17.5	18.9	7.4
20	18.7	7.3
22.5	17.7	7.4
25	15.1	7.6
27.5	12.5	7.5
30	10.4	7.3
32.5	9.4	6.8
35	8.6	6.3
37.5	8.1	5.7
40	7.8	5.2
42.5	7.7	4.6
45	7.5	3.8
50	7.3	3.3
55	7.2	2.6
60	7.1	1.8
65	7	0.8
