2019 Data Report for Cobb Lake, Barry County

Site ID: 080259

Cobb Lake, Barry County 2019 CLMP Results

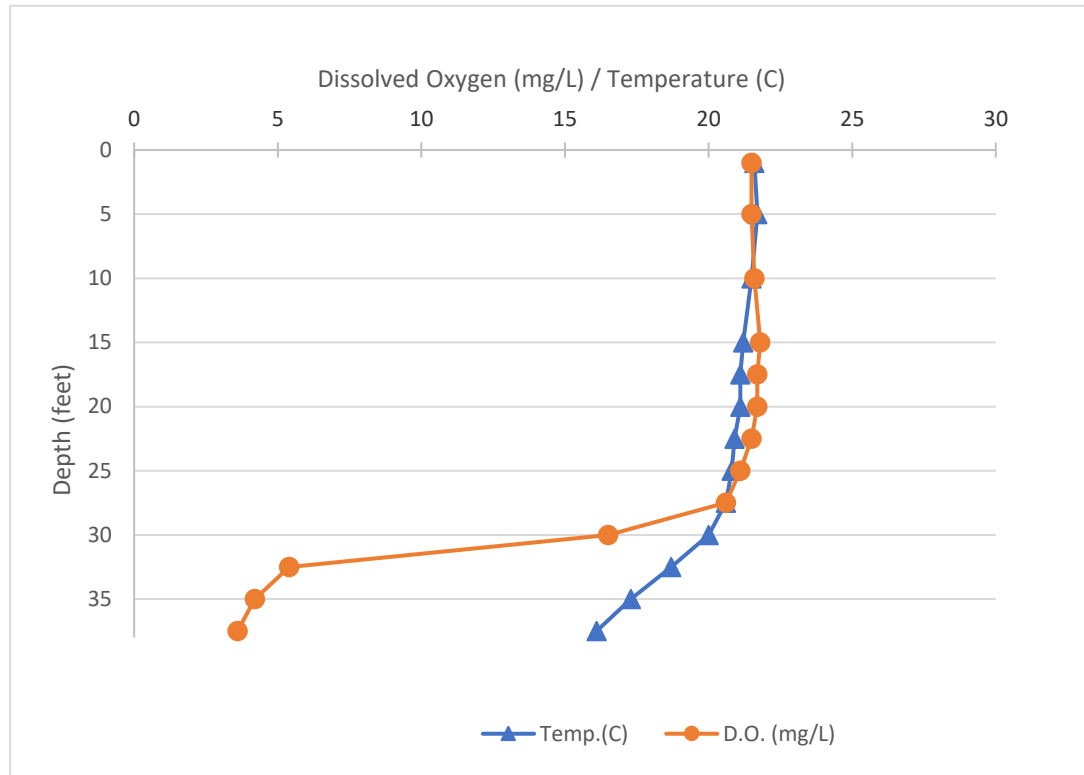
9/15/2019

Dissolved Oxygen and Temperature Profile

Depth (ft)	Temp.(C)	D.O. (mg/L)
1	21.6	21.5
5	21.7	21.5
10	21.5	21.6
15	21.2	21.8
17.5	21.1	21.7
20	21.1	21.7
22.5	20.9	21.5
25	20.8	21.1
27.5	20.6	20.6
30	20	16.5
32.5	18.7	5.4
35	17.3	4.2
37.5	16.1	3.6
