# 2019 Data Report for First Fortune Lake, Iron County

Site ID: 360080

# First Fortune Lake, Iron County 2019 CLMP Results

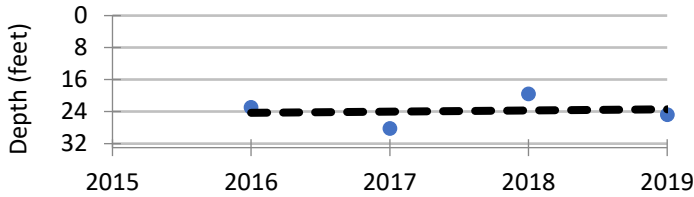
## Secchi Disk Transparency (feet)

Year	# Readings	Min	Max	Average	Std. Dev	Carlson TSI
2019	15	17.0	36.5	24.8	6.4	31
2016-2018	34	15.0	39.5	24.8	4.6	32
2019 All CLMP Lakes	3392	1.5	50.0	12.8	5.8	42

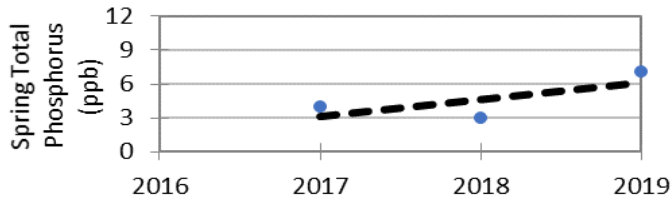
## Spring Phosphorus (parts per billion)

Year	# Samples	Min	Max	Average	Std. Dev
2019	1	7.0	7.0	7.0	NA
2017-2018	2	<=3 W	<5 T	3.5	0.7
2019 All CLMP Lakes	220	<= 3	100.0	14.9	11.0

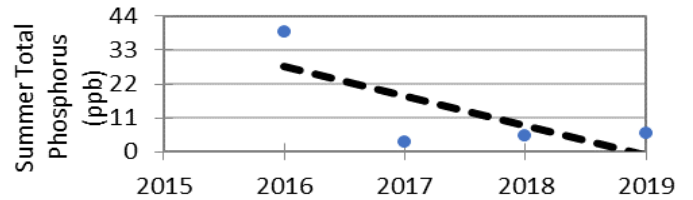
## Summer Phosphorus (parts per billion)

Year	# Samples	Min	Max	Average	Std. Dev	Carlson TSI
2019	1	6.0	6.0	6.0	NA	30
2016-2018	3	<=3 W	39.0	15.7	20.2	35
2019 All CLMP Lakes	281	<= 3	65.0	12.8	9.3	38

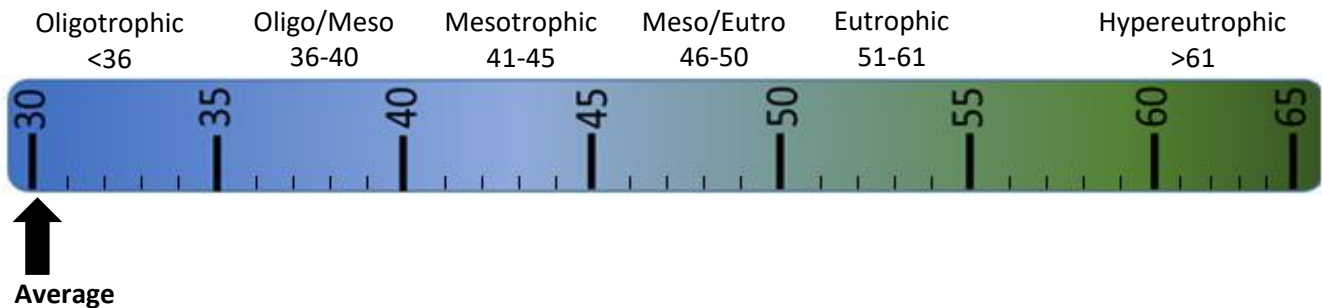
TSI for First Fortune Lake in 2019	
Average	30
Secchi Disk	31
Summer TP	30
Chlorophyll-a

In 1977, limnologist Dr. Robert Carlson developed a numerical scale (0-100) where the numbers indicate the level of nutrient enrichment. Using the proper equations, we can convert results from Summer Total Phosphorus, Secchi Depth, and Chlorophyll-a to this Trophic Status Index (TSI). The TSI numbers are furthermore grouped into general categories (oligotrophic, mesotrophic, eutrophic, and hypereutrophic), to quickly give us a way to understand the general nutrient level of any lake.

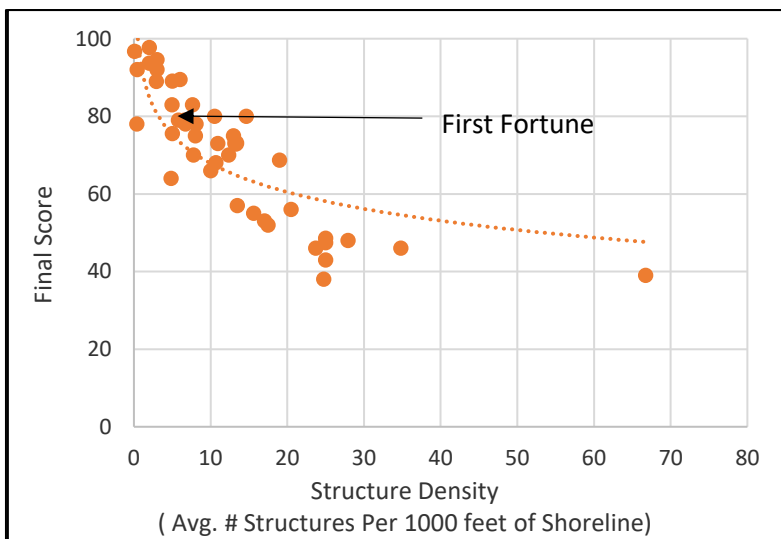
### How does your lake compare to others in the program?

First Fortune Lake:	
Number of Sections:	18
Number of Structures:	121
Structure Density:	6.7
Final Score:	78

All 42 Participating Lakes from 2015-2018:	
Avg. Number of Sections:	16.3
Avg. Number of Structures:	248.5
Avg. Structure Density:	15.2
Avg. Final Score:	70.5

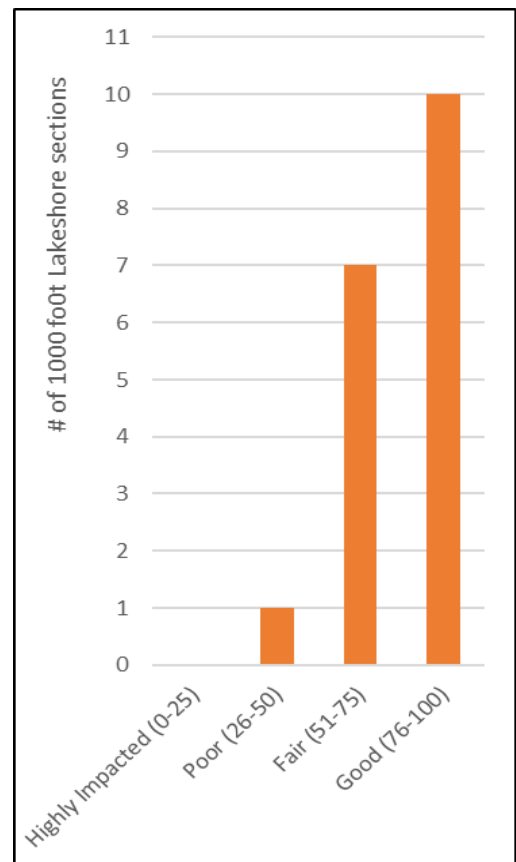
Overall, the lakeshore habitat of First Fortune Lake is doing well, with all of the 1000 foot sections scoring Poor through Good: 1 poor, 7 fair, and 10 good.

In terms of possible improvements, consider section 3, the only section on this lake to score a poor with a score of 49. The worst part of section 3 was the riparian zone, which could be improved by reducing the amount of mowed grass and increasing the amount of unmowed vegetation along the lakeshore.

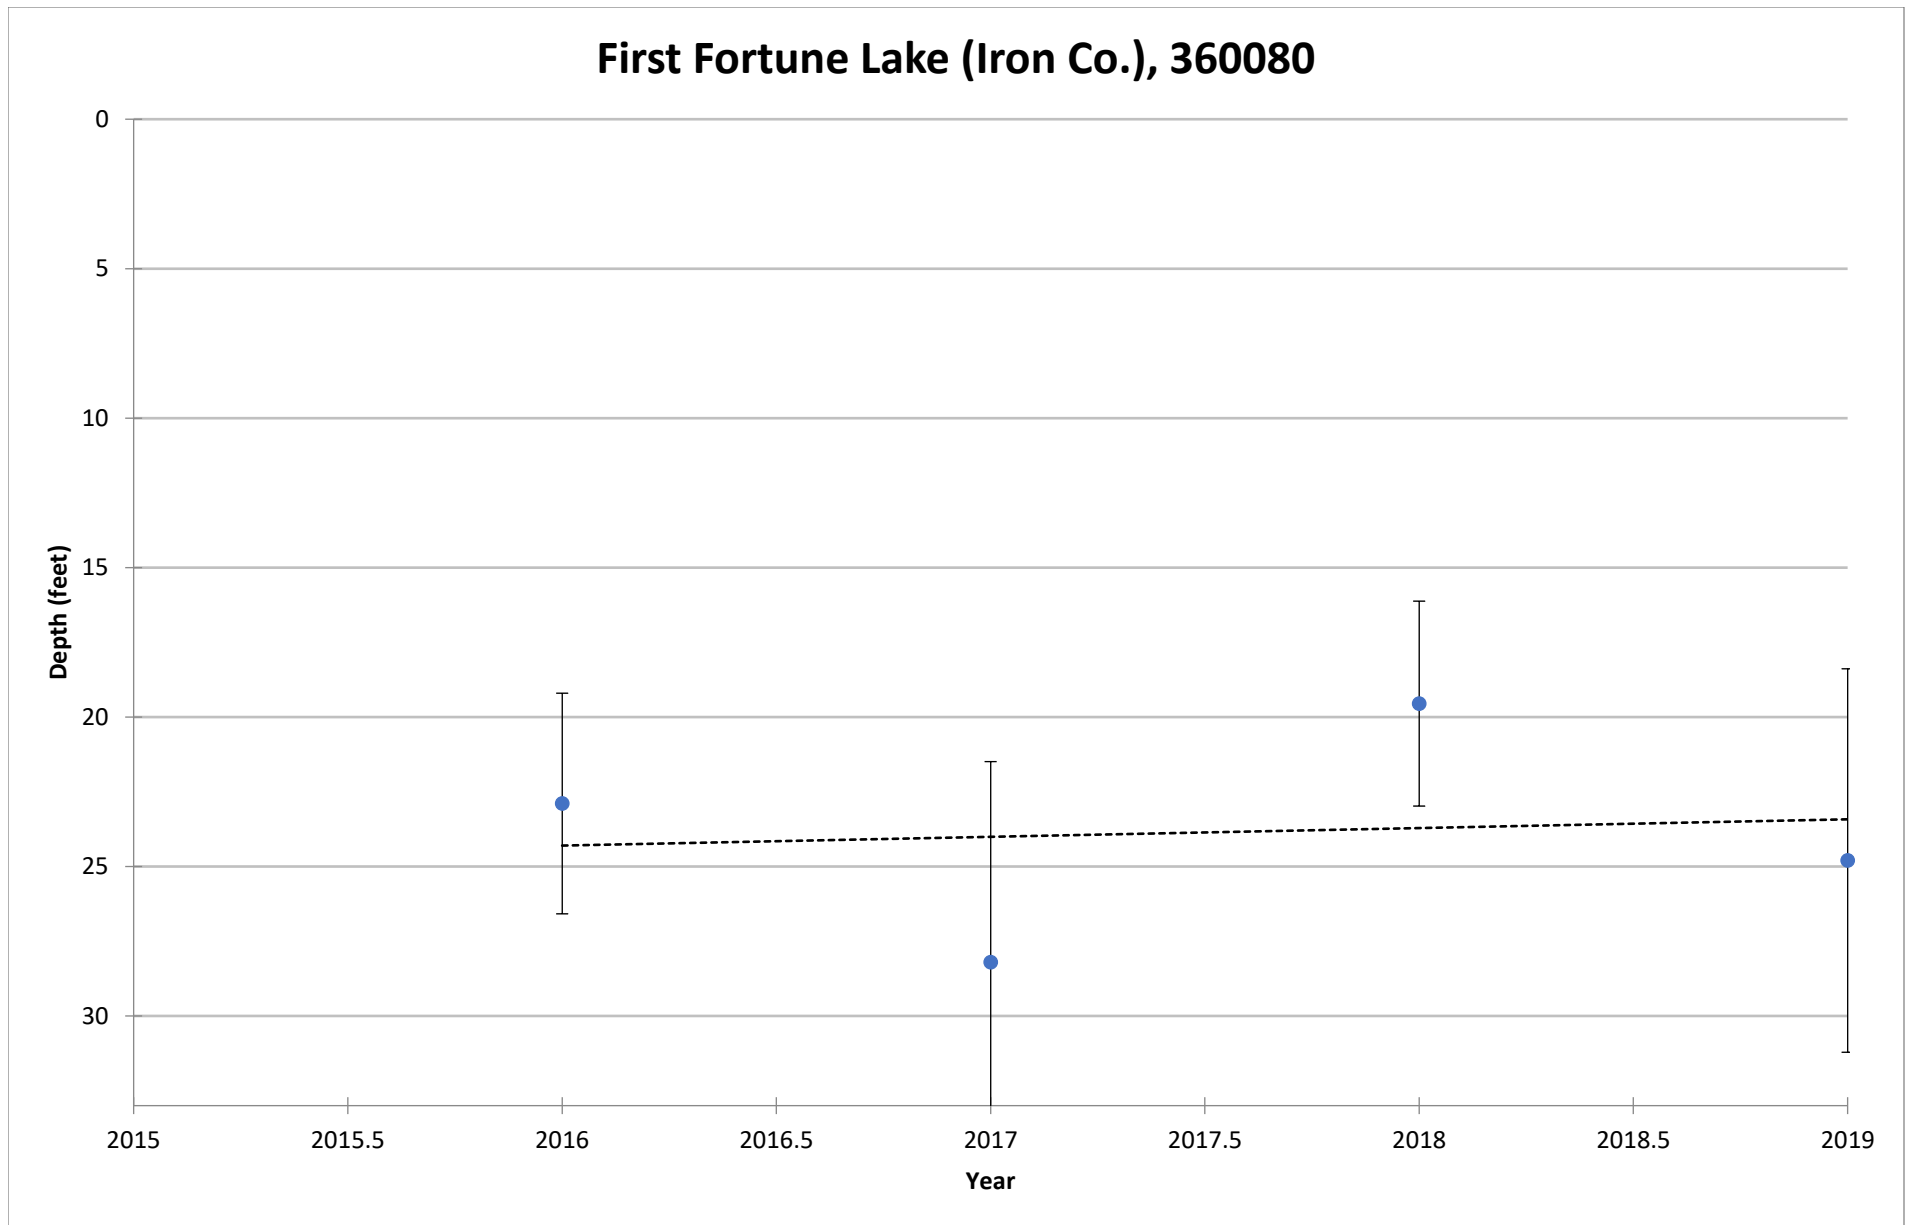
COOPERATIVE LAKES MONITORING PROGRAM  
SUMMER MEAN TRANSPARENCY

**First Fortune Lake (Iron Co.), 360080**

Vertical bars indicate standard deviation

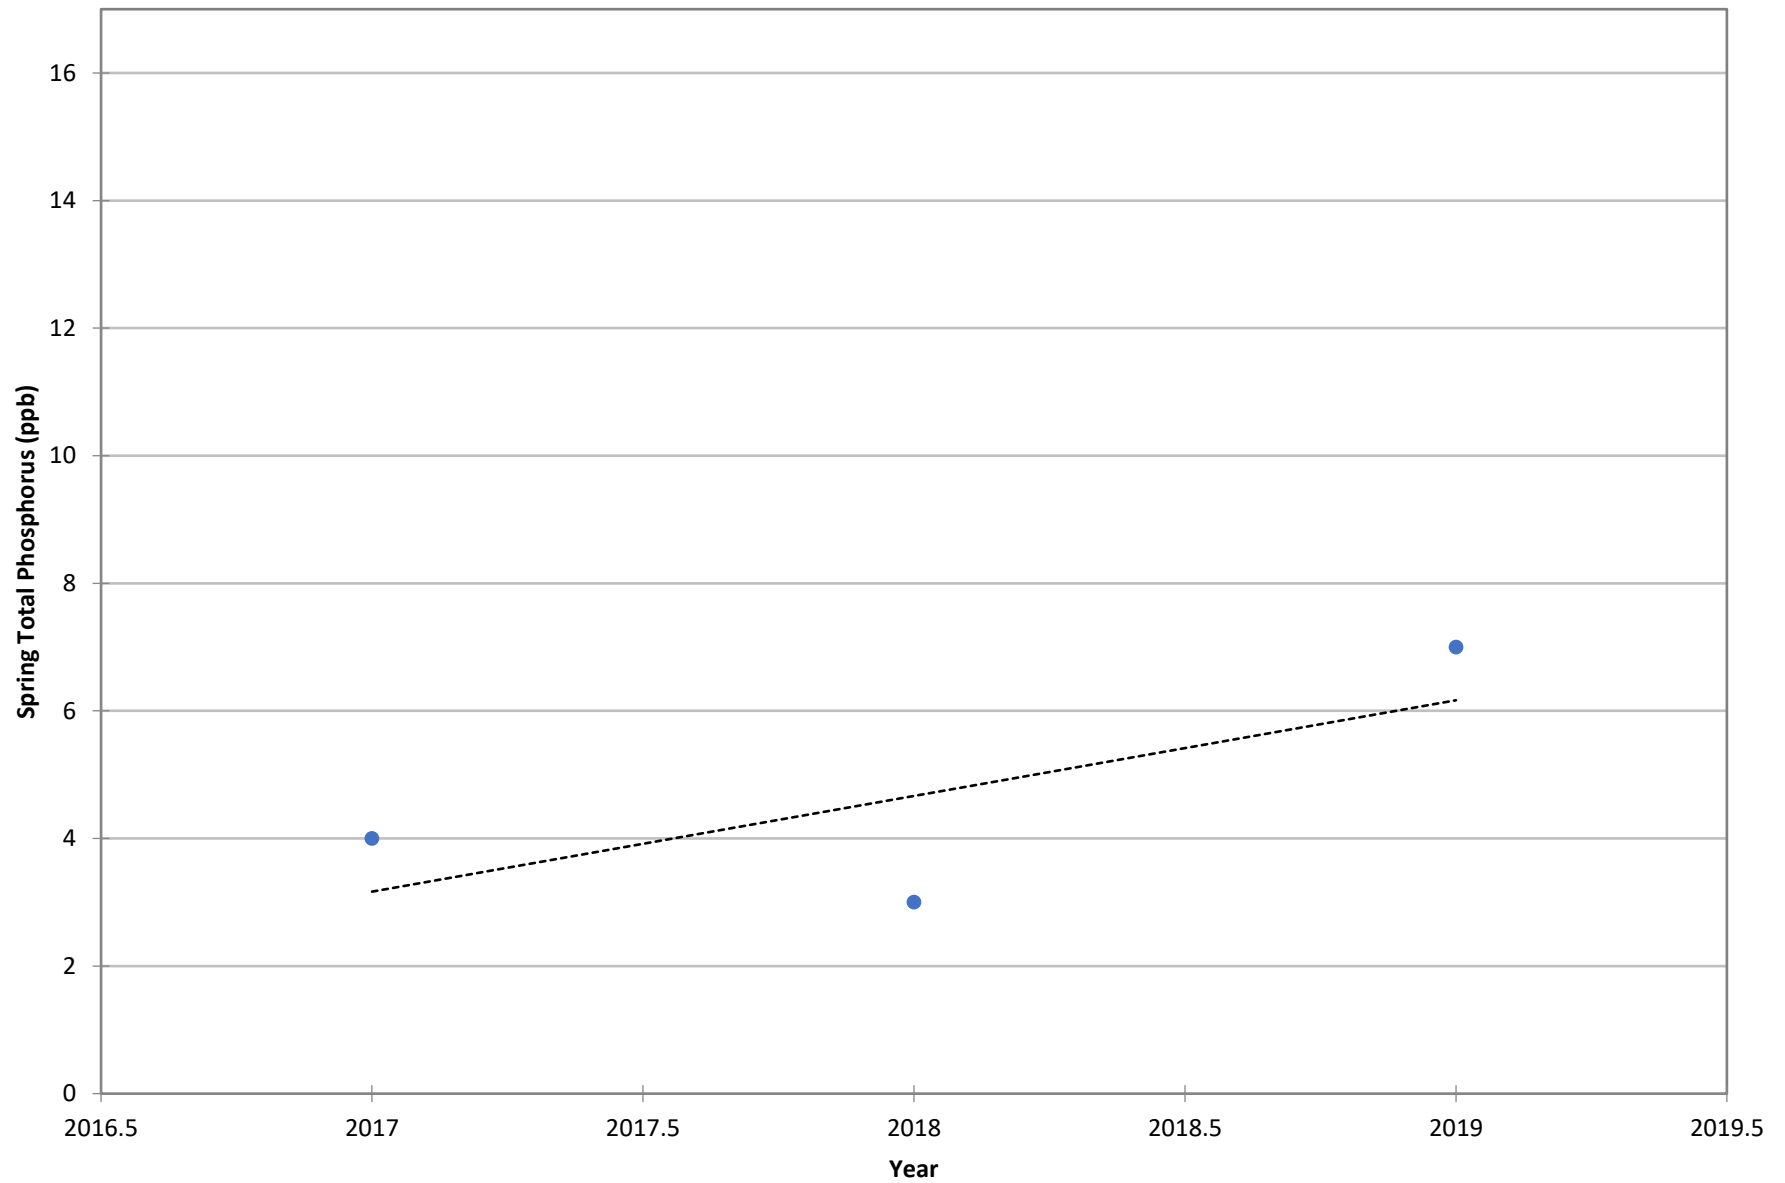
COOPERATIVE LAKES MONITORING PROGRAM  
SPRING TOTAL PHOSPHORUS

**First Fortune Lake (Iron Co.), 360080**

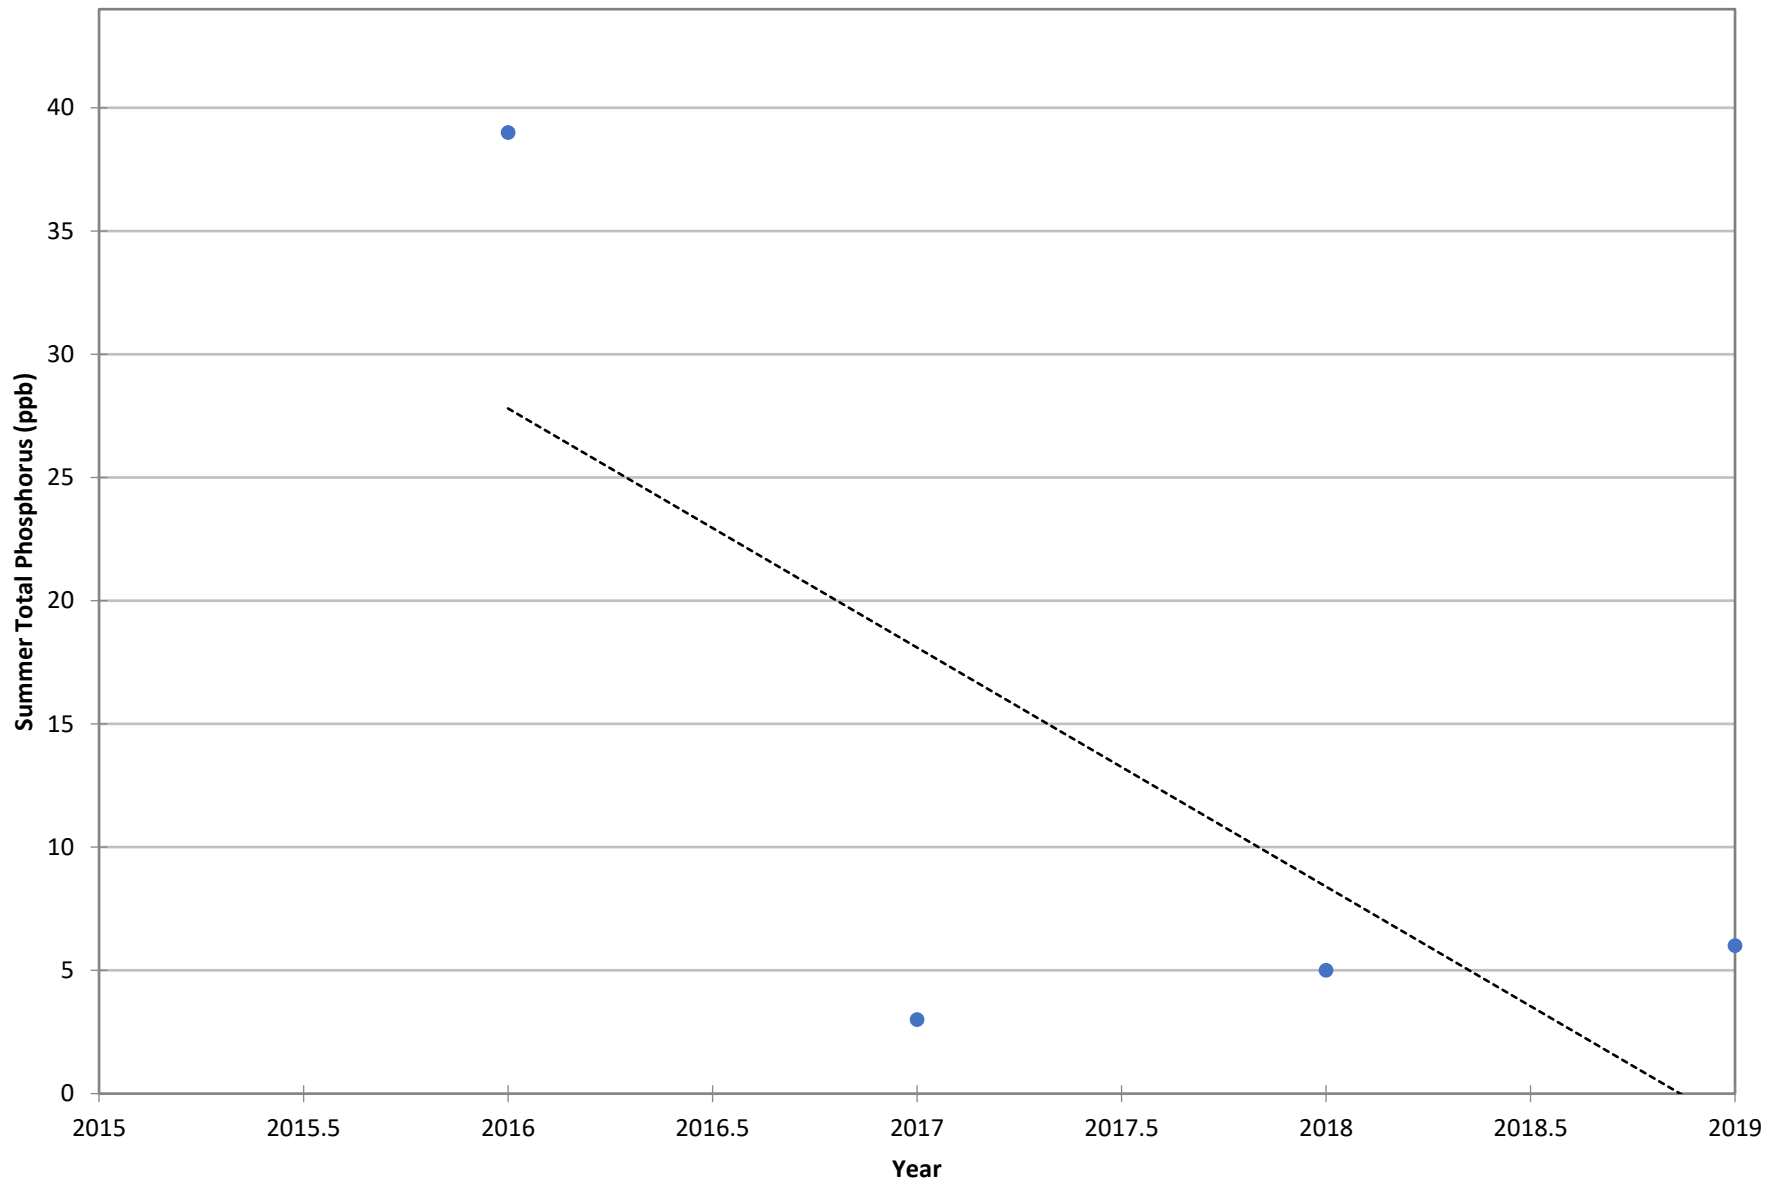
COOPERATIVE LAKES MONITORING PROGRAM  
SUMMER TOTAL PHOSPHORUS

**First Fortune Lake (Iron Co.), 360080**
