2019 Data Report for Second Fortune, Iron County

Site ID: 360177

Second Fortune, Iron County 2019 CLMP Results

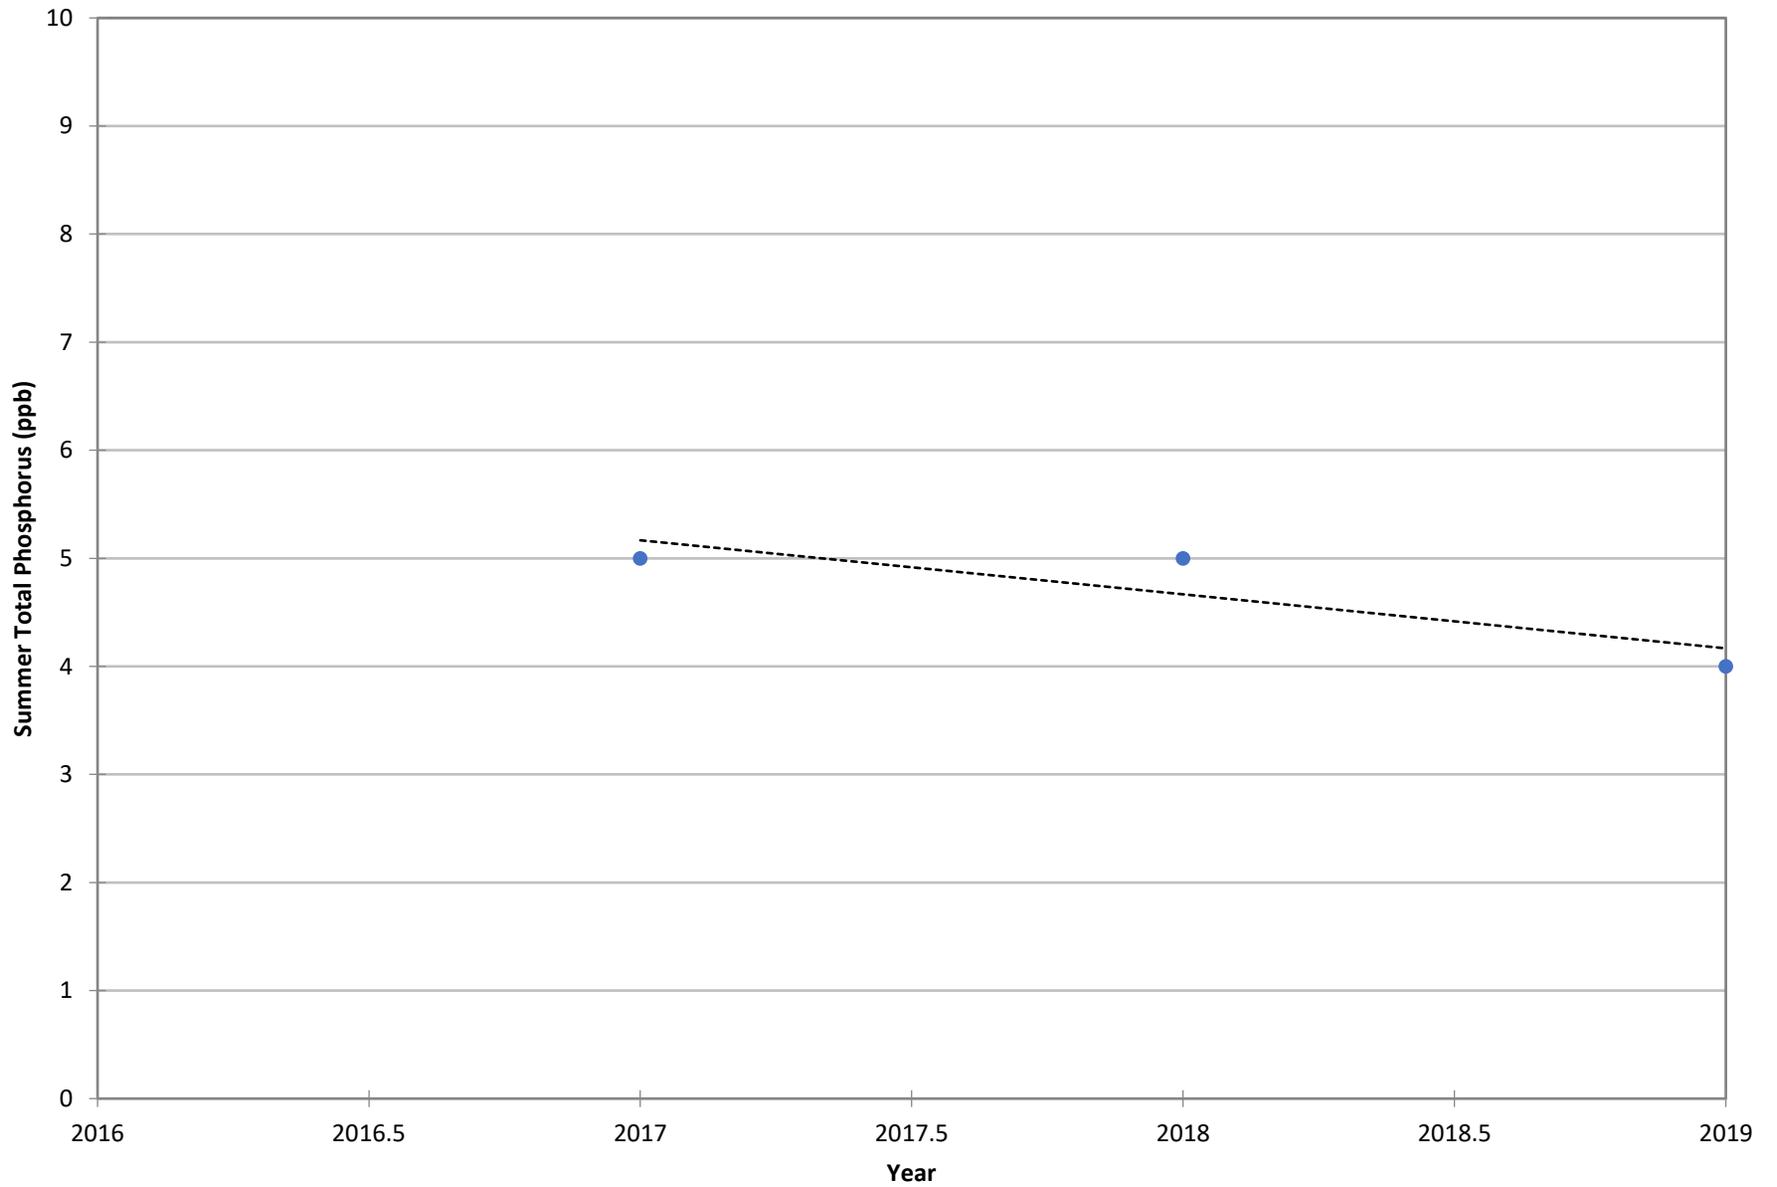
COOPERATIVE LAKES MONITORING PROGRAM
SUMMER TOTAL PHOSPHORUS

Second Fortune (Iron Co.), 360177
