2019 Data Report for

Lake Lancelot, Gladwin County

Site ID: 260104

Lake Lancelot, Gladwin County 2019 CLMP Results

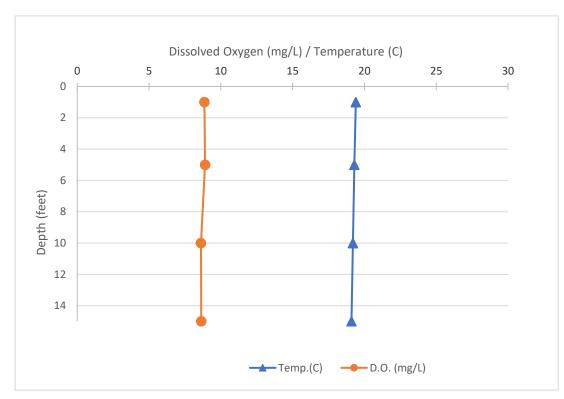
County: Gladwin Site ID: 260104 Date: 9/9/2019

Depth (ft)	Temp.(C)	D.O. (mg/L)
1	19.4	8.86
1	19.4	8.86
1	19.4	8.86
1	19.4	8.86
1	19.4	8.86
5	19.3	8.9
5	19.3	8.9
5	19.3	8.9
5	19.3	8.9
5	19.3	8.9
10	19.2	8.62
10	19.2	8.62
10	19.2	8.62
10	19.2	8.62
10	19.2	8.62
15	19.1	8.64
15	19.1	8.64
15	19.1	8.64
15	19.1	8.64
15	19.1	8.64
