# 2019 Data Report for

# **Perch Lake, Iron County**

Site ID: 360046

# Perch Lake, Iron County 2019 CLMP Results

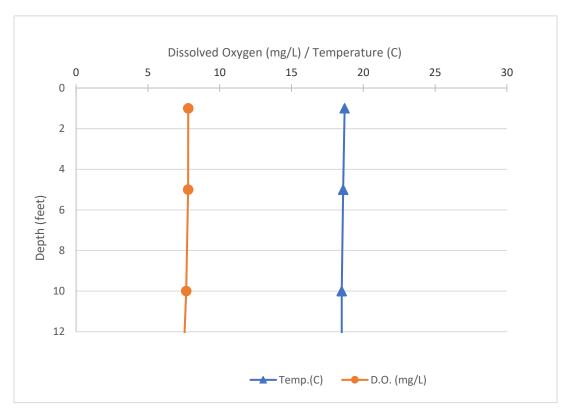
County: Iron
Site ID: 360046
Date: 9/17/2016

Depth (ft)	Temp.(C)	D.O. (mg/L)
1	18.7	7.81
1	18.7	7.81
1	18.7	7.81
1	18.7	7.81
1	18.7	7.81
5	18.6	7.8
5	18.6	7.8
5	18.6	7.8
5	18.6	7.8
5	18.6	7.8
10	18.5	7.67
10	18.5	7.67
10	18.5	7.67
10	18.5	7.67
10	18.5	7.67
12.5	18.5	7.53
12.5	18.5	7.53
12.5	18.5	7.53
12.5	18.5	7.53
12.5	18.5	7.53
