2019 Data Report for Birch Lake, Cass County

Site ID: 140187

Birch Lake, Cass County 2019 CLMP Results

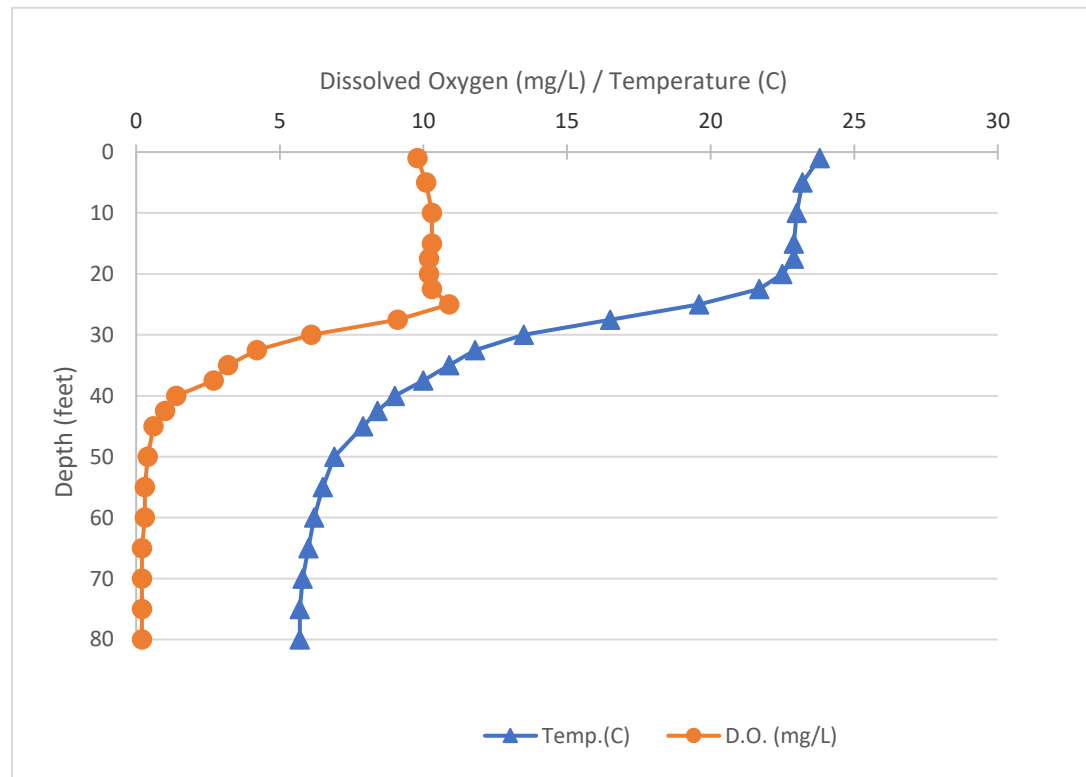
9/20/2019

Dissolved Oxygen and Temperature Profile

Depth (ft)	Temp.(C)	D.O. (mg/L)
1	23.8	9.8
5	23.2	10.1
10	23	10.3
15	22.9	10.3
17.5	22.9	10.2
20	22.5	10.2
22.5	21.7	10.3
25	19.6	10.9
27.5	16.5	9.1
30	13.5	6.1
32.5	11.8	4.2
35	10.9	3.2
37.5	10	2.7
40	9	1.4
42.5	8.4	1
45	7.9	0.6
50	6.9	0.4
55	6.5	0.3
60	6.2	0.3
65	6	0.2
70	5.8	0.2
75	5.7	0.2
80	5.7	0.2
