# 2019 Data Report for Corey Lake, St. Joseph County

Site ID: 750142

# Corey Lake, St. Joseph County 2019 CLMP Results

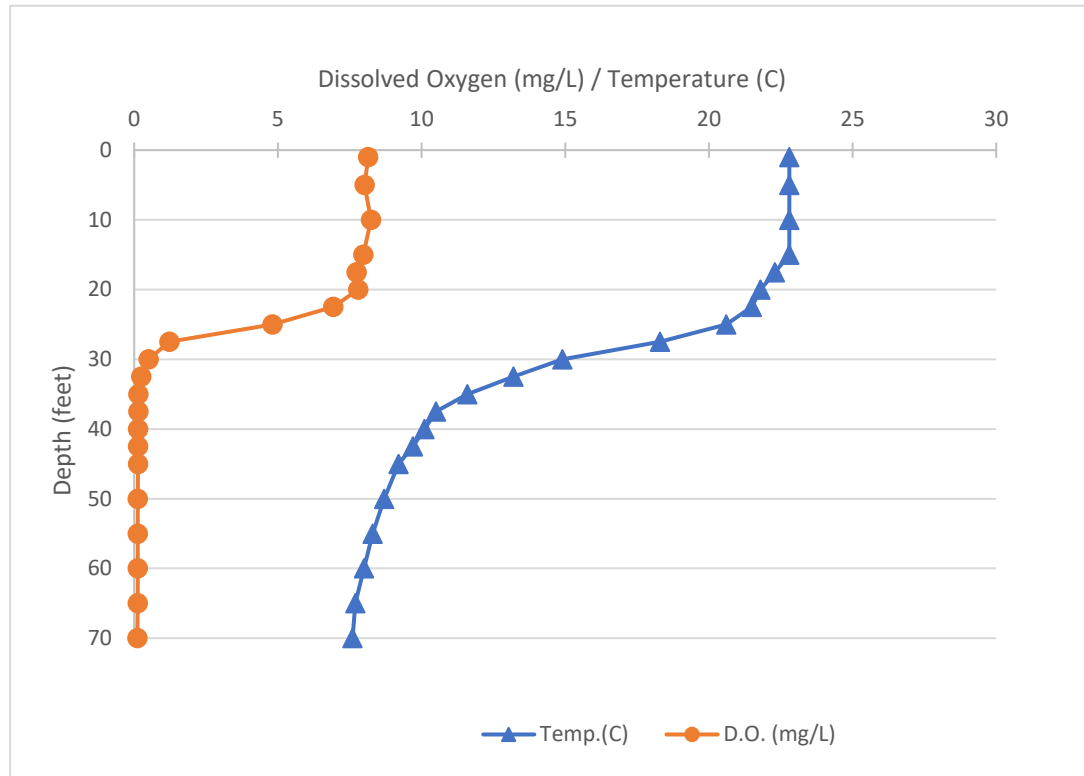
9/17/2019

Depth (ft)	Temp.(C)	D.O. (mg/L)
1	22.8	8.14
5	22.8	8.02
10	22.8	8.24
15	22.8	7.97
17.5	22.3	7.74
20	21.8	7.8
22.5	21.5	6.93
25	20.6	4.81
27.5	18.3	1.23
30	14.9	0.5
32.5	13.2	0.25
35	11.6	0.15
37.5	10.5	0.15
40	10.1	0.14
42.5	9.7	0.14
45	9.2	0.13
50	8.7	0.12
55	8.3	0.12
60	8	0.12
65	7.7	0.12
70	7.6	0.11
