**2019 Data Report
for
Duck Lake, Muskegon County**

Site ID: 610778

Duck Lake, Muskegon County 2019 CLMP Results

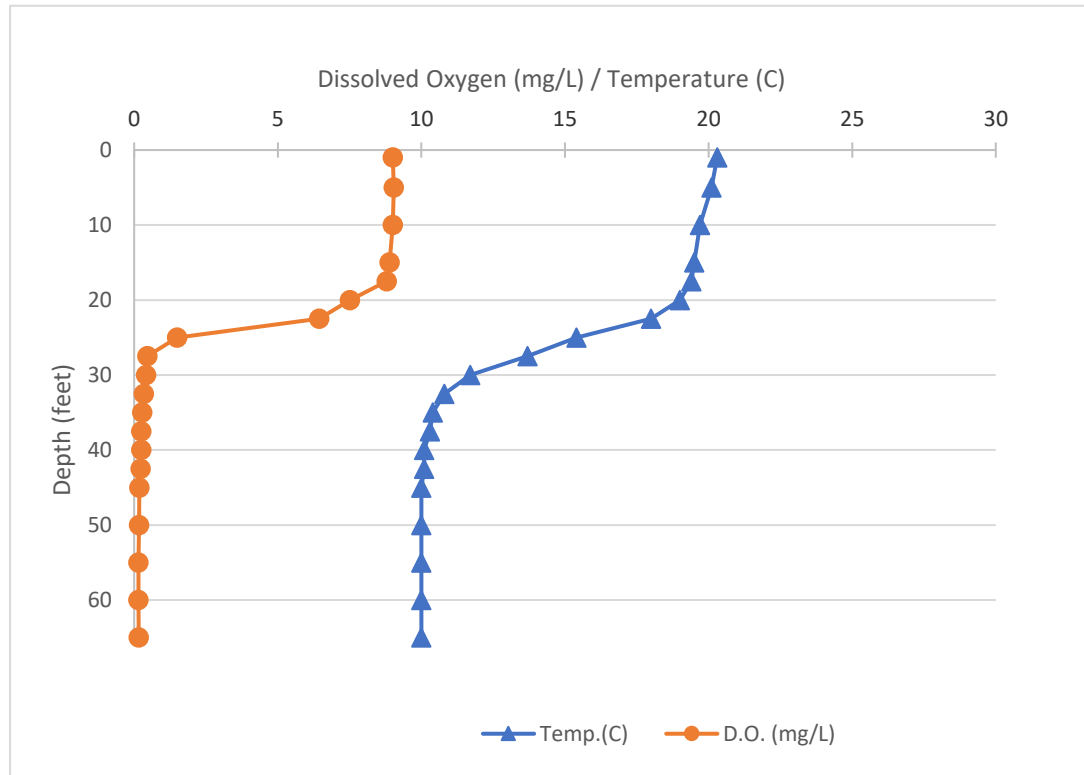
Name: Duck Lake
 County: Muskegon
 Site ID: 610778
 Date: 9/14/2019

Dissolved Oxygen and Temperature Profile

Depth (ft)	Temp.(C)	D.O. (mg/L)
1	20.3	9
5	20.1	9.04
10	19.7	9.01
15	19.5	8.89
17.5	19.4	8.79
20	19	7.51
22.5	18	6.44
25	15.4	1.5
27.5	13.7	0.46
30	11.7	0.41
32.5	10.8	0.34
35	10.4	0.28
37.5	10.3	0.25
40	10.1	0.25
42.5	10.1	0.23
45	10	0.18
50	10	0.17
55	10	0.15
60	10	0.15
65	10	0.16
