2019 Data Report for Juno Lake, Cass County

Site ID: 140058

Juno Lake, Cass County 2019 CLMP Results

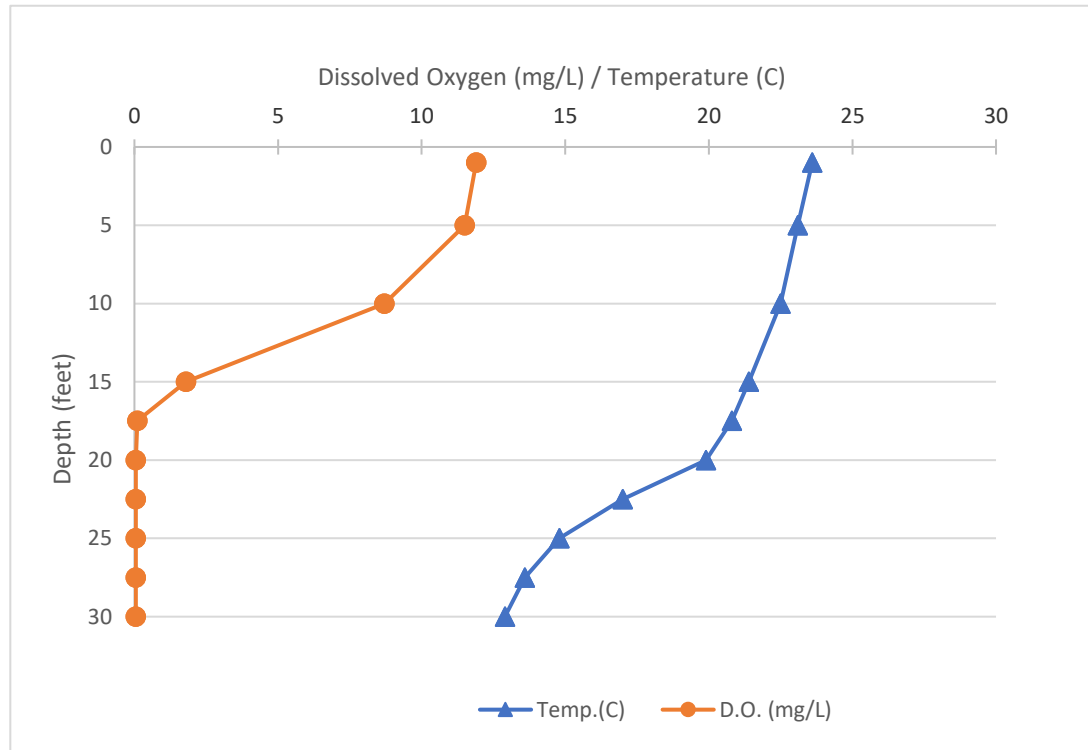
9/21/2019

Dissolved Oxygen and Temperature Profile

Depth (ft)	Temp.(C)	D.O. (mg/L)
1	23.6	11.9
1	23.6	11.9
5	23.1	11.5
5	23.1	11.5
10	22.5	8.7
10	22.5	8.7
15	21.4	1.8
15	21.4	1.8
17.5	20.8	0.1
17.5	20.8	0.1
20	19.9	0.05
20	19.9	0.05
22.5	17	0.05
22.5	17	0.05
25	14.8	0.05
25	14.8	0.05
27.5	13.6	0.05
27.5	13.6	0.05
30	12.9	0.05
30	12.9	0.05
