2019 Data Report for North Lake Leelanau, Leelanau County

Site ID: 450236

North Lake Leelanau, Leelanau County 2019 CLMP Results

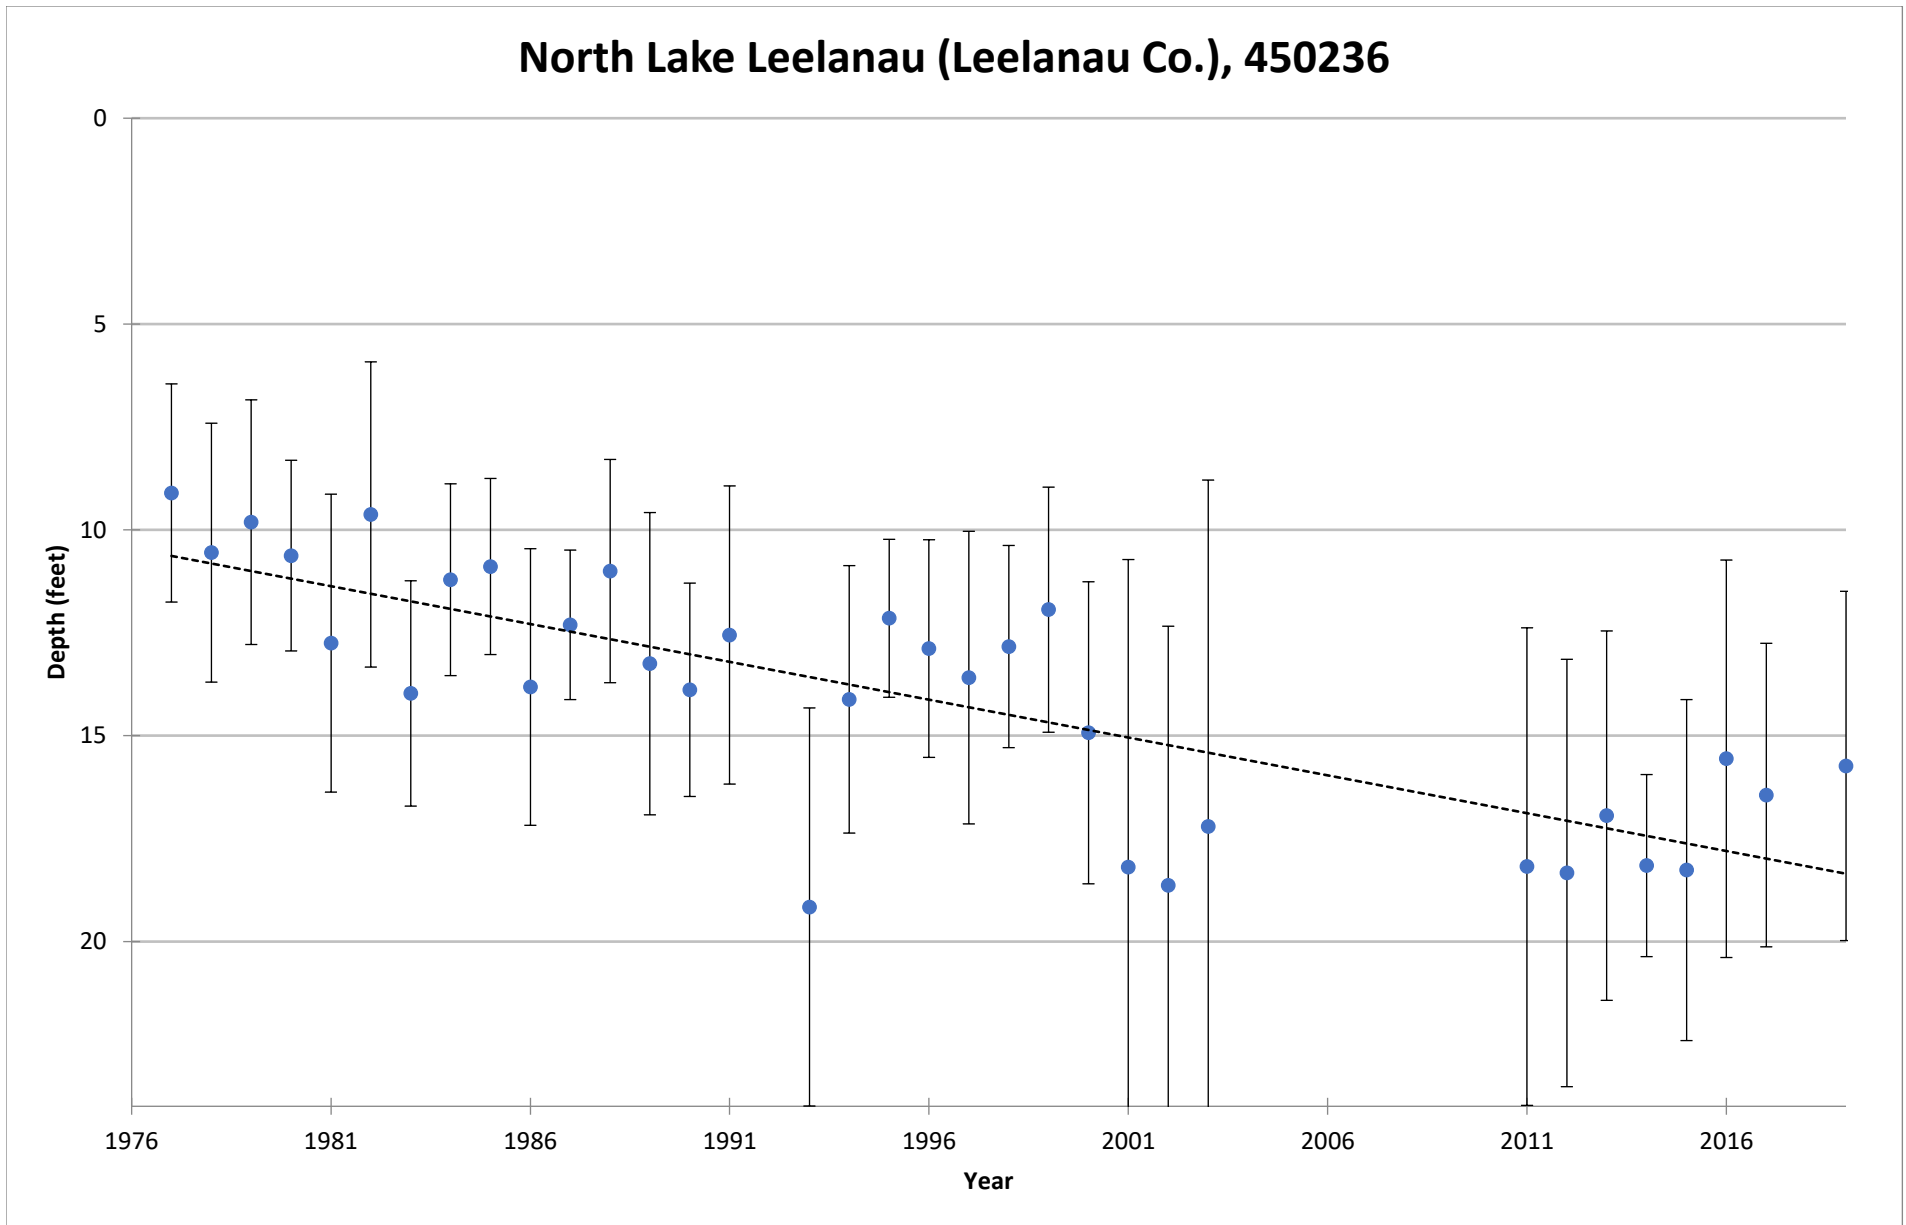
COOPERATIVE LAKES MONITORING PROGRAM
SUMMER MEAN TRANSPARENCY

North Lake Leelanau (Leelanau Co.), 450236

Vertical bars indicate standard deviation

Long term trends indicate that the monitored parameters have changed very little since monitoring began, except for transparency which has significantly improved since the 1970s.

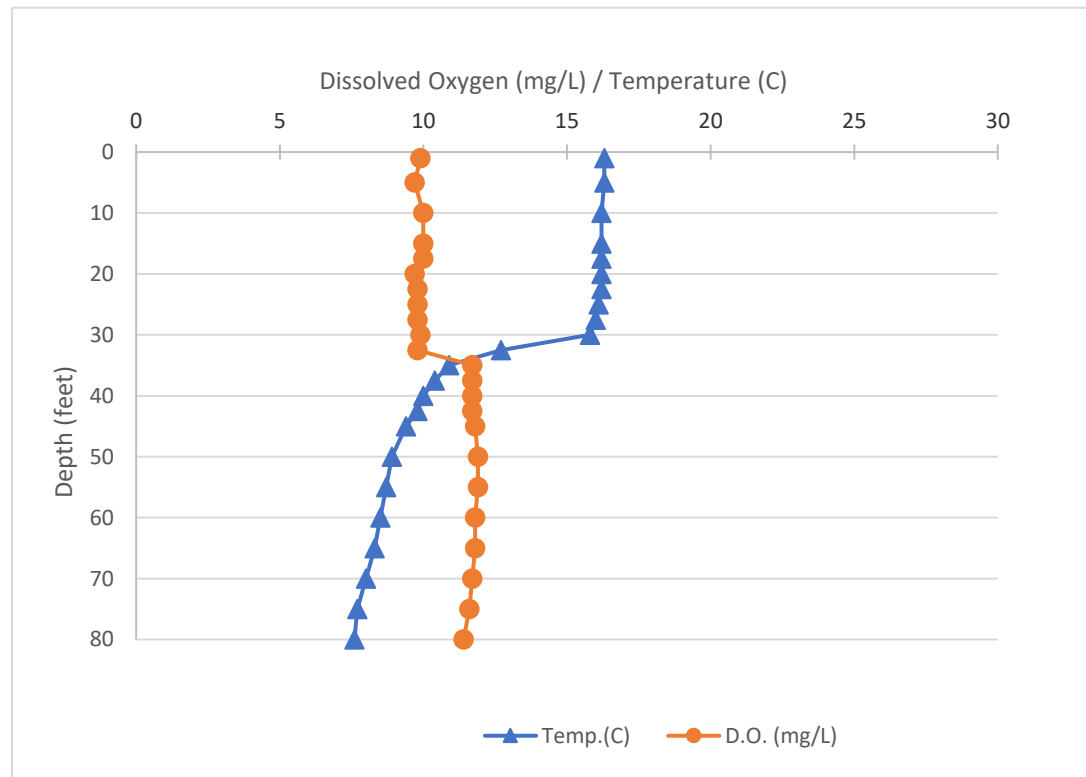
Dissolved Oxygen and Temperature Profile

Name: North Lake Leelanau
 County: Leelanau
 Site ID: 450236
 Date: 9/20/2019

Depth (ft)	Temp.(C)	D.O. (mg/L)
1	16.3	9.9
5	16.3	9.7
10	16.2	10
15	16.2	10
17.5	16.2	10
20	16.2	9.7
22.5	16.2	9.8
25	16.1	9.8
27.5	16	9.8
30	15.8	9.9
32.5	12.7	9.8
35	10.9	11.7
37.5	10.4	11.7
40	10	11.7
42.5	9.8	11.7
45	9.4	11.8
50	8.9	11.9
55	8.7	11.9
60	8.5	11.8
65	8.3	11.8
70	8	11.7
75	7.7	11.6
80	7.6	11.4
