2019 Data Report for Maceday Lake, Oakland County

Site ID: 630415

Maceday Lake, Oakland County 2019 CLMP Results

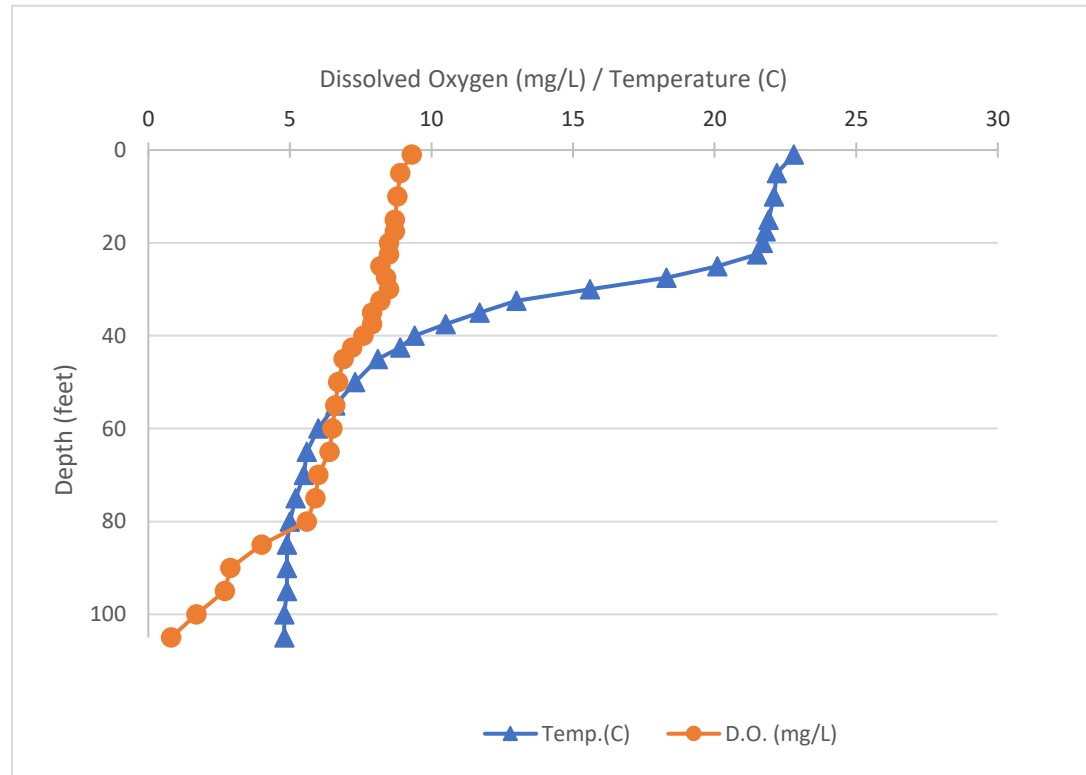
9/20/2019

Dissolved Oxygen and Temperature Profile

Depth (ft)	Temp.(C)	D.O. (mg/L)
1	22.8	9.3
5	22.2	8.9
10	22.1	8.8
15	21.9	8.7
17.5	21.8	8.7
20	21.7	8.5
22.5	21.5	8.5
25	20.1	8.2
27.5	18.3	8.4
30	15.6	8.5
32.5	13	8.2
35	11.7	7.9
37.5	10.5	7.9
40	9.4	7.6
42.5	8.9	7.2
45	8.1	6.9
50	7.3	6.7
55	6.6	6.6
60	6	6.5
65	5.6	6.4
70	5.5	6
75	5.2	5.9
80	5	5.6
85	4.9	4
90	4.9	2.9
95	4.9	2.7
100	4.8	1.7
105	4.8	0.8

The low level of nutrients in the lake results in dissolved oxygen being available throughout the water column for the most of the summer, and only by the end of the summer does the bottom of the lake become anoxic.
