**2019 Data Report
for
Scram Lake, Kent County**

Site ID: 410728

Scram Lake, Kent County 2019 CLMP Results

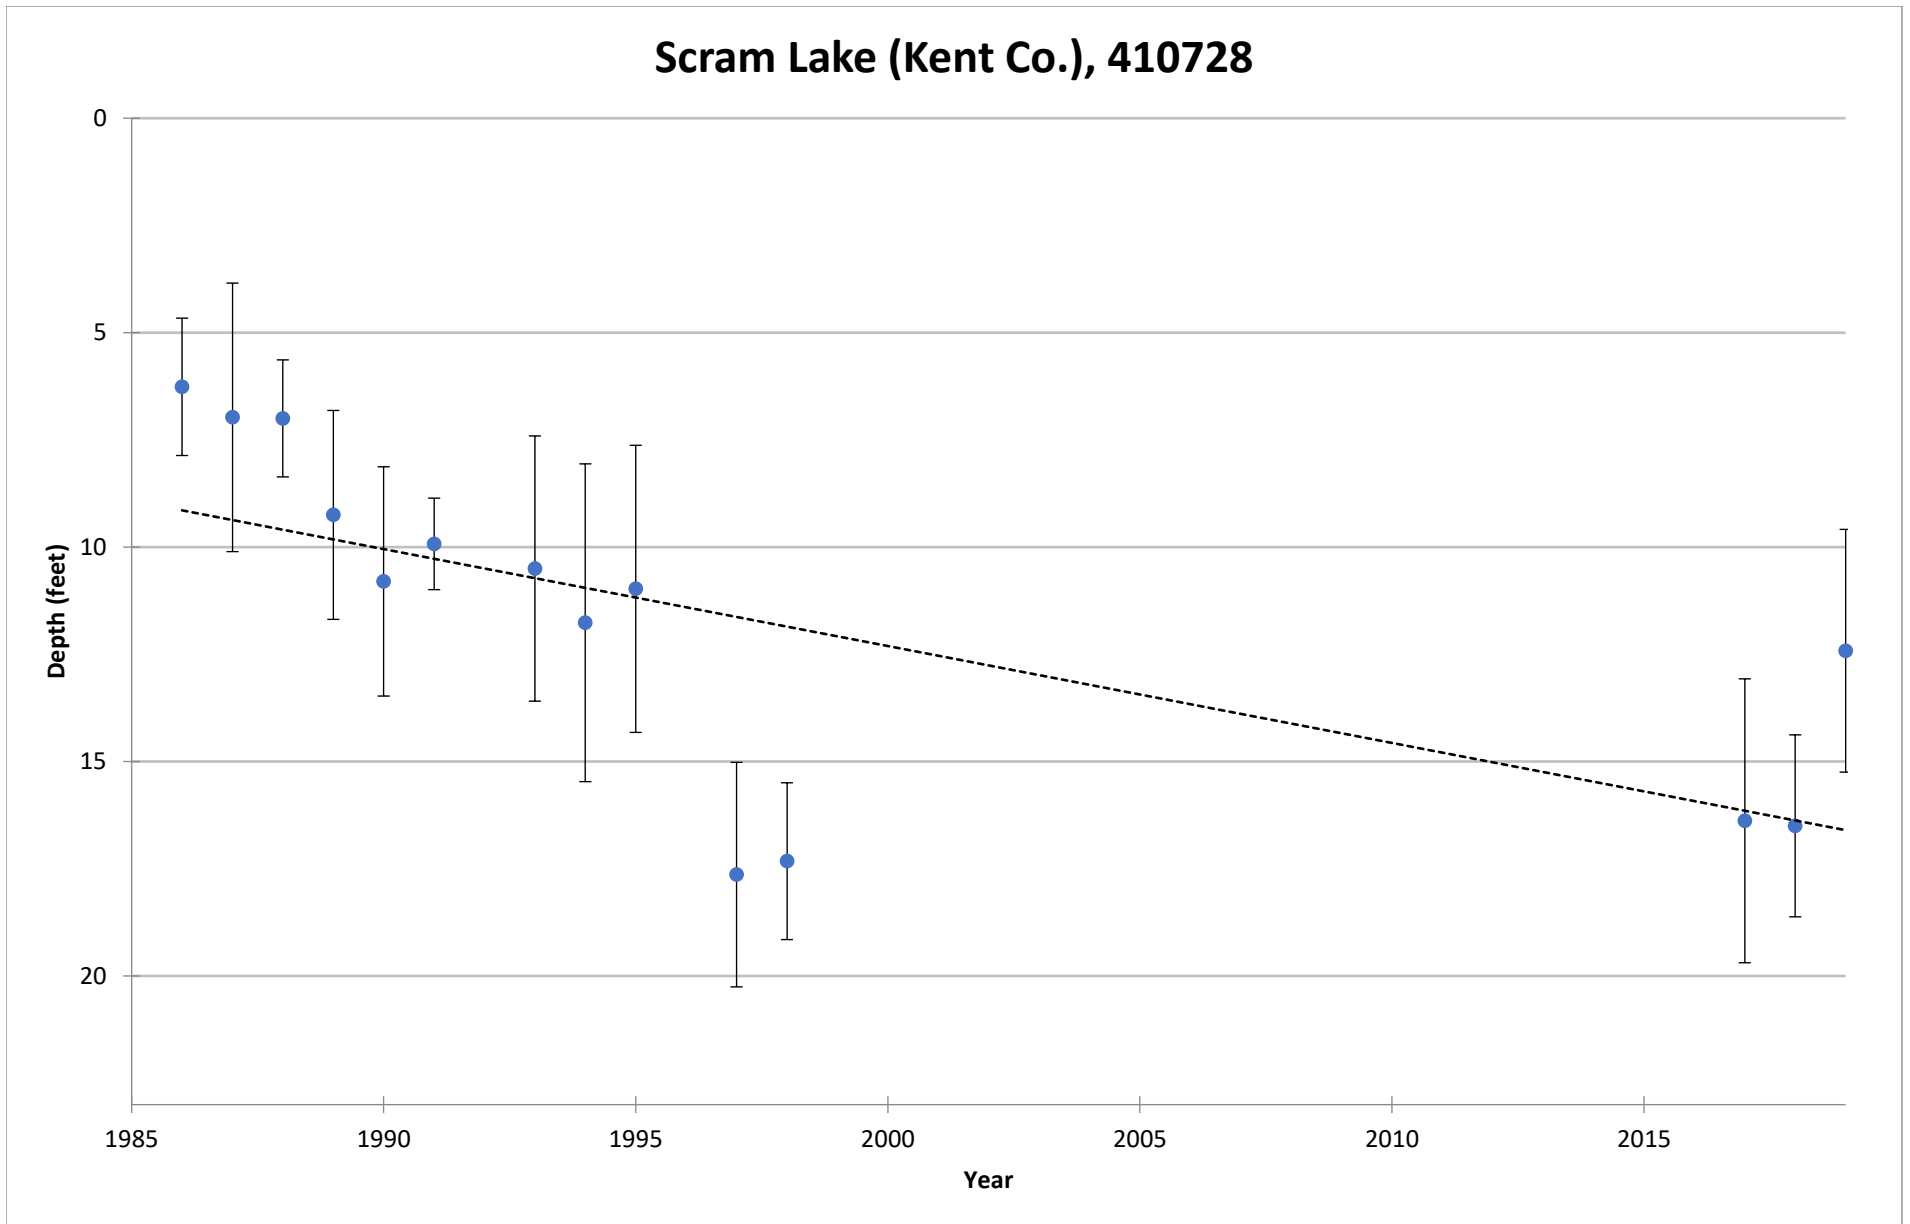
Scram Lake (Kent Co.), 410728

COOPERATIVE LAKES MONITORING PROGRAM
SUMMER MEAN TRANSPARENCY

Vertical bars indicate standard deviation

Long term trends indicate that transparency has significantly improved since monitoring began in 1980's. The phosphorus and chlorophyll, which have only been sampled within the last several years, do not show a signs of change beyond expected year to year fluctuation.

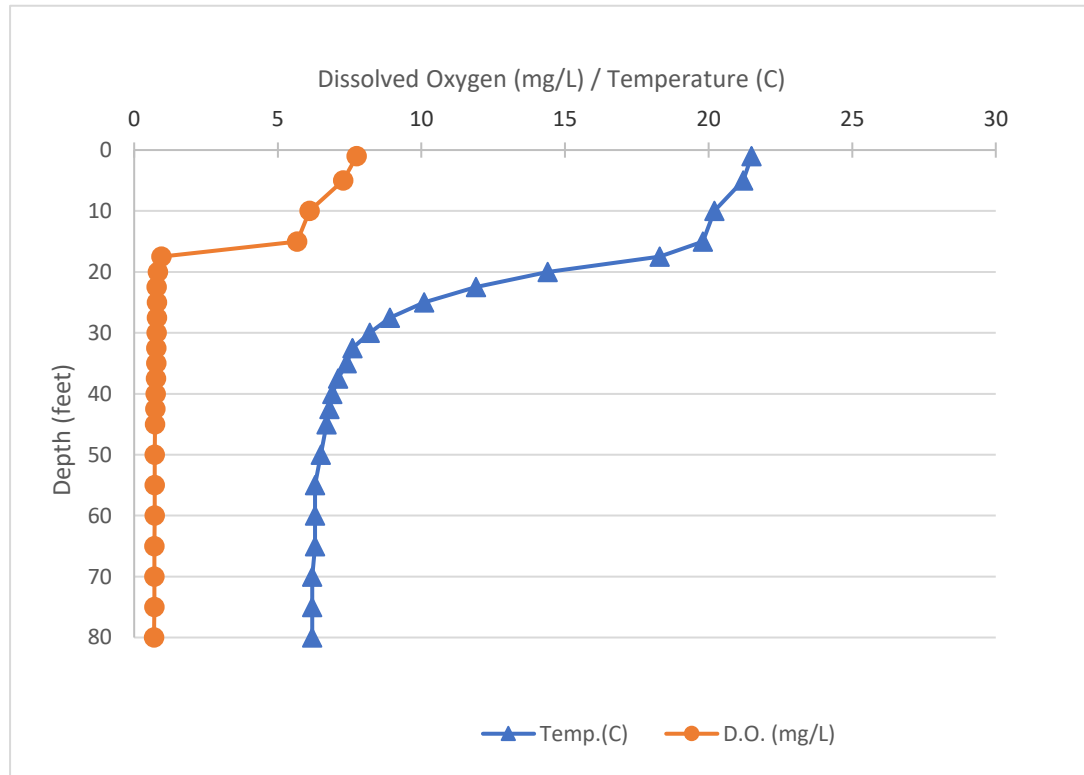
9/11/2019

Dissolved Oxygen and Temperature Profile

Depth (ft)	Temp.(C)	D.O. (mg/L)
1	21.5	7.75
5	21.2	7.28
10	20.2	6.11
15	19.8	5.67
17.5	18.3	0.95
20	14.4	0.83
22.5	11.9	0.78
25	10.1	0.79
27.5	8.9	0.79
30	8.2	0.78
32.5	7.6	0.77
35	7.4	0.77
37.5	7.1	0.76
40	6.9	0.75
42.5	6.8	0.74
45	6.7	0.73
50	6.5	0.72
55	6.3	0.71
60	6.3	0.71
65	6.3	0.7
70	6.2	0.7
75	6.2	0.7
80	6.2	0.69
