2019 Data Report for Woods Lake, Kalamazoo County

Site ID: 390542

Woods Lake, Kalamazoo County 2019 CLMP Results

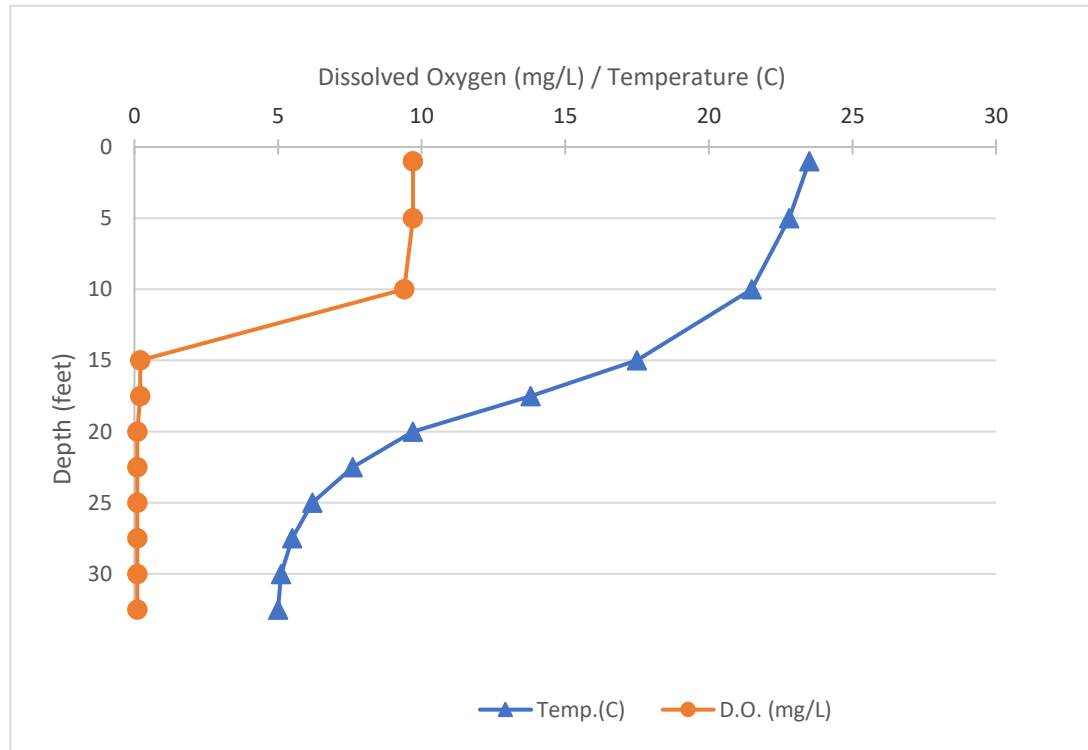
9/19/2019

Dissolved Oxygen and Temperature Profile

Depth (ft)	Temp.(C)	D.O. (mg/L)
1	23.5	9.7
5	22.8	9.7
10	21.5	9.4
15	17.5	0.2
17.5	13.8	0.2
20	9.7	0.1
22.5	7.6	0.1
25	6.2	0.1
27.5	5.5	0.1
30	5.1	0.1
32.5	5	0.1
