# **2021 Data Report for Beaver Lake, Alpena County**

Site ID: 040097

# Beaver Lake, Alpena County 2021 CLMP Results

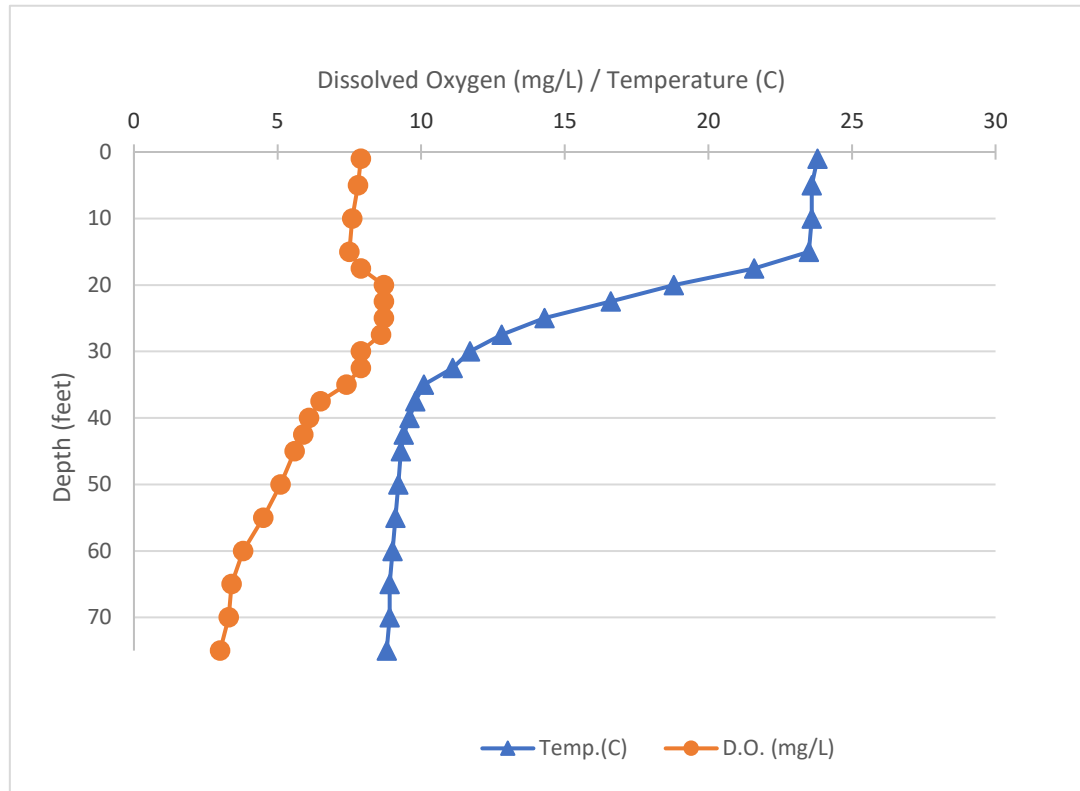
Name: Beaver Lake  
 County: Alpena  
 Site ID: 40097  
 Date: 6/23/2012

### Dissolved Oxygen and Temperature Profile

Depth (ft)	Temp.(C)	D.O. (mg/L)
1	23.8	7.9
5	23.6	7.8
10	23.6	7.6
15	23.5	7.5
17.5	21.6	7.9
20	18.8	8.7
22.5	16.6	8.7
25	14.3	8.7
27.5	12.8	8.6
30	11.7	7.9
32.5	11.1	7.9
35	10.1	7.4
37.5	9.8	6.5
40	9.6	6.1
42.5	9.4	5.9
45	9.3	5.6
50	9.2	5.1
55	9.1	4.5
60	9	3.8
65	8.9	3.4
70	8.9	3.3
75	8.8	3
