2021 Data Report for Corey Lake, St. Joseph County

Site ID: 750142

Corey Lake, St. Joseph County 2021 CLMP Results

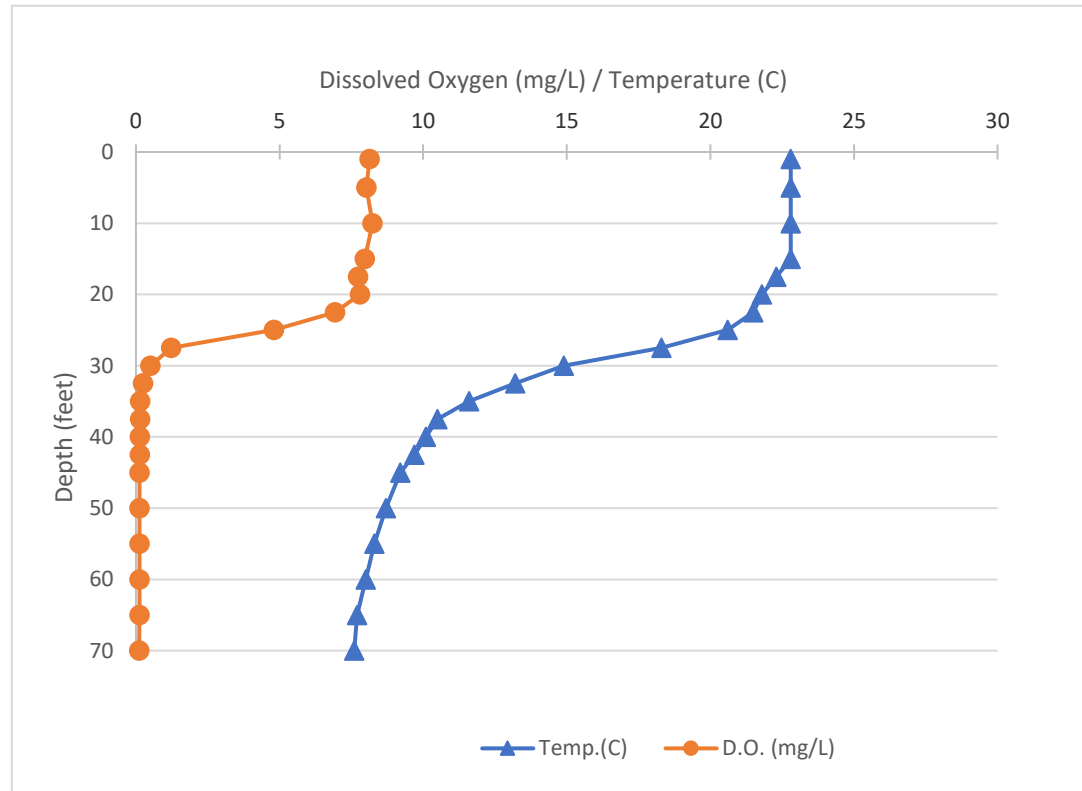
9/17/2019

Dissolved Oxygen and Temperature Profile

Depth (ft)	Temp.(C)	D.O. (mg/L)
1	22.8	8.14
5	22.8	8.02
10	22.8	8.24
15	22.8	7.97
17.5	22.3	7.74
20	21.8	7.8
22.5	21.5	6.93
25	20.6	4.81
27.5	18.3	1.23
30	14.9	0.5
32.5	13.2	0.25
35	11.6	0.15
37.5	10.5	0.15
40	10.1	0.14
42.5	9.7	0.14
45	9.2	0.13
50	8.7	0.12
55	8.3	0.12
60	8	0.12
65	7.7	0.12
70	7.6	0.11

The lake keeps some dissolved oxygen in the bottom waters through mid-summer, but by late summer the lake has stratified and the bottom water is devoid of oxygen.
