2021 Data Report for Lake Diane, Hillsdale County

Site ID: 300173

Lake Diane, Hillsdale County 2021 CLMP Results

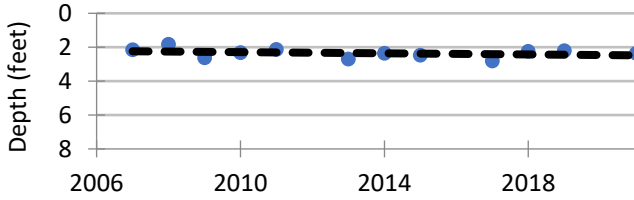
Secchi Disk Transparency (feet)

Year	# Readings	Min	Max	Avg	Std. Dev	Carlson TSI
2021	11	2.0	3.0	2.4	0.4	65
2016-2019	31	1.5	3.5	2.4	0.5	64
2007-2015	135	1.5	3.5	2.3	0.3	65
2021 All CLMP Lakes	2817	1.0	50.0	12.7	2.9	42

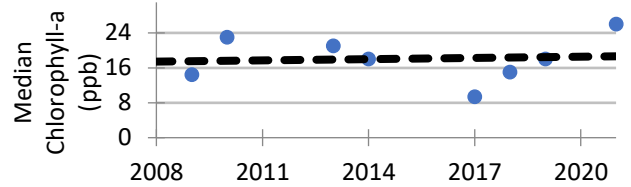
Chlorophyll-a (parts per billion)

Year	# Samples	Min	Max	Med	Std. Dev	Carlson TSI
2021	5	8.7	34.0	26.0	10.1	63
2016-2019	14	5.9	33.0	15.0	8.5	57
2008-2015	25	2.0	50.0	15.0	10.4	60
2021 All CLMP Lakes	635	< 1.0	42.0	2.2	3.4	39

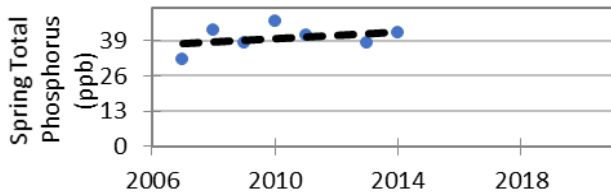
Spring Phosphorus (parts per billion)

Year	# Samples	Min	Max	Avg	Std. Dev
2014	1	42.0	42.0	42.0	NA
2009-2013	4	38.0	46.0	40.8	3.8
2007-2008	2	32.0	43.0	37.5	7.8
2021 All CLMP Lakes	220	<= 3	100.0	14.9	11.0

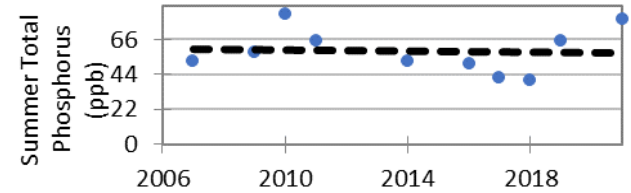
Summer Phosphorus (parts per billion)

Year	# Samples	Min	Max	Avg	Std. Dev	Carlson TSI
2021	1	79.0	79.0	79.0	NA	67
2016-2019	4	40.0	65.0	49.5	11.4	60
2007-2015	5	52.0	82.0	61.8	12.5	63
2021 All CLMP Lakes	281	<= 3	65.0	12.8	9.3	38

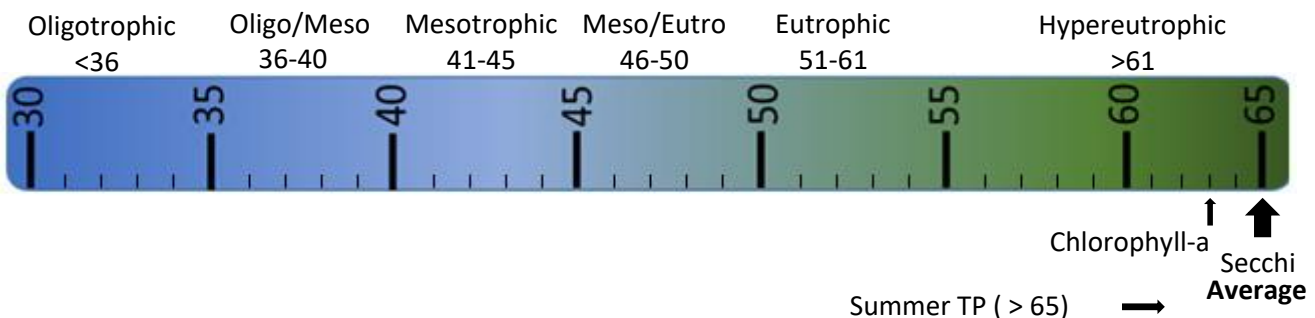
With an average TSI score of 65 based on 2021 Secchi transparency, chlorophyll-a, and summer total phosphorus data, this lake is rated as a hypereutrophic lake.

TSI for Lake Diane in 2021	
Average	65
Secchi Disk	65
Summer TP	67
Chlorophyll-a	63

Oligotrophic: Generally deep and clear lakes with little aquatic plant or algae growth. These lakes maintain sufficient dissolved oxygen in the cool, deep-bottom waters during late summer to support cold water fish, such as trout and whitefish.

Mesotrophic: Lakes that fall between oligotrophic and eutrophic. Mid-ranged amounts of nutrients.

Eutrophic: Highly productive eutrophic lakes are generally shallow, turbid, and support abundant aquatic plant growth. In deep eutrophic lakes, the cool bottom waters usually contain little or no dissolved oxygen. Therefore, these lakes can only support warm water fish, such as bass and pike.

Hypereutrophic: A specialized category of eutrophic lakes. These lakes exhibit extremely high productivity, such as nuisance algae and weed growth.

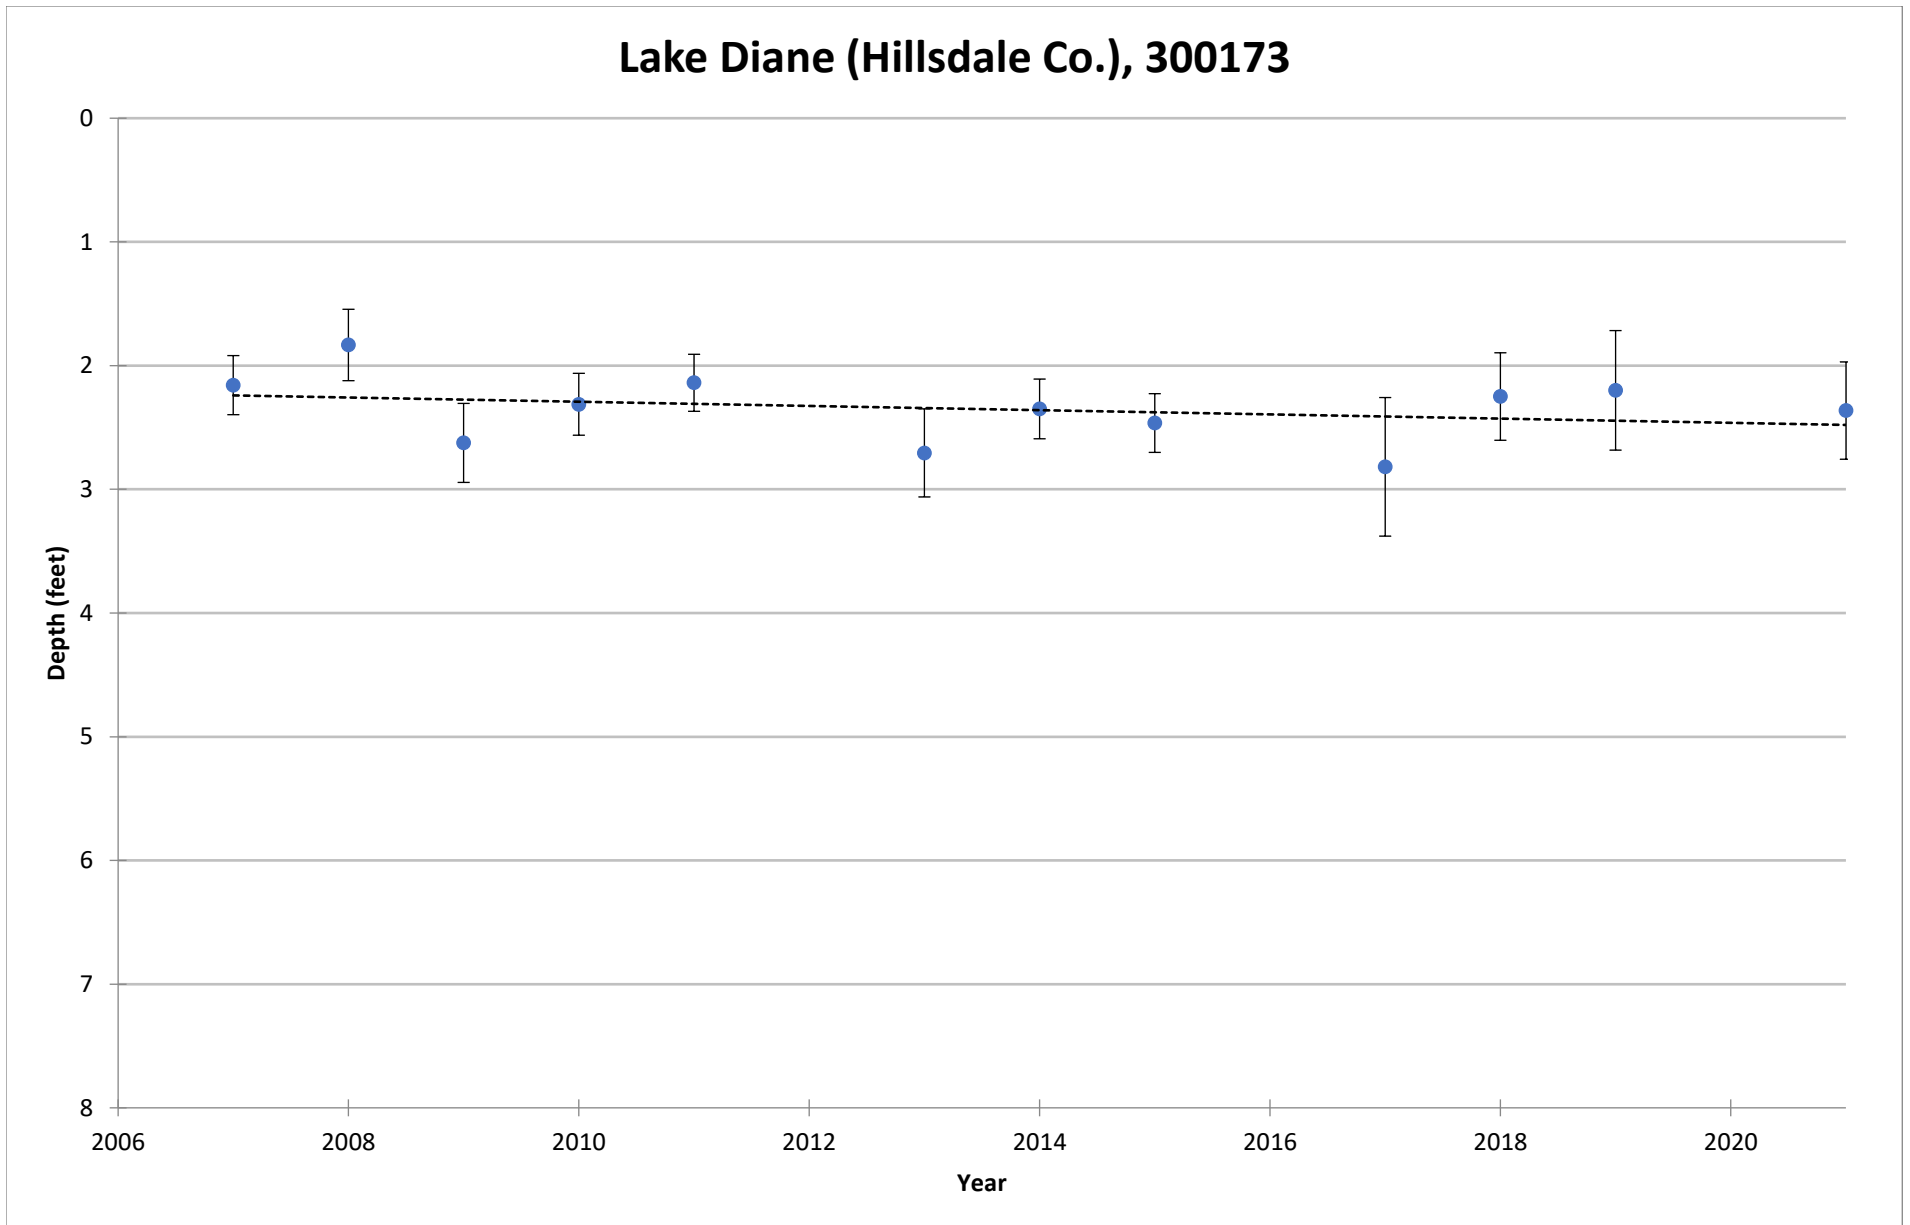
COOPERATIVE LAKES MONITORING PROGRAM
SUMMER MEAN TRANSPARENCY

Vertical bars indicate standard deviation

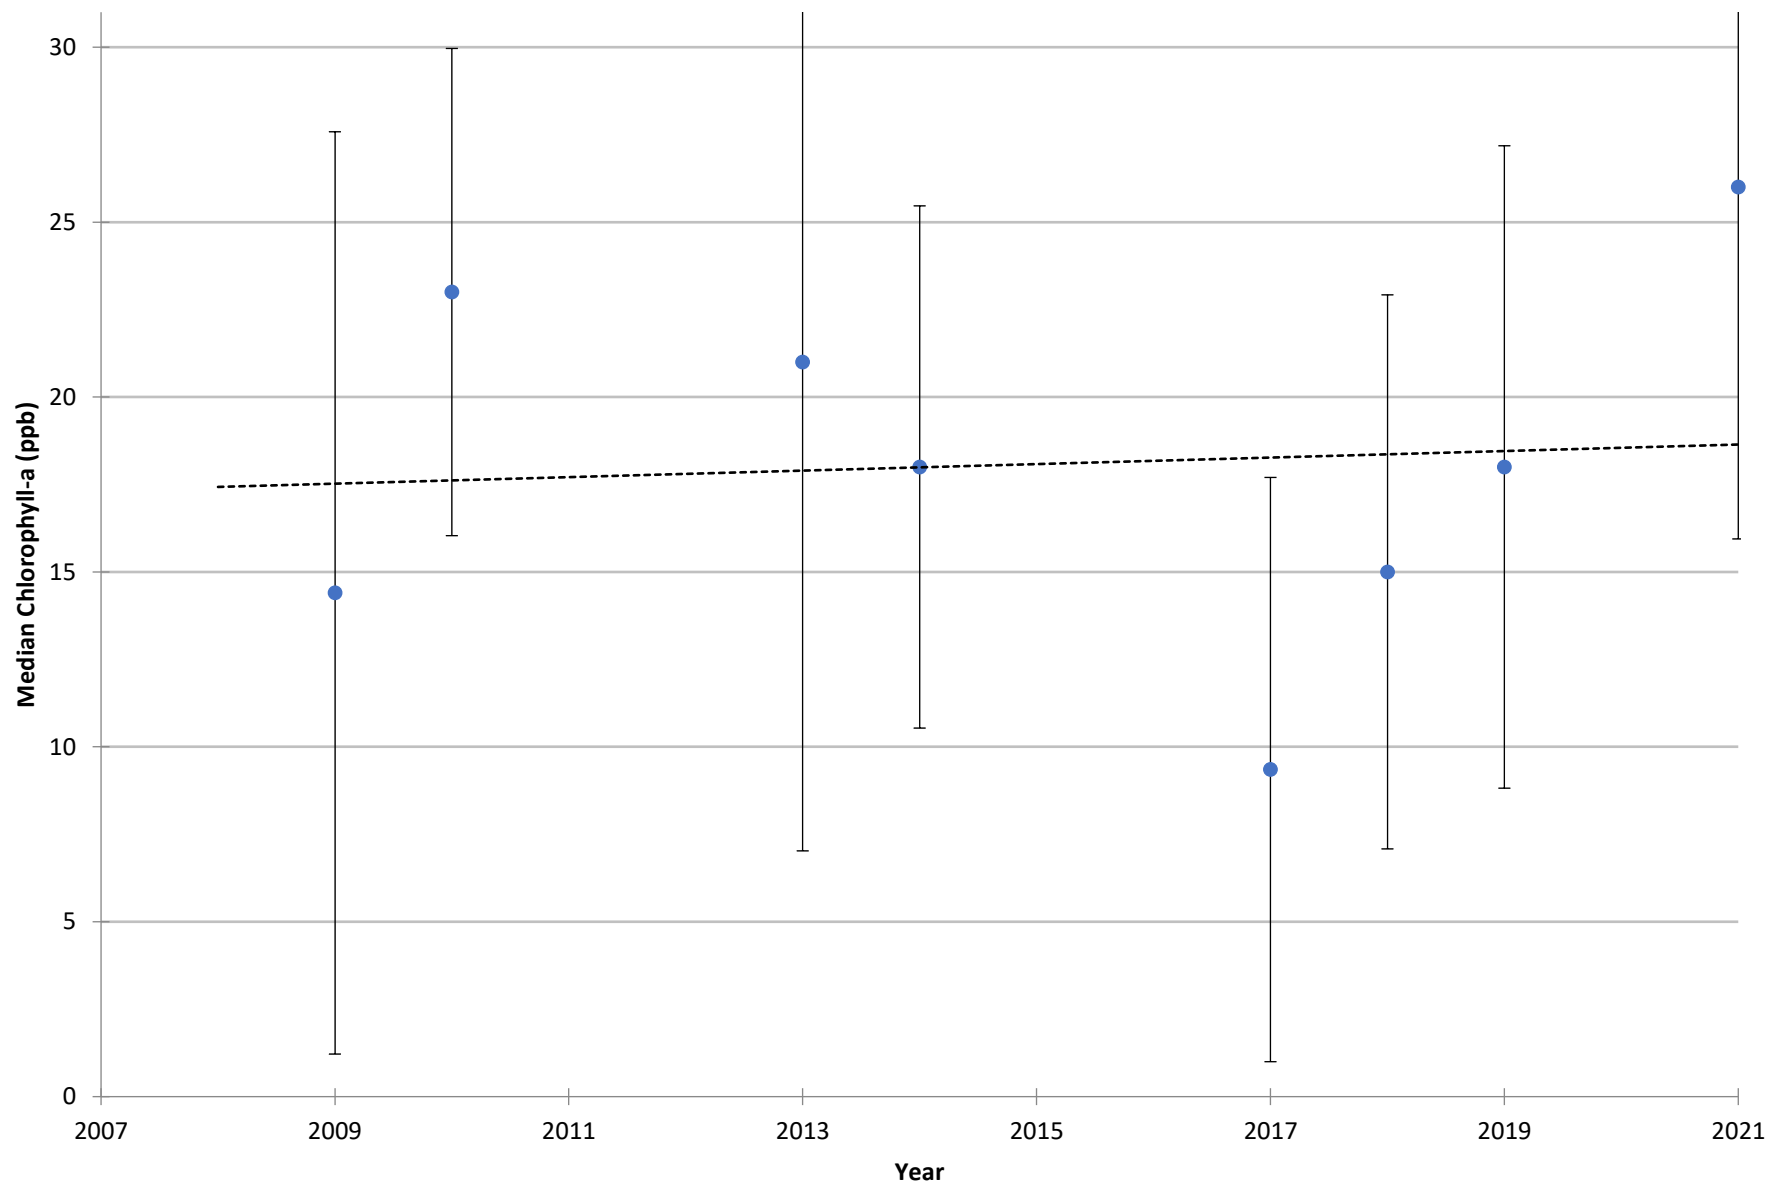
COOPERATIVE LAKES MONITORING PROGRAM
SUMMER MEDIAN CHLOROPHYLL-A

Vertical bars indicate standard deviation

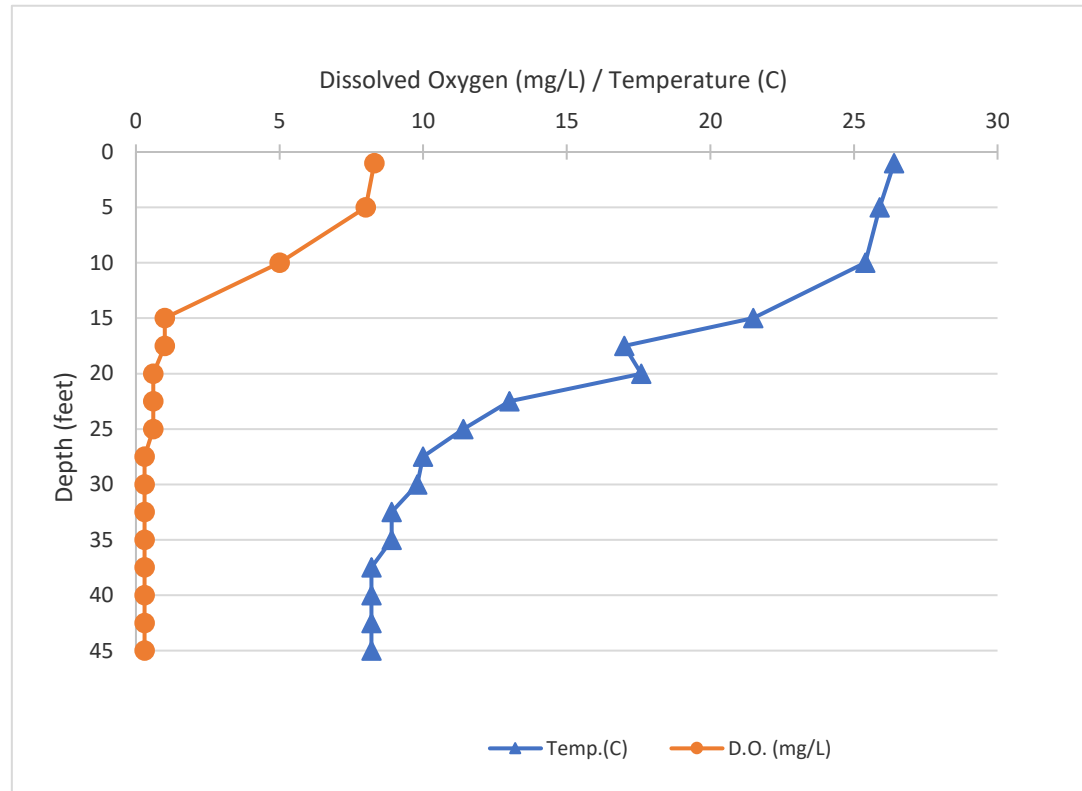
6/3/2017

Dissolved Oxygen and Temperature Profile

Depth (ft)	Temp.(C)	D.O. (mg/L)
1	26.4	8.3
5	25.9	8
10	25.4	5
15	21.5	1
17.5	17	1
20	17.6	0.6
22.5	13	0.6
25	11.4	0.6
27.5	10	0.3
30	9.8	0.3
32.5	8.9	0.3
35	8.9	0.3
37.5	8.2	0.3
40	8.2	0.3
42.5	8.2	0.3
45	8.2	0.3

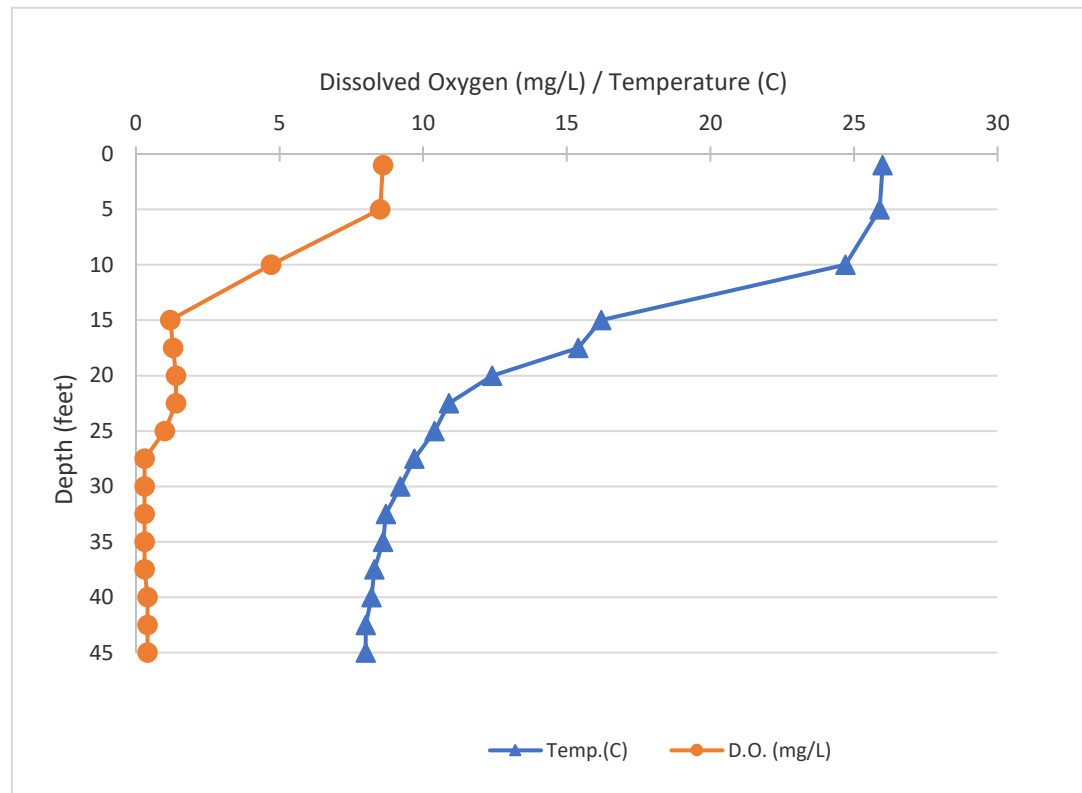
6/17/2017

Dissolved Oxygen and Temperature Profile

Depth (ft)	Temp.(C)	D.O. (mg/L)
1	26	8.6
5	25.9	8.5
10	24.7	4.7
15	16.2	1.2
17.5	15.4	1.3
20	12.4	1.4
22.5	10.9	1.4
25	10.4	1
27.5	9.7	0.3
30	9.2	0.3
32.5	8.7	0.3
35	8.6	0.3
37.5	8.3	0.3
40	8.2	0.4
42.5	8	0.4
45	8	0.4

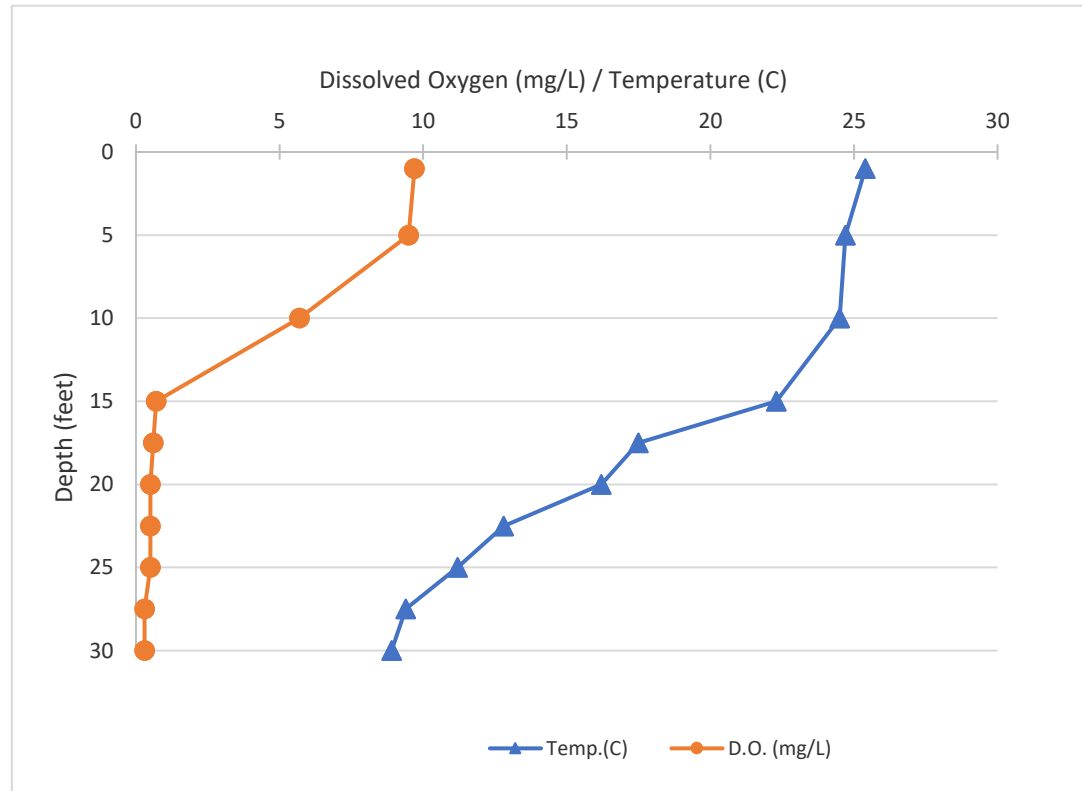
7/4/2017

Dissolved Oxygen and Temperature Profile

Depth (ft)	Temp.(C)	D.O. (mg/L)
1	25.4	9.7
1	25.4	9.7
5	24.7	9.5
5	24.7	9.5
10	24.5	5.7
10	24.5	5.7
15	22.3	0.7
15	22.3	0.7
17.5	17.5	0.6
17.5	17.5	0.6
20	16.2	0.5
20	16.2	0.5
22.5	12.8	0.5
22.5	12.8	0.5
25	11.2	0.5
25	11.2	0.5
27.5	9.4	0.3
27.5	9.4	0.3
30	8.9	0.3
30	8.9	0.3

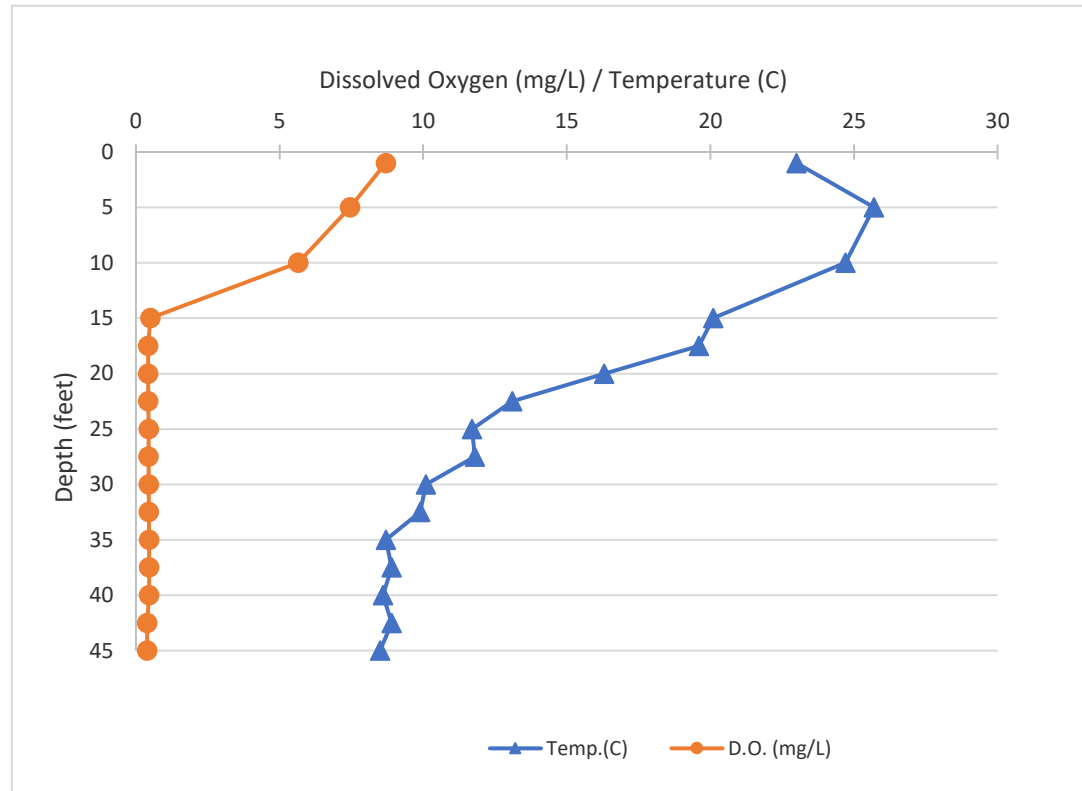
7/16/2017

Dissolved Oxygen and Temperature Profile

Depth (ft)	Temp.(C)	D.O. (mg/L)
1	23	8.7
5	25.7	7.46
10	24.7	5.65
15	20.1	0.5
17.5	19.6	0.43
20	16.3	0.43
22.5	13.1	0.43
25	11.7	0.45
27.5	11.8	0.44
30	10.1	0.45
32.5	9.9	0.45
35	8.7	0.46
37.5	8.9	0.46
40	8.6	0.46
42.5	8.9	0.39
45	8.5	0.39

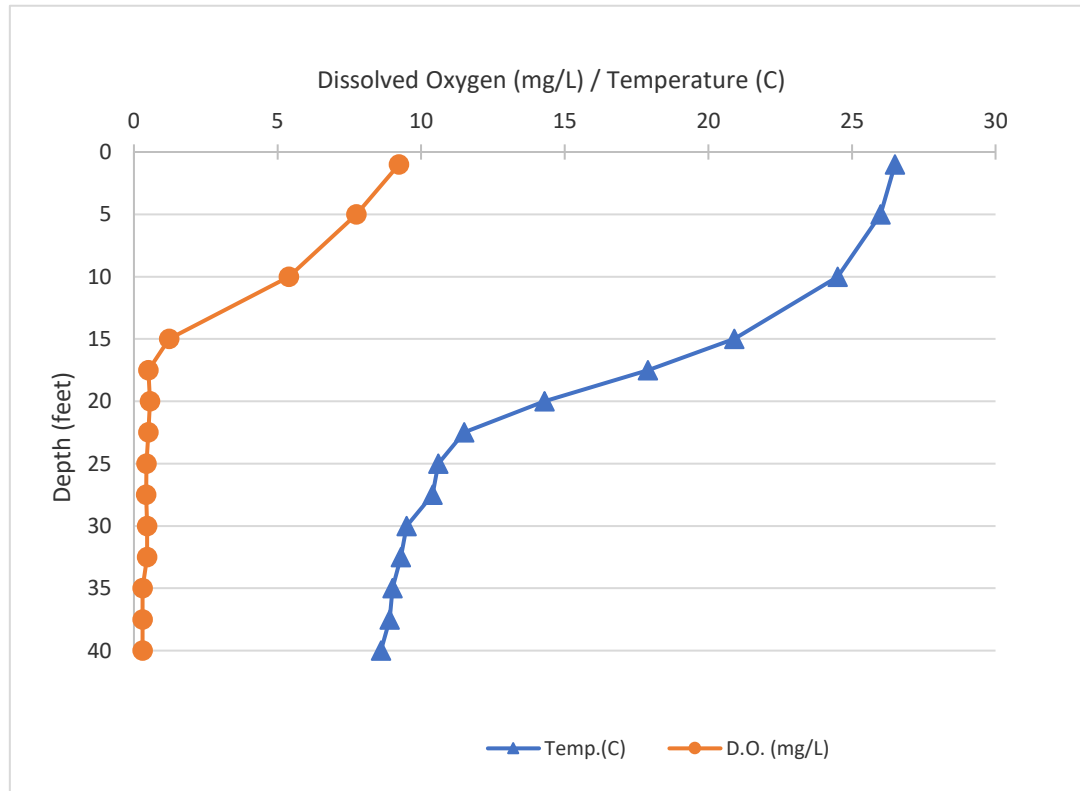
8/2/2017

Dissolved Oxygen and Temperature Profile

Depth (ft)	Temp.(C)	D.O. (mg/L)
1	26.5	9.23
5	26	7.75
10	24.5	5.4
15	20.9	1.23
17.5	17.9	0.5
20	14.3	0.56
22.5	11.5	0.5
25	10.6	0.44
27.5	10.4	0.43
30	9.5	0.46
32.5	9.3	0.46
35	9	0.3
37.5	8.9	0.3
40	8.6	0.3

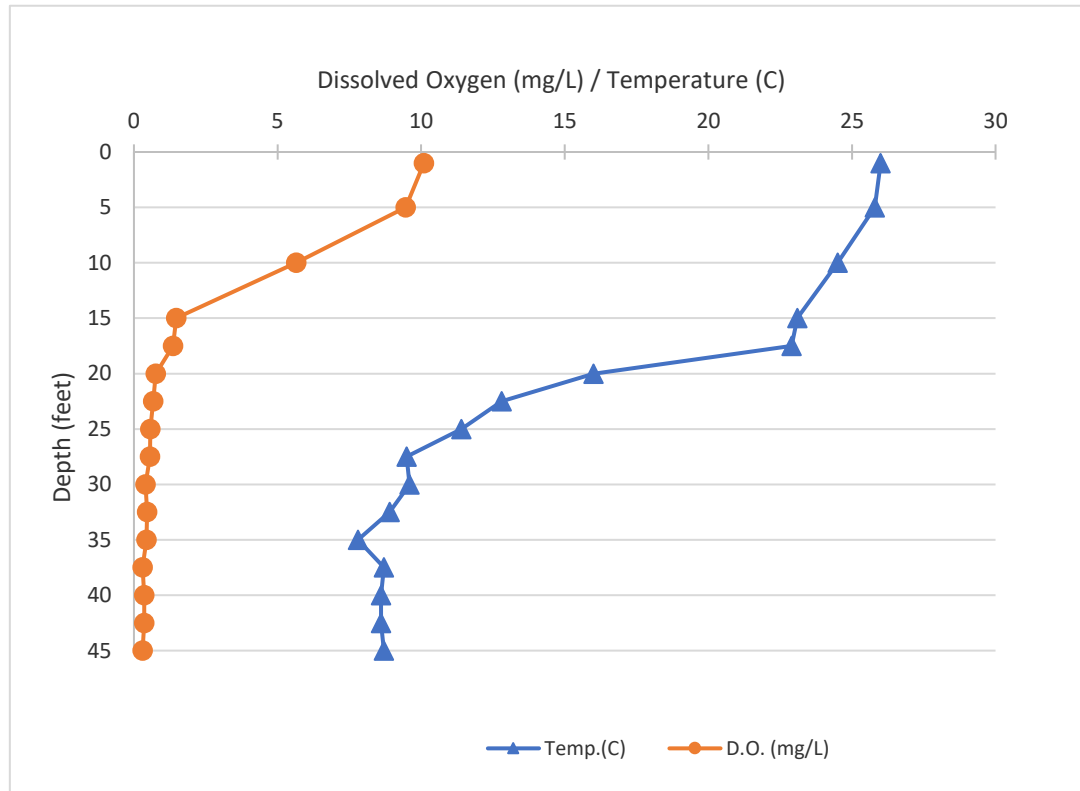
8/19/2017

Dissolved Oxygen and Temperature Profile

Depth (ft)	Temp.(C)	D.O. (mg/L)
1	26	10.1
5	25.8	9.46
10	24.5	5.65
15	23.1	1.47
17.5	22.9	1.36
20	16	0.76
22.5	12.8	0.67
25	11.4	0.57
27.5	9.5	0.56
30	9.6	0.4
32.5	8.9	0.46
35	7.8	0.44
37.5	8.7	0.3
40	8.6	0.36
42.5	8.6	0.36
45	8.7	0.3

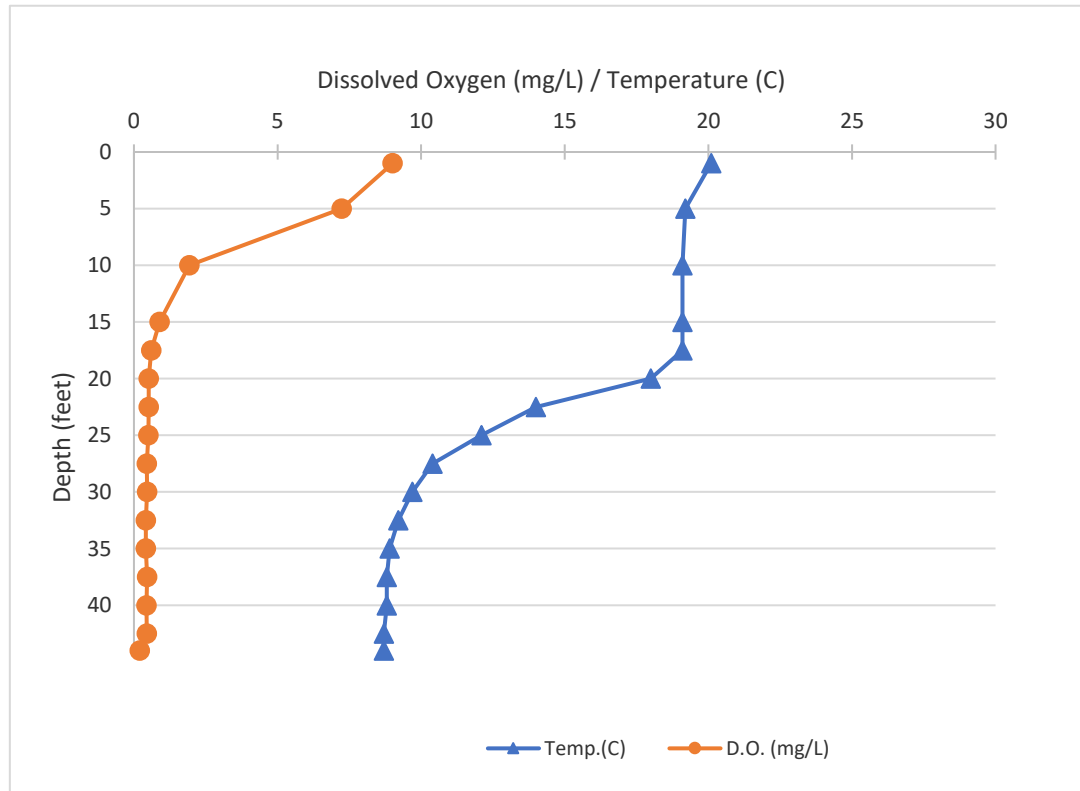
9/8/2017

Dissolved Oxygen and Temperature Profile

Depth (ft)	Temp.(C)	D.O. (mg/L)
1	20.1	9.01
5	19.2	7.23
10	19.1	1.93
15	19.1	0.89
17.5	19.1	0.6
20	18	0.51
22.5	14	0.51
25	12.1	0.5
27.5	10.4	0.45
30	9.7	0.46
32.5	9.2	0.41
35	8.9	0.41
37.5	8.8	0.46
40	8.8	0.44
42.5	8.7	0.45
44	8.7	0.2

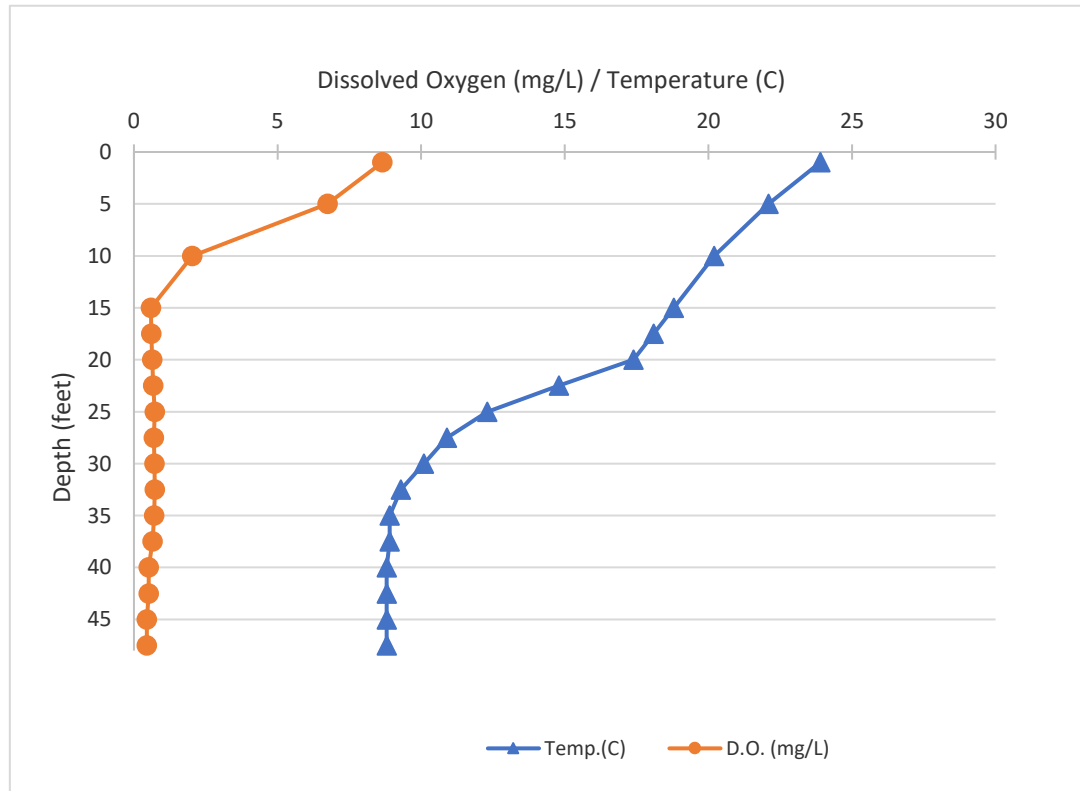
9/16/2017

Dissolved Oxygen and Temperature Profile

Depth (ft)	Temp.(C)	D.O. (mg/L)
1	23.9	8.65
5	22.1	6.74
10	20.2	2.03
15	18.8	0.59
17.5	18.1	0.6
20	17.4	0.64
22.5	14.8	0.67
25	12.3	0.73
27.5	10.9	0.69
30	10.1	0.71
32.5	9.3	0.73
35	8.9	0.7
37.5	8.9	0.65
40	8.8	0.51
42.5	8.8	0.51
45	8.8	0.45
47.5	8.8	0.45
