2021 Data Report for

Second Fortune Lake, Iron County

Site ID: 360177

Second Fortune Lake, Iron County 2021 CLMP Results

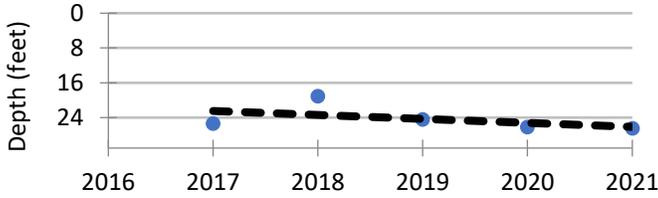
Secchi Disk Transparency (feet)

Year	# Readings	Min	Max	Average	Std. Dev	Carlson TSI
2021	8	19.0	37.5	26.4	6.8	30
2016-2020	45	14.5	43.0	26.4	6.4	32
2021 All CLMP Lakes	2817	1.0	50.0	12.7	2.9	42

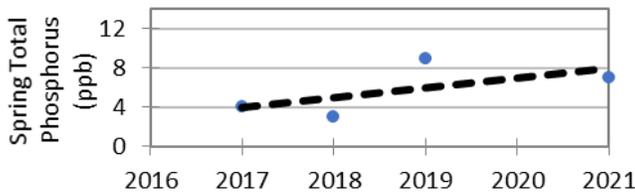
Spring Phosphorus (parts per billion)

Year	# Samples	Min	Max	Average	Std. Dev
2021	1	7.0	7.0	7.0	NA
2016-2019	3	<=3 W	9.0	5.3	3.2
2021 All CLMP Lakes	220	<= 3	100.0	14.9	11.0

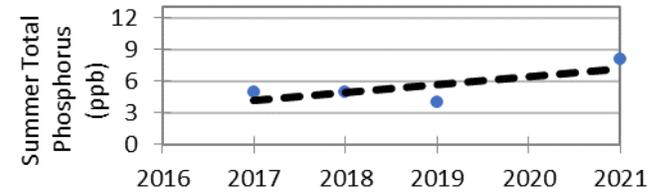
Summer Phosphorus (parts per billion)

Year	# Samples	Min	Max	Average	Std. Dev	Carlson TSI
2021	1	8.0	8.0	8.0	NA	34
2016-2019	3	<5 T	5.0	4.7	0.6	<27
2021 All CLMP Lakes	281	<= 3	65.0	12.8	9.3	38

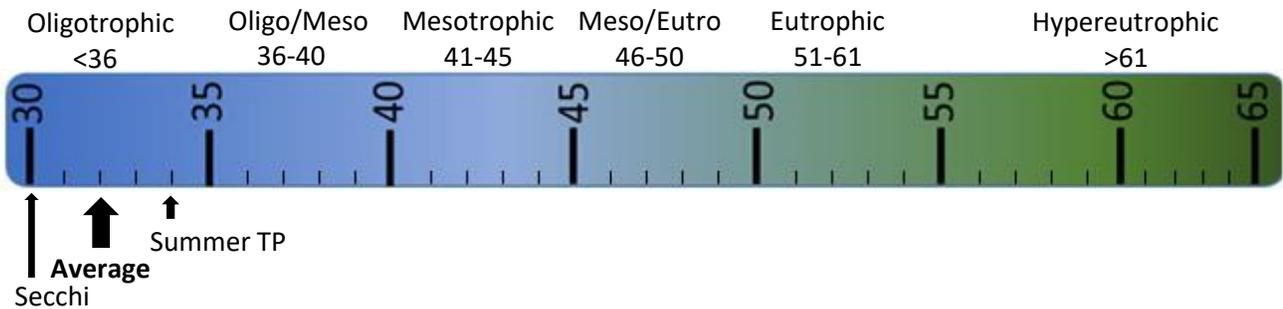
With an average TSI score of 32 based on 2021 Secchi transparency, chlorophyll-a, and summer total phosphorus data, this lake is rated as an oligotrophic lake.

TSI for Second Fortune Lake in 2021	
Average	32
Secchi Disk	30
Summer TP	34
Chlorophyll-a

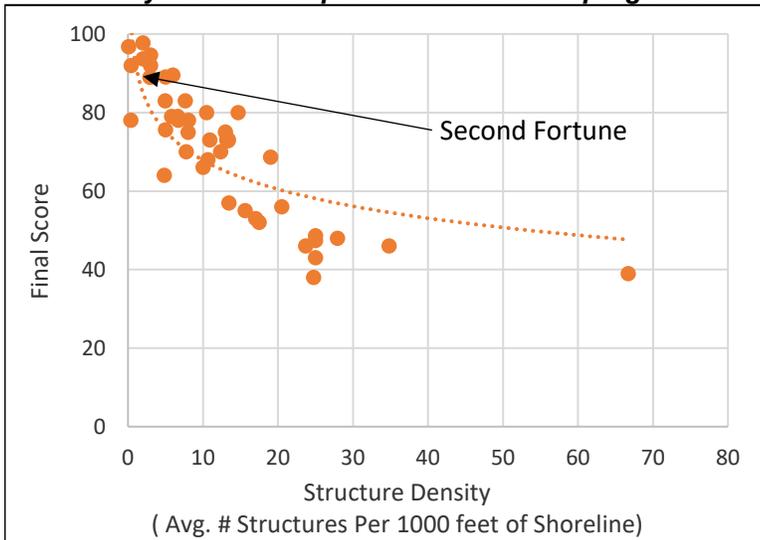
How does your lake compare to others in the program?

Second Fortune Lake:	
Number of Sections:	10
Number of Structures:	53
Structure Density:	5.3
Final Score:	89

All 31 Participating Lakes from 2015-2017:	
Avg. Number of Sections:	16
Avg. Number of Structures:	233
Avg. Structure Density:	14.6
Avg. Final Score:	66

Overall, the lakeshore habitat of Second Fortune Lake is doing well and scored higher than average when compared to other lakes in the program. All of the 1000 foot sections scored either Fair or Good: 1 fair, and 9 good.

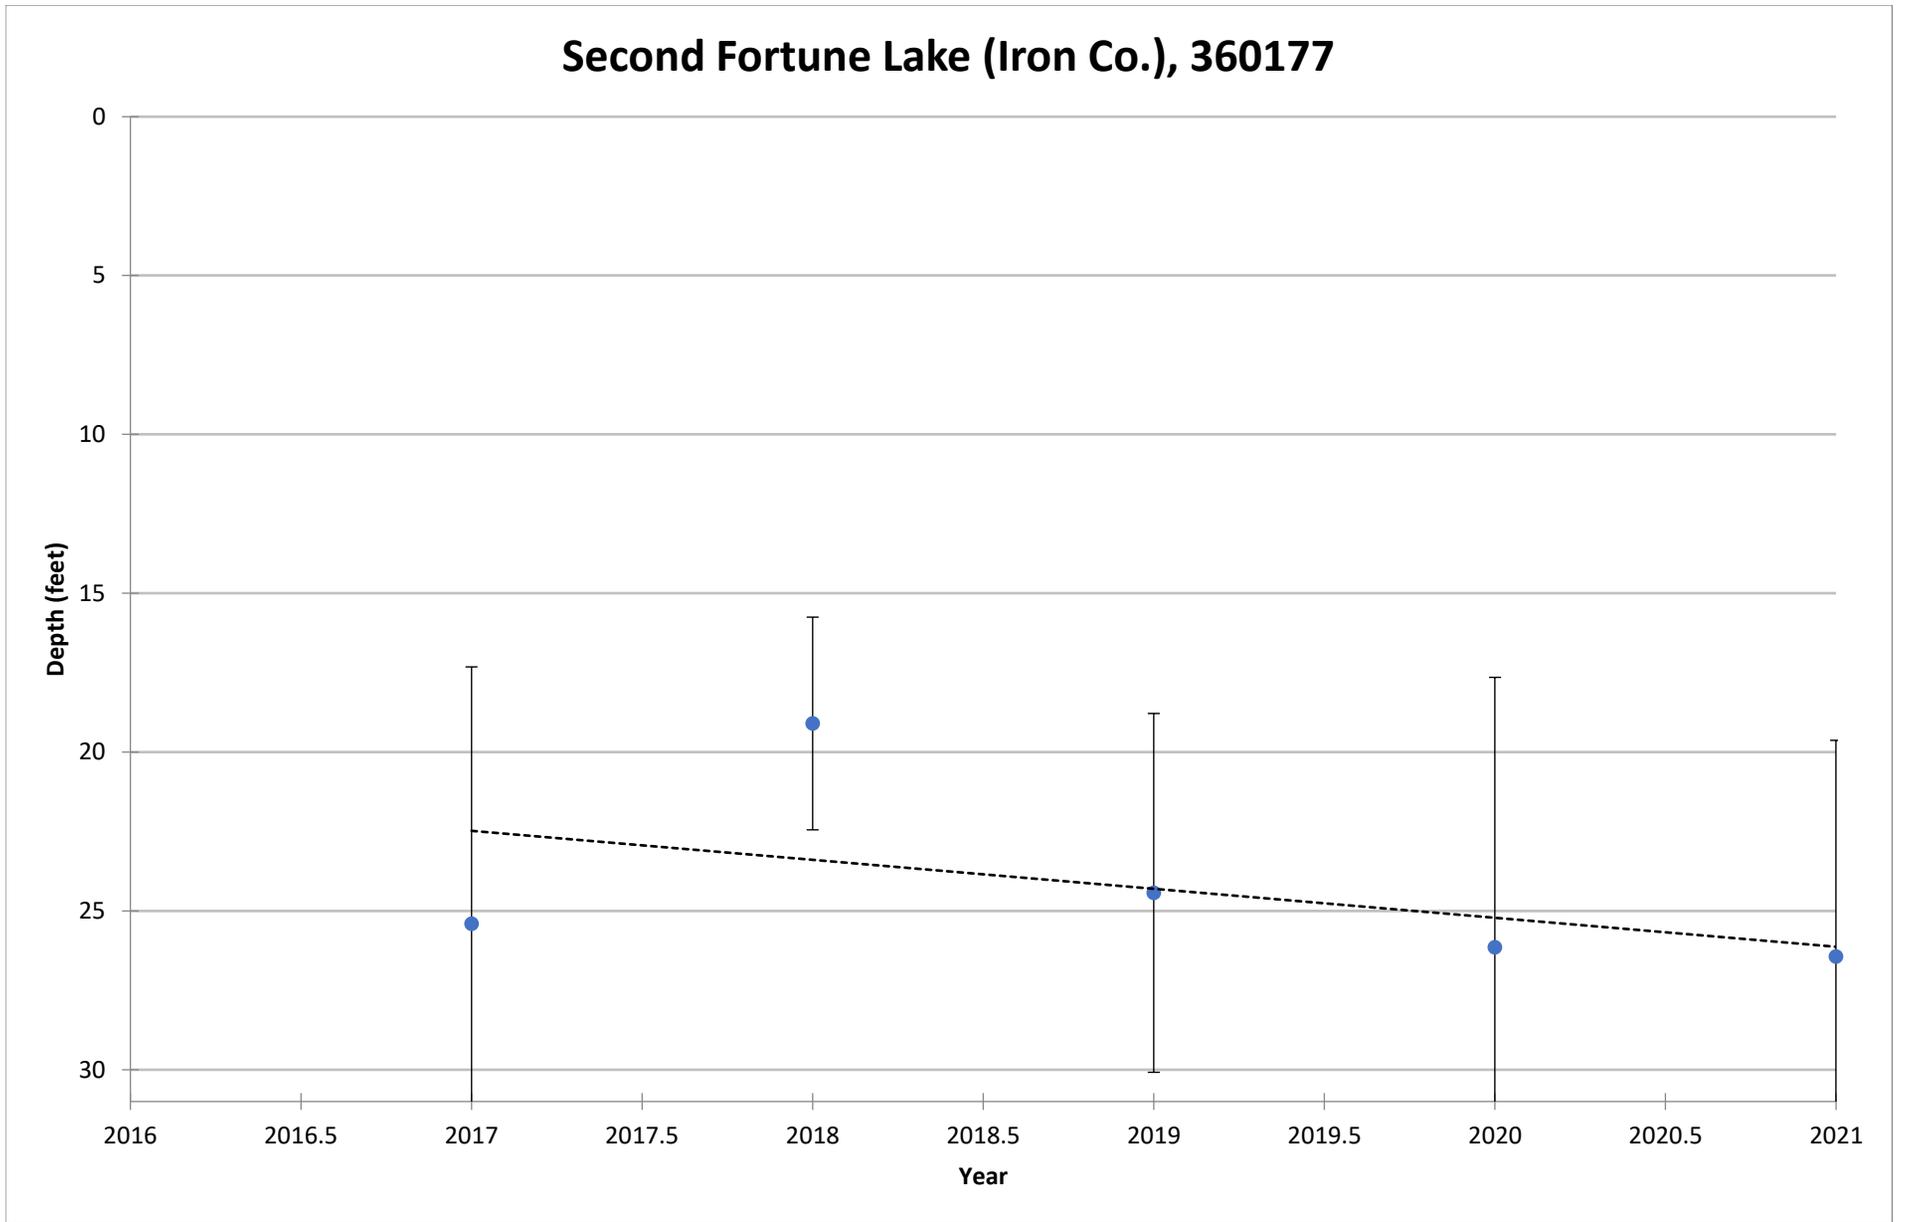
COOPERATIVE LAKES MONITORING PROGRAM
SUMMER MEAN TRANSPARENCY

Second Fortune Lake (Iron Co.), 360177

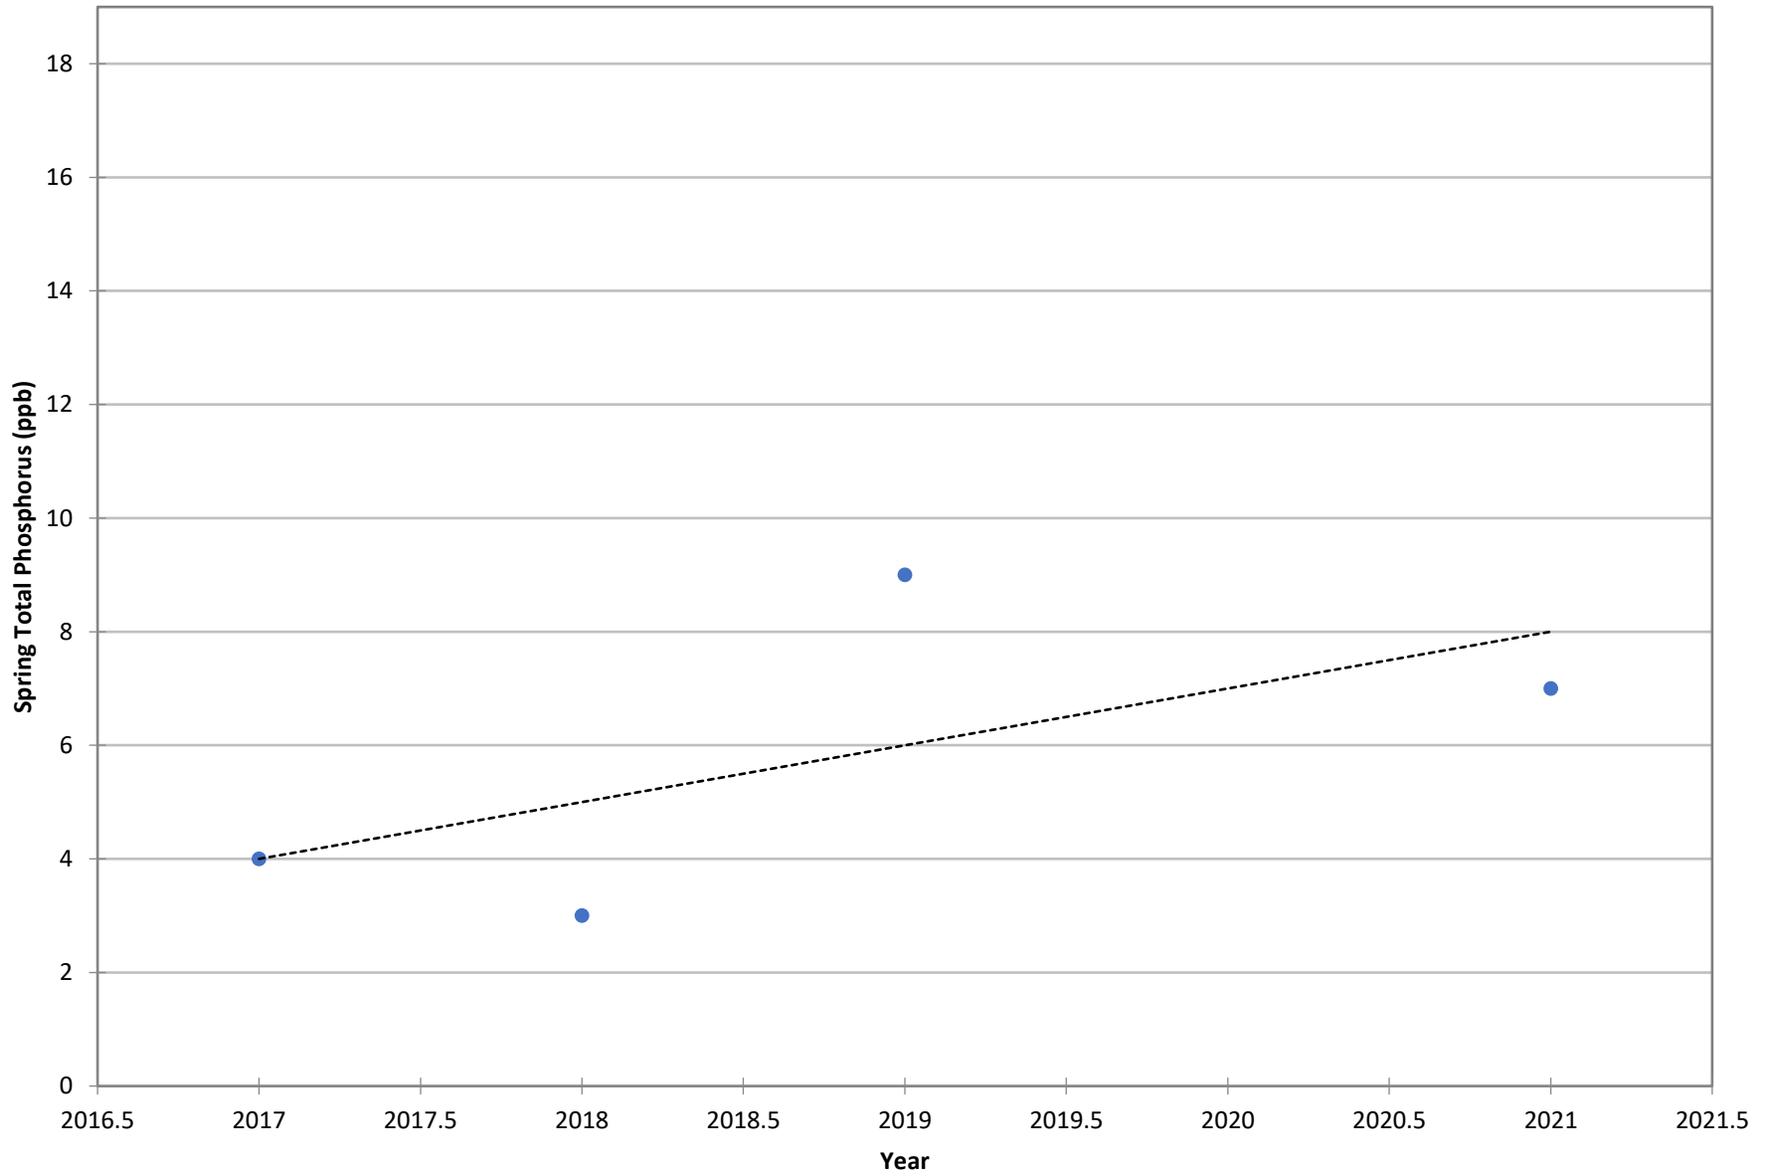
COOPERATIVE LAKES MONITORING PROGRAM
SPRING TOTAL PHOSPHORUS

Vertical bars indicate standard deviation

Second Fortune Lake (Iron Co.), 360177

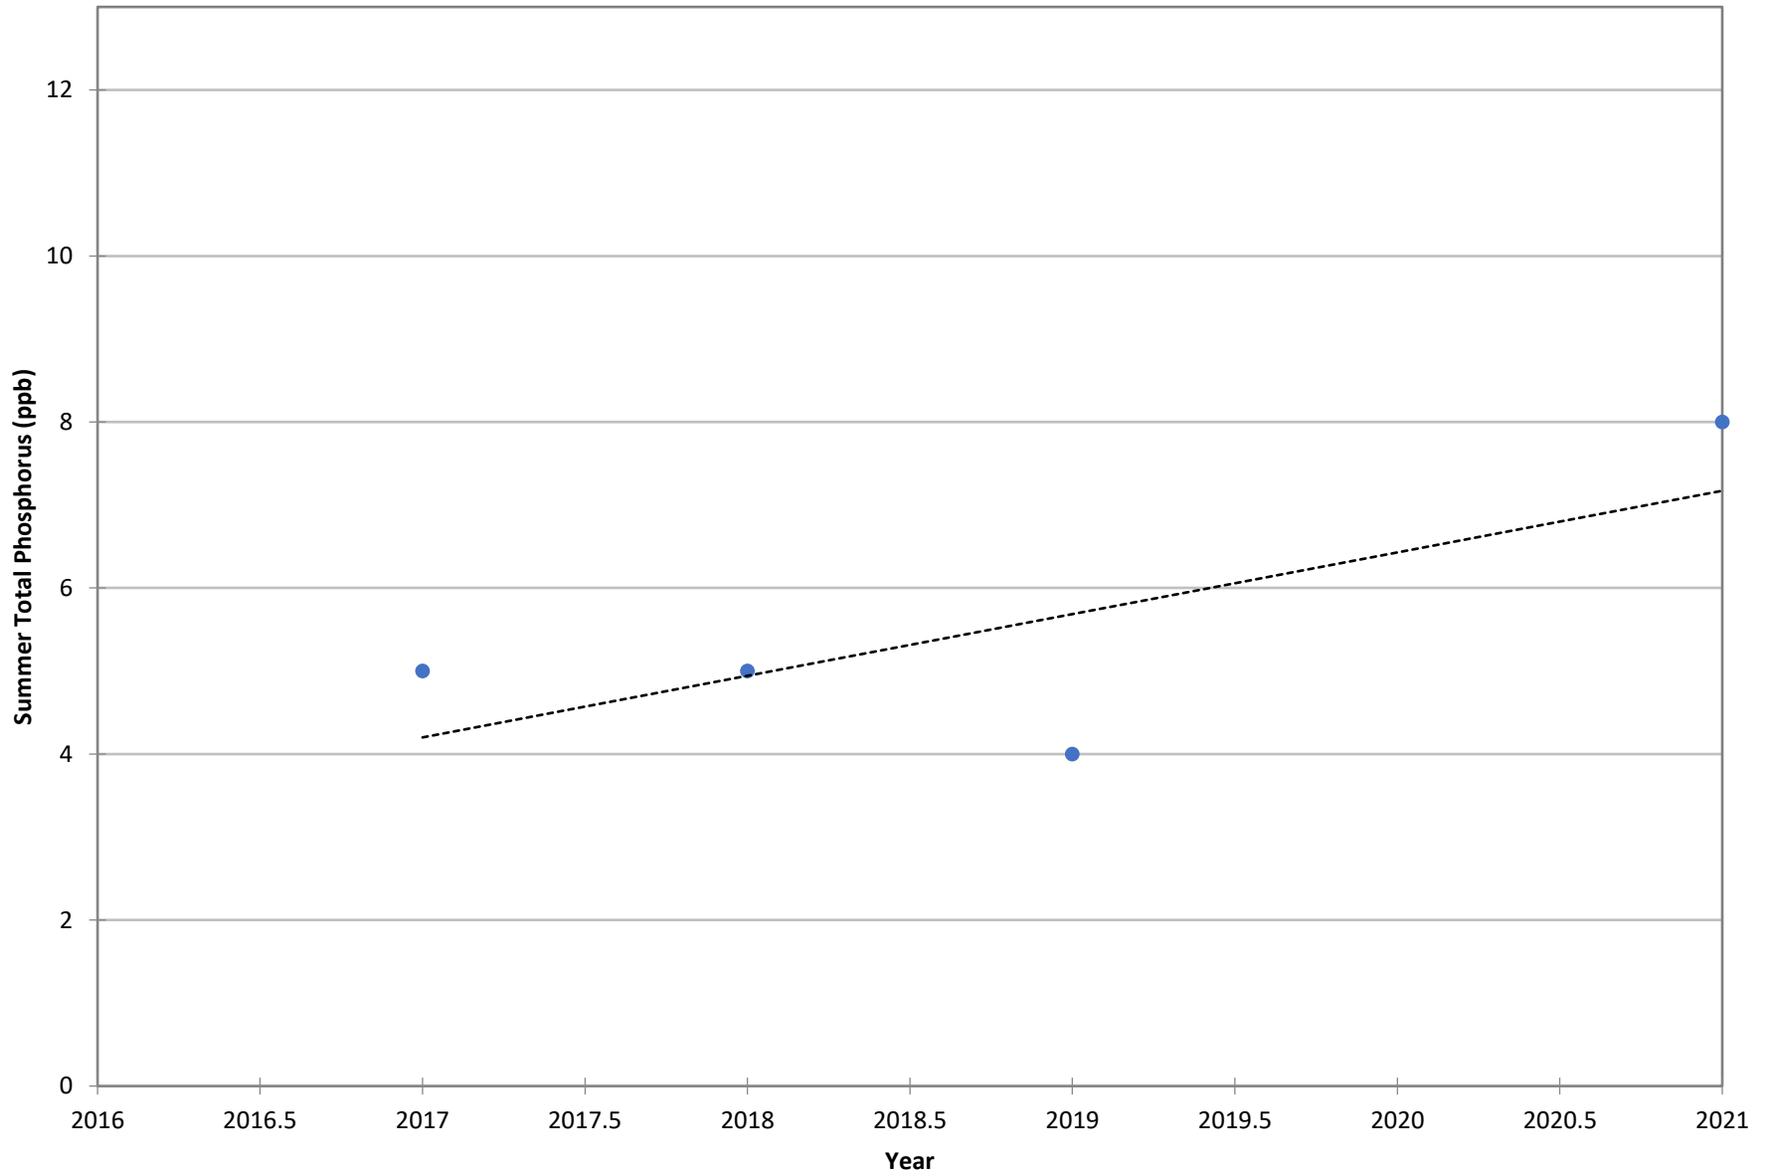
COOPERATIVE LAKES MONITORING PROGRAM
SUMMER TOTAL PHOSPHORUS

Second Fortune Lake (Iron Co.), 360177
