# 2021 Data Report for

# Fremont Lake, Newaygo County

Site ID: 620029

# Fremont Lake, Newaygo County 2021 CLMP Results

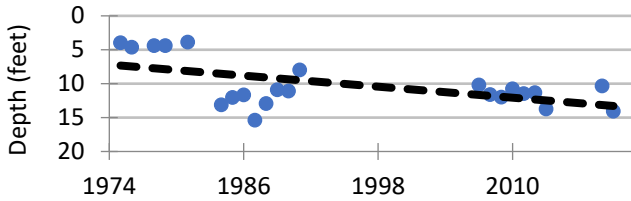
## Secchi Disk Transparency (feet)

Year	# Readings	Min	Max	Avg	Std. Dev	Carlson TSI
2019	8	7.5	21.5	14.1	5.4	39
2014-2018	21	5.0	18.5	14.1	4.3	43
1975-2013	319	2.0	30.0	9.9	4.1	45
2021 All CLMP Lakes	2817	1.0	50.0	12.7	2.9	42

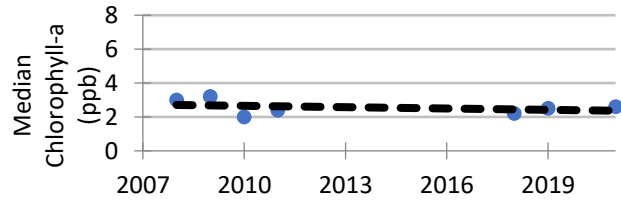
## Chlorophyll-a (parts per billion)

Year	# Samples	Min	Max	Med	Std. Dev	Carlson TSI
2021	4	1.9	4.5	2.6	1.1	40
2018-2019	8	<1.0	4.4	2.4	1.2	39
2008-2015	20	<1.0	7.6	2.4	2.2	40
2021 All CLMP Lakes	635	< 1.0	42.0	2.2	3.4	39

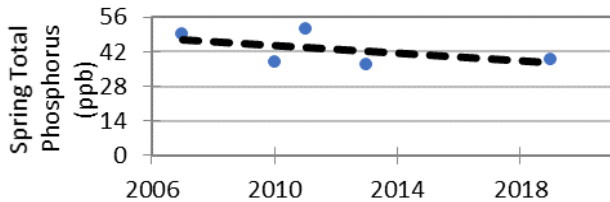
## Spring Phosphorus (parts per billion)

Year	# Samples	Min	Max	Avg	Std. Dev	Carlson TSI
2019	1	39.0	39.0	39.0	NA	
2007-2013	4	37.0	51.0	43.8	7.3	
2021 All CLMP Lakes	220	<= 3	100.0	14.9	11.0

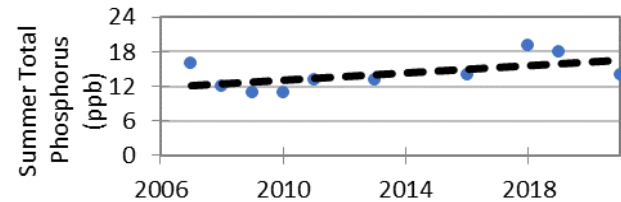
## Summer Phosphorus (parts per billion)

Year	# Samples	Min	Max	Avg	Std. Dev	Carlson TSI
2021	1	14.0	14.0	14.0	NA	42
2016-2019	3	14.0	19.0	17.0	2.6	45
2007-2015	6	11.0	16.0	12.7	1.9	41
2021 All CLMP Lakes	281	<= 3	65.0	12.8	9.3	38

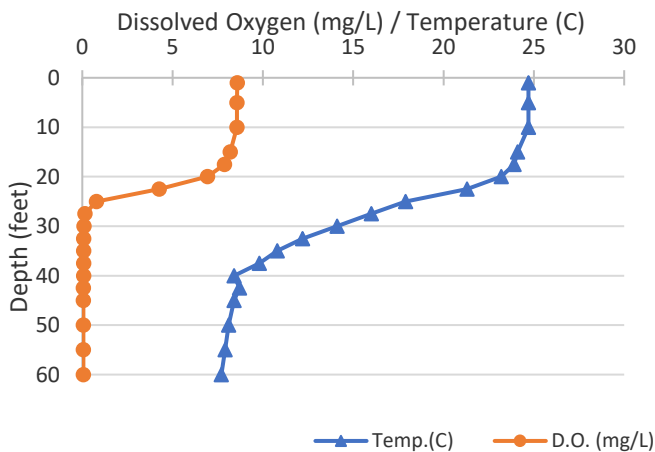
## Dissolved Oxygen and Temperature Profile 8/20/2019

The lake keeps some dissolved oxygen in the bottom waters through early summer, but by mid to late summer the lake has stratified and the bottom water is devoid of oxygen.

If you enrolled in Dissolved Oxygen/Temperature, the summary page will have a graph of one of the profiles taken during the late summer (typically August or September). If your lake stratifies, we will use a graph showing the earliest time of stratification, because identifying the timing of this condition and the depth at which it occurs is typically the most important use of dissolved oxygen measurements.

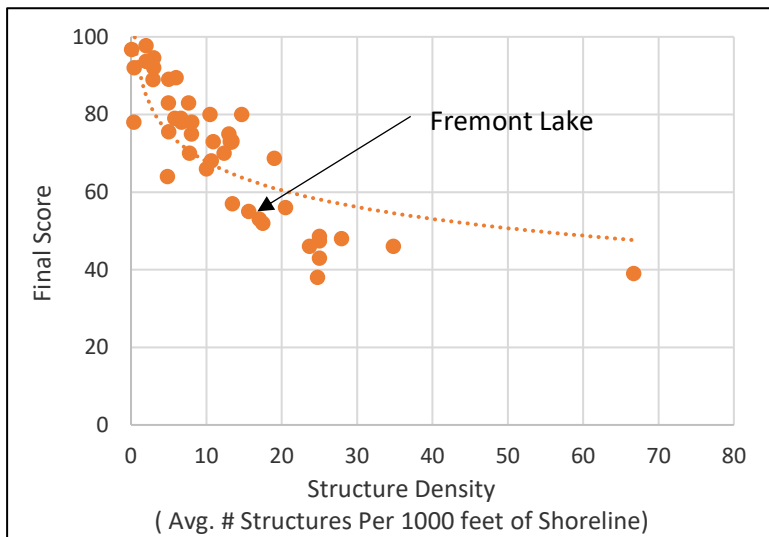
### How does your lake compare to others in the program?

Fremont Lake:	
Number of Sections:	25
Number of Structures:	424
Structure Density:	17
Final Score:	53

All 42 Participating Lakes from 2015-2018:	
Avg. Number of Sections:	16.3
Avg. Number of Structures:	248.5
Avg. Structure Density:	15.2
Avg. Final Score:	70.5

Overall, the lakeshore habitat of Fremont Lake is below average when compared to the other lakes in the program. 50% percent of the lake sections score poor or worse (1 highly impacted, 12 poor, 5 fair, 7 good).

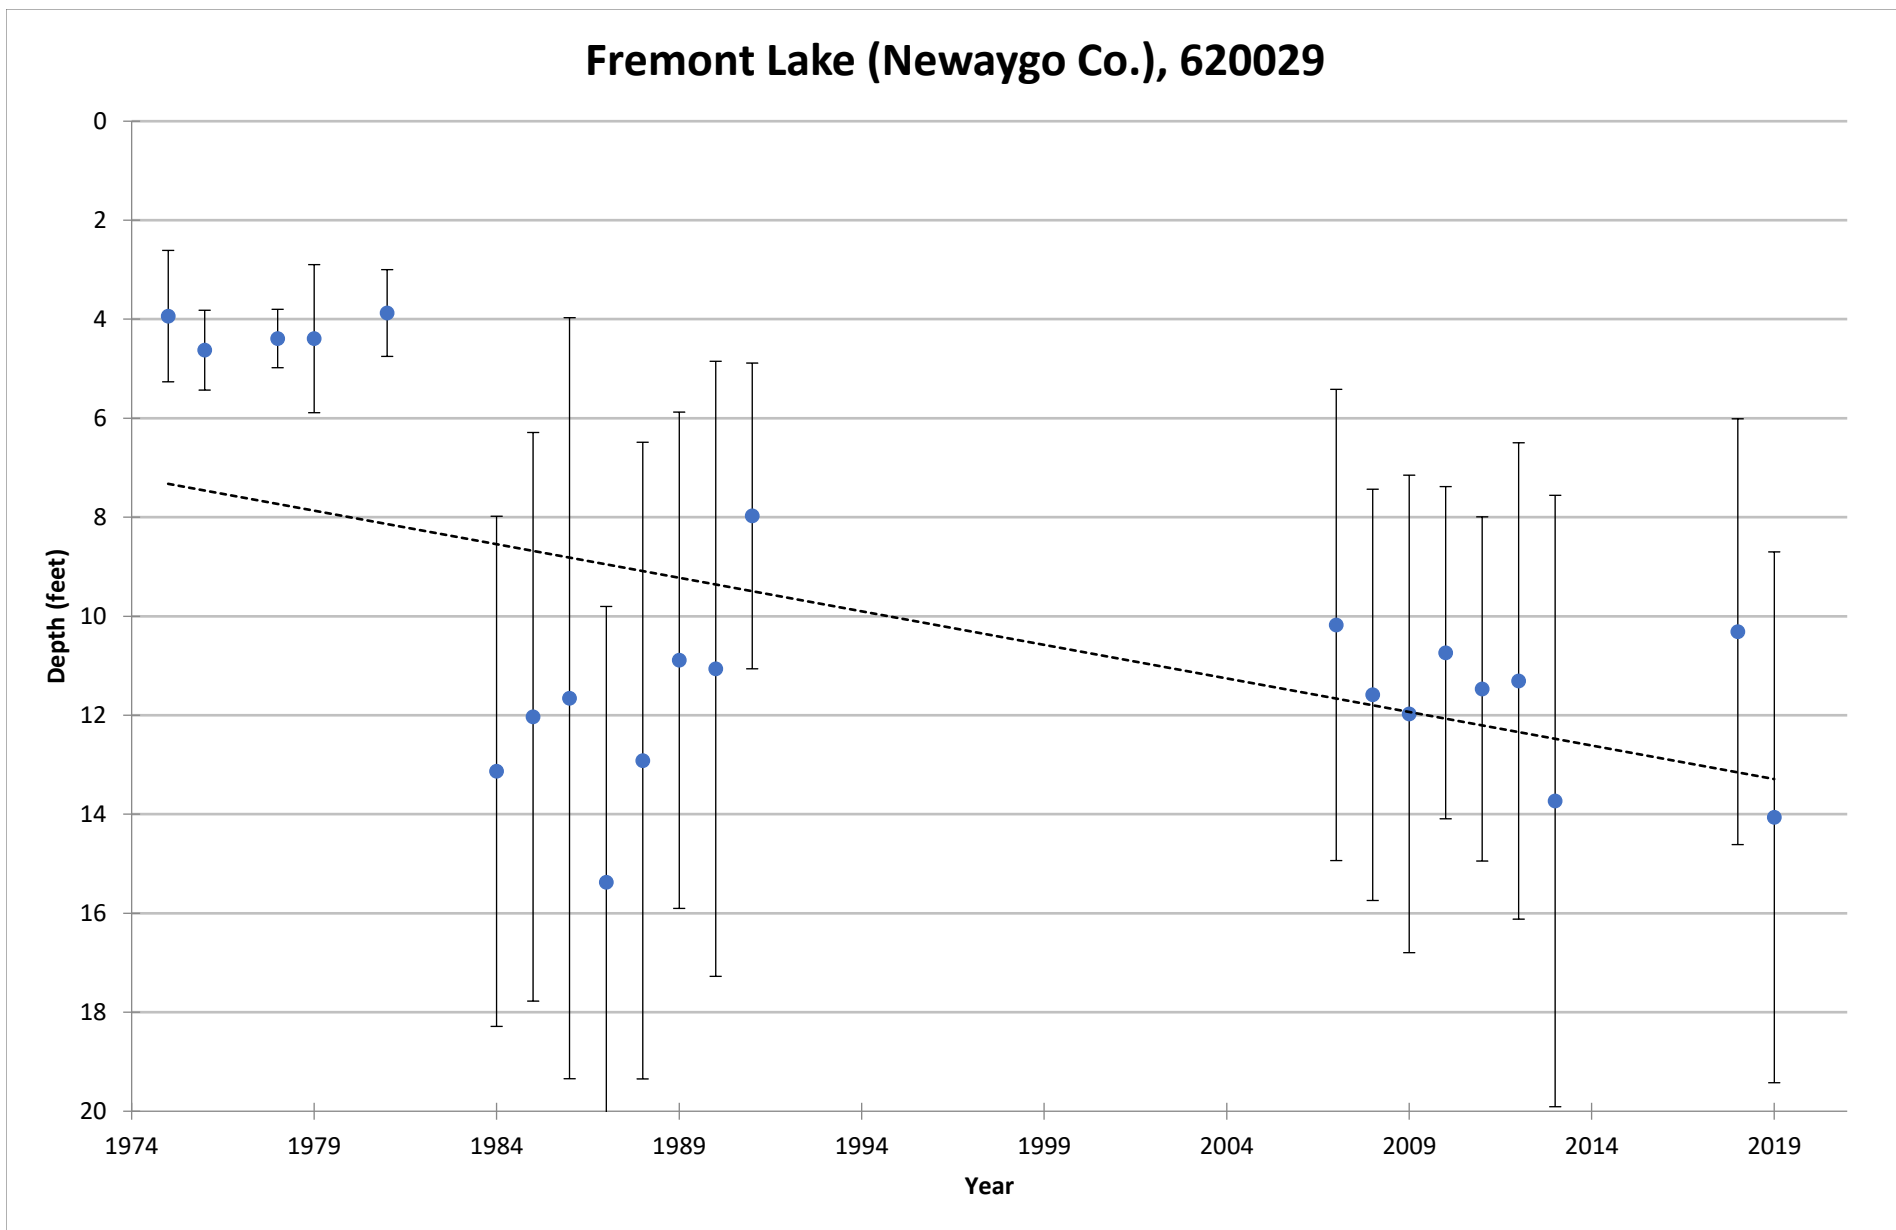
COOPERATIVE LAKES MONITORING PROGRAM  
SUMMER MEAN TRANSPARENCY

**Fremont Lake (Newaygo Co.), 620029**

Vertical bars indicate standard deviation

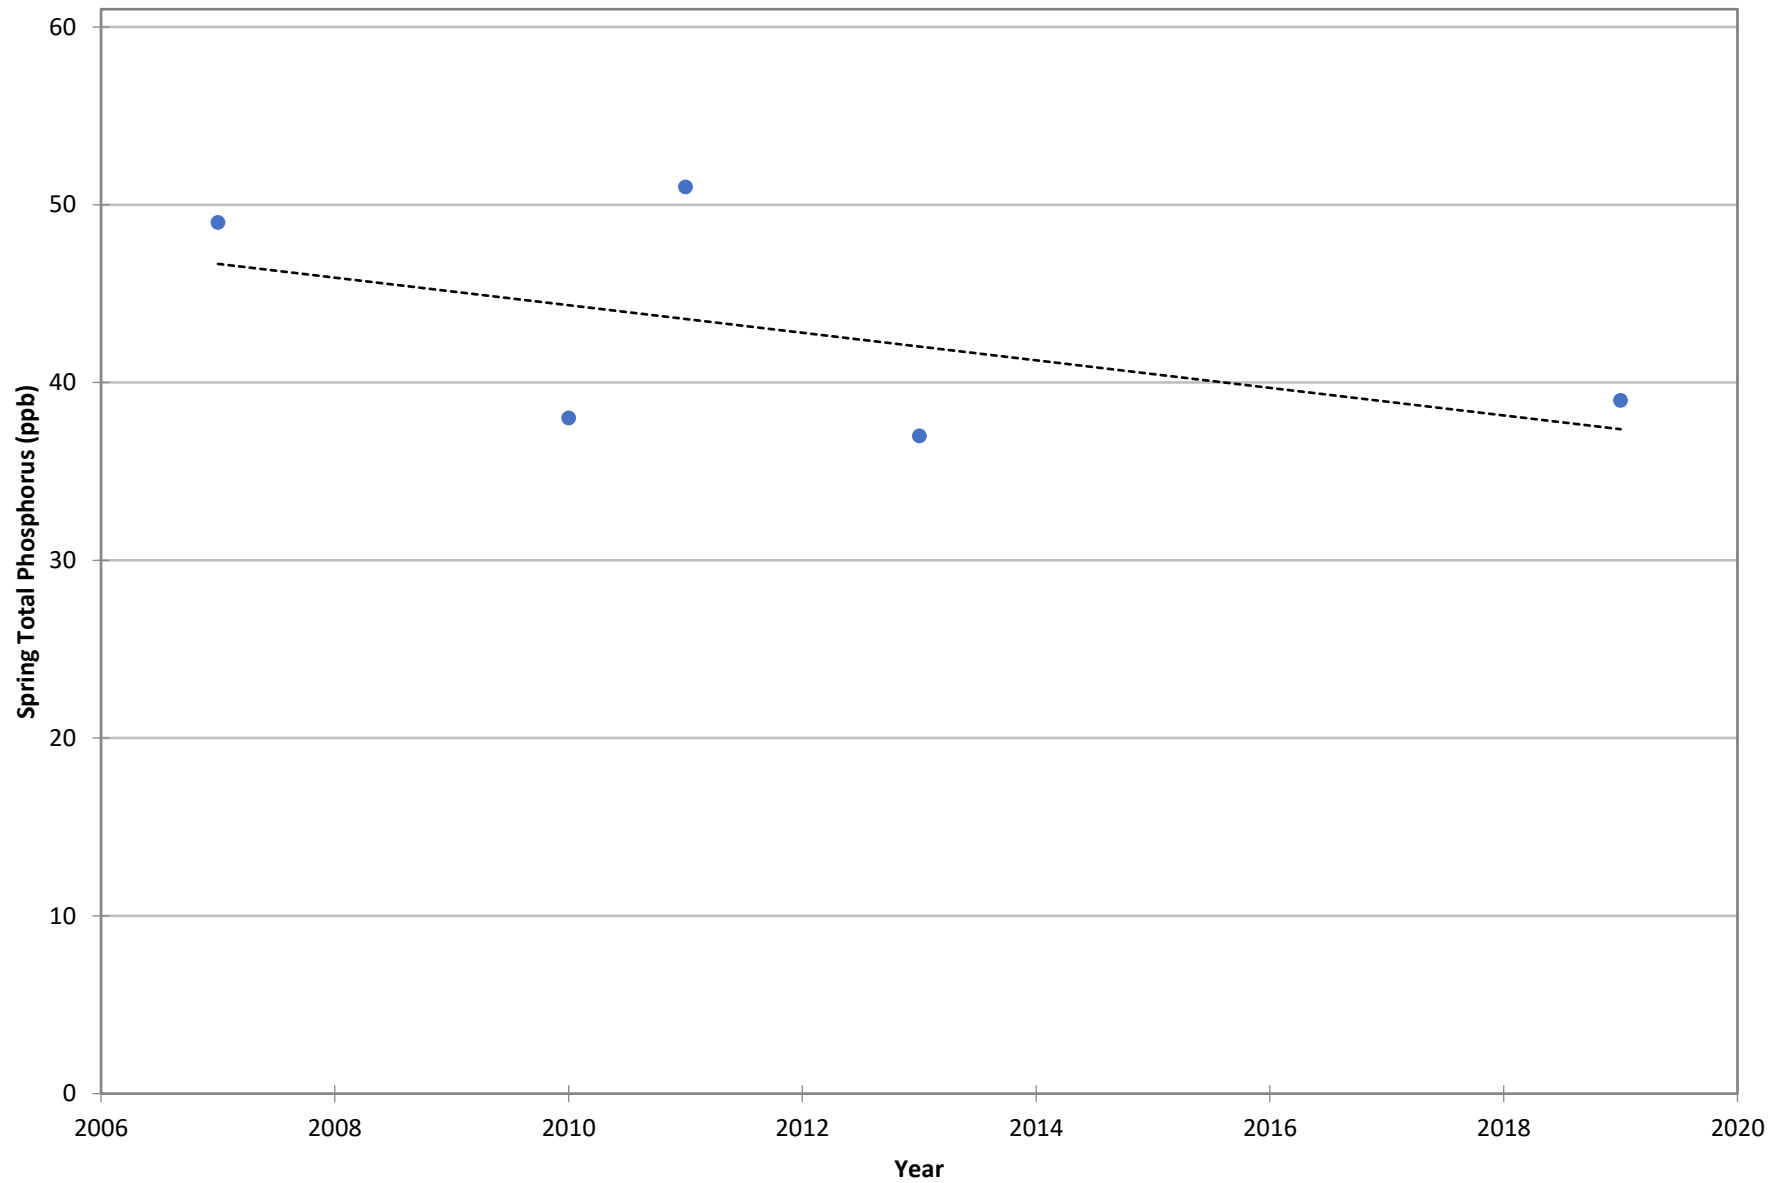
COOPERATIVE LAKES MONITORING PROGRAM  
SPRING TOTAL PHOSPHORUS

**Fremont Lake (Newaygo Co.), 620029**

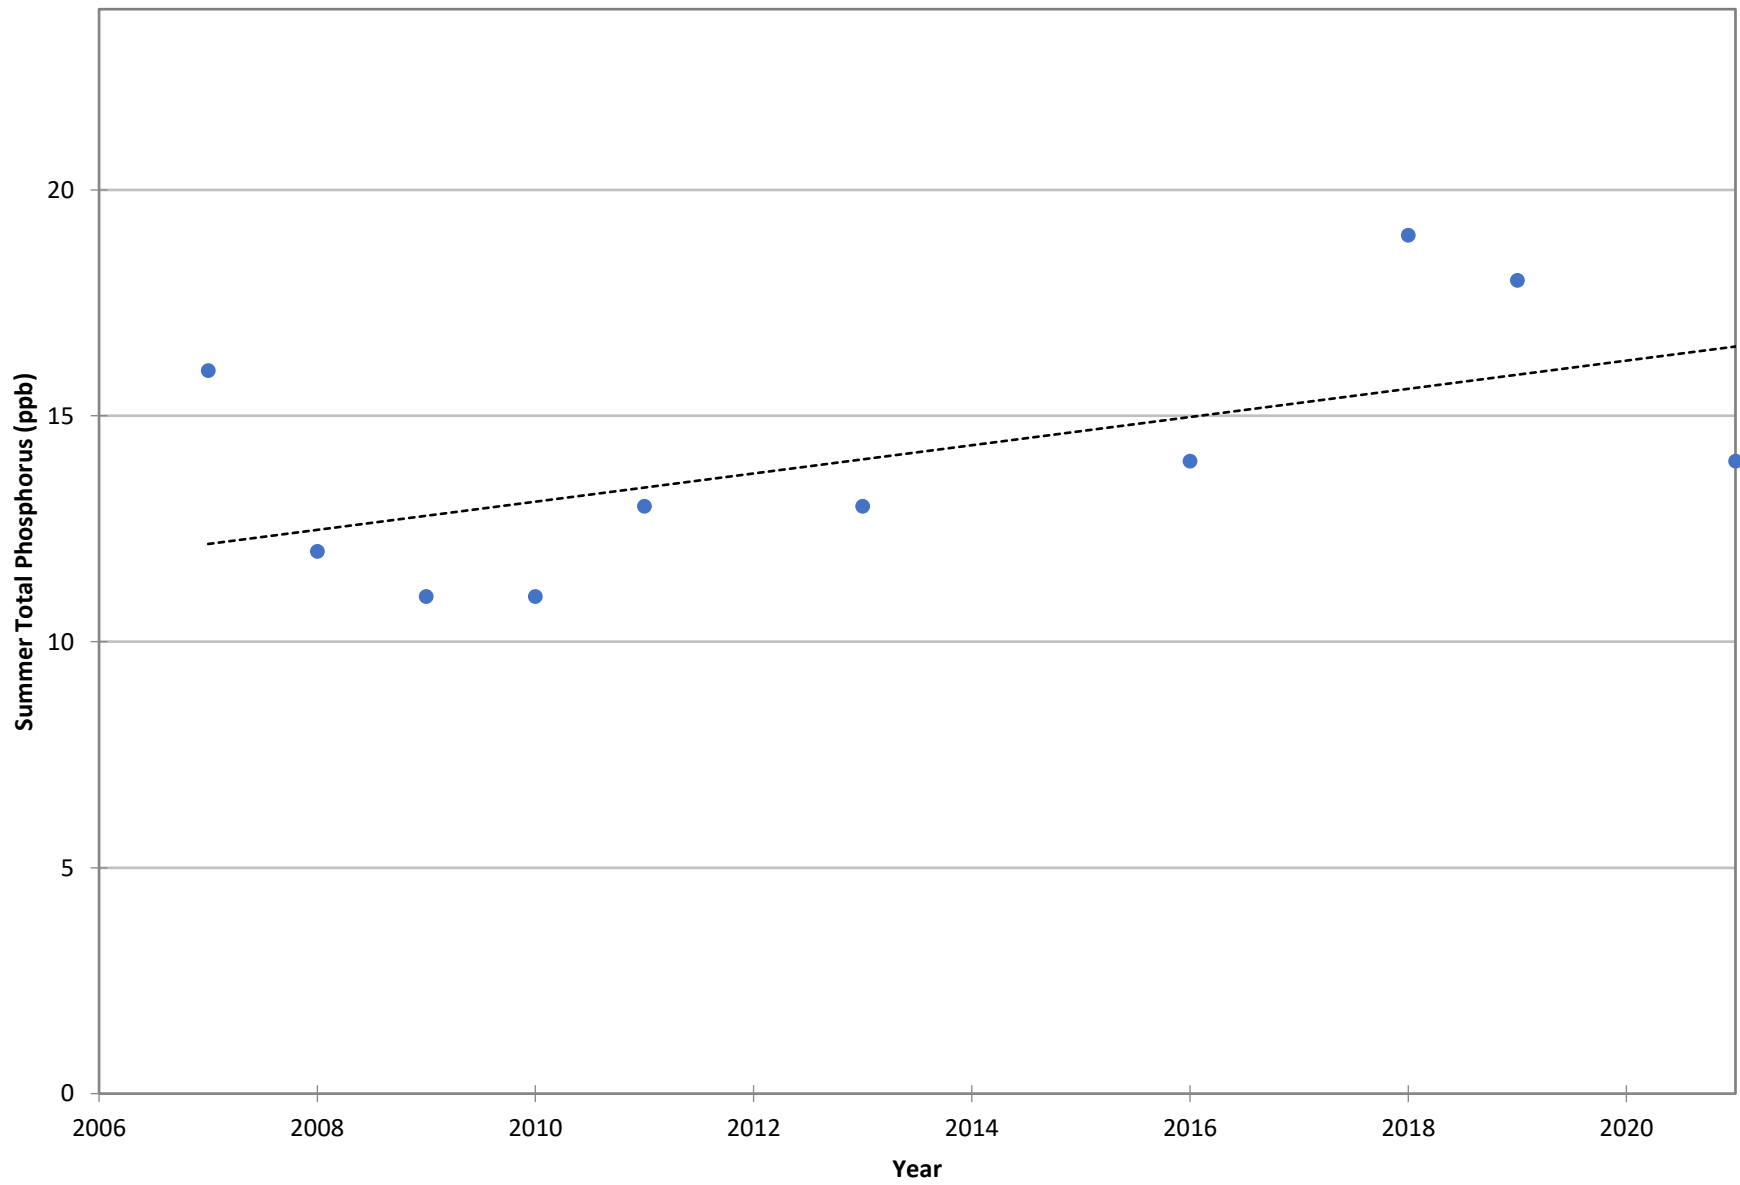
COOPERATIVE LAKES MONITORING PROGRAM  
SUMMER TOTAL PHOSPHORUS

**Fremont Lake (Newaygo Co.), 620029**

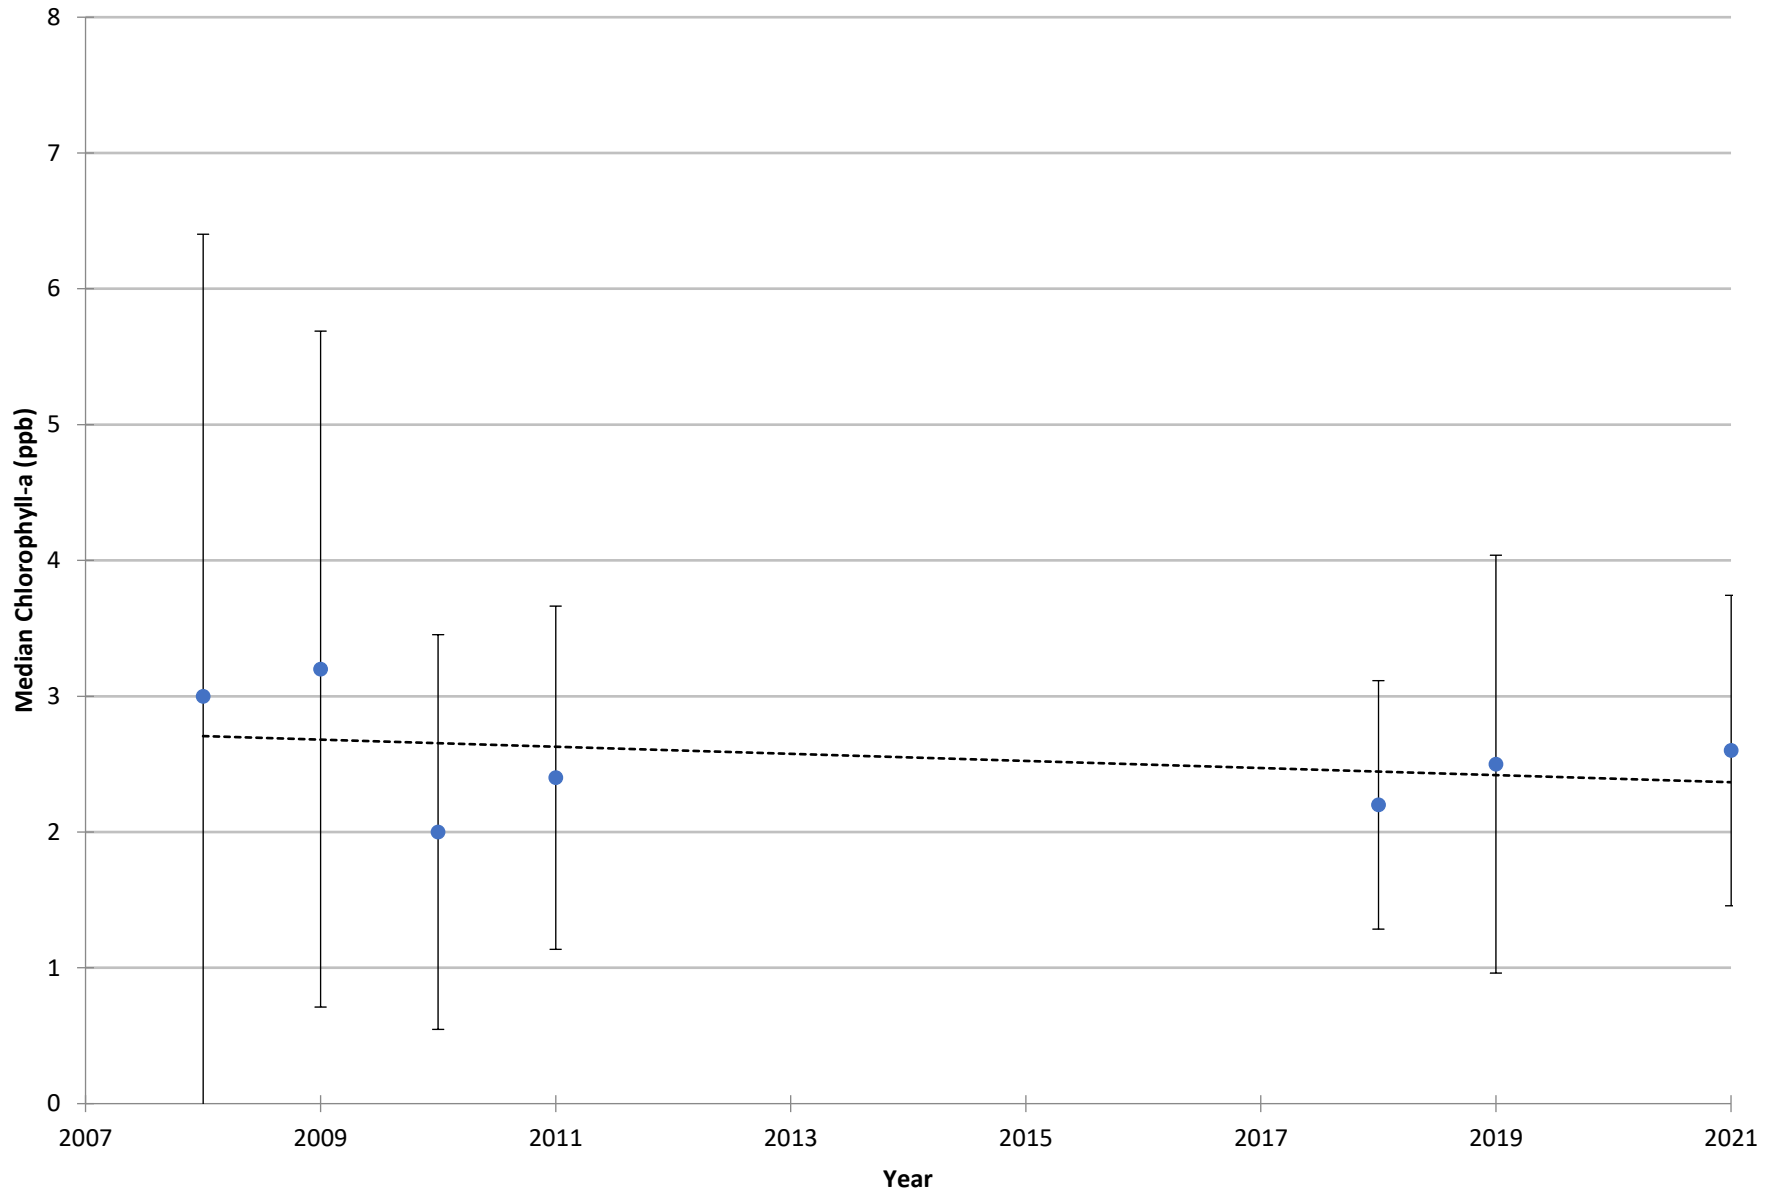
COOPERATIVE LAKES MONITORING PROGRAM  
SUMMER MEDIAN CHLOROPHYLL-A

**Fremont Lake (Newaygo Co.), 620029**

Vertical bars indicate standard deviation

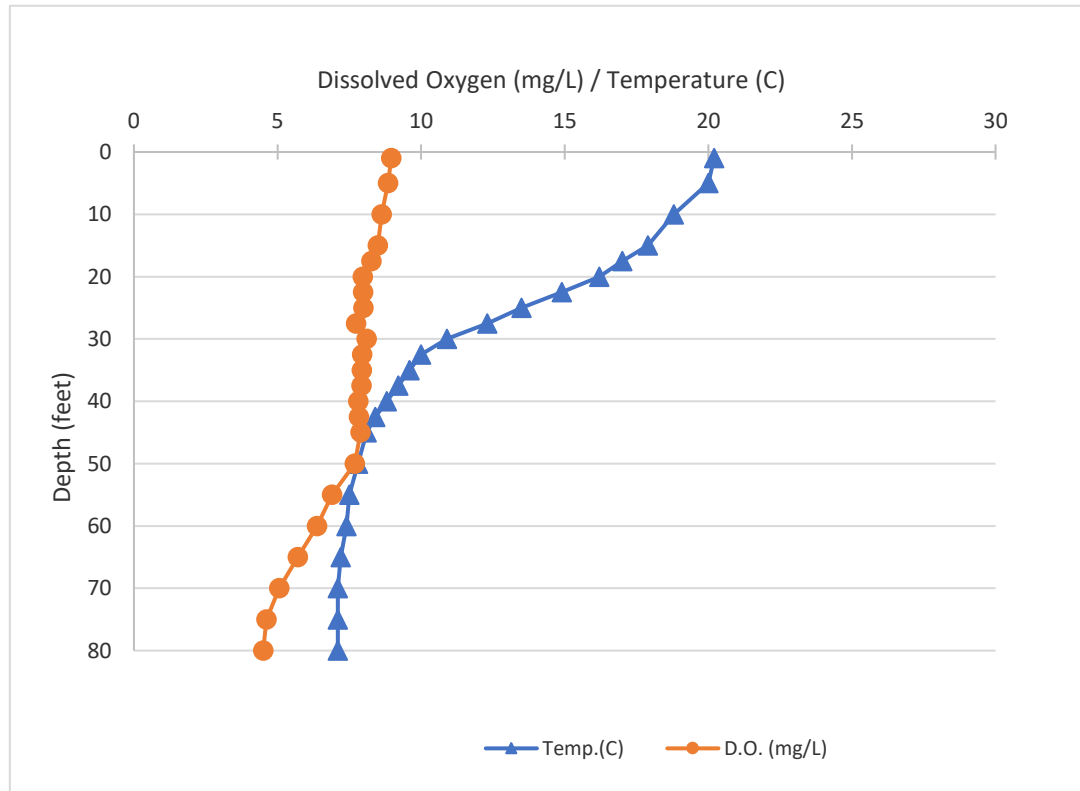
6/7/2019

Depth (ft)	Temp.(C)	D.O. (mg/L)
1	20.2	8.96
5	20	8.85
10	18.8	8.63
15	17.9	8.49
17.5	17	8.27
20	16.2	7.97
22.5	14.9	7.98
25	13.5	7.99
27.5	12.3	7.73
30	10.9	8.1
32.5	10	7.95
35	9.6	7.94
37.5	9.2	7.92
40	8.8	7.81
42.5	8.4	7.83
45	8.1	7.89
50	7.8	7.69
55	7.5	6.9
60	7.4	6.38
65	7.2	5.71
70	7.1	5.06
75	7.1	4.62
80	7.1	4.5

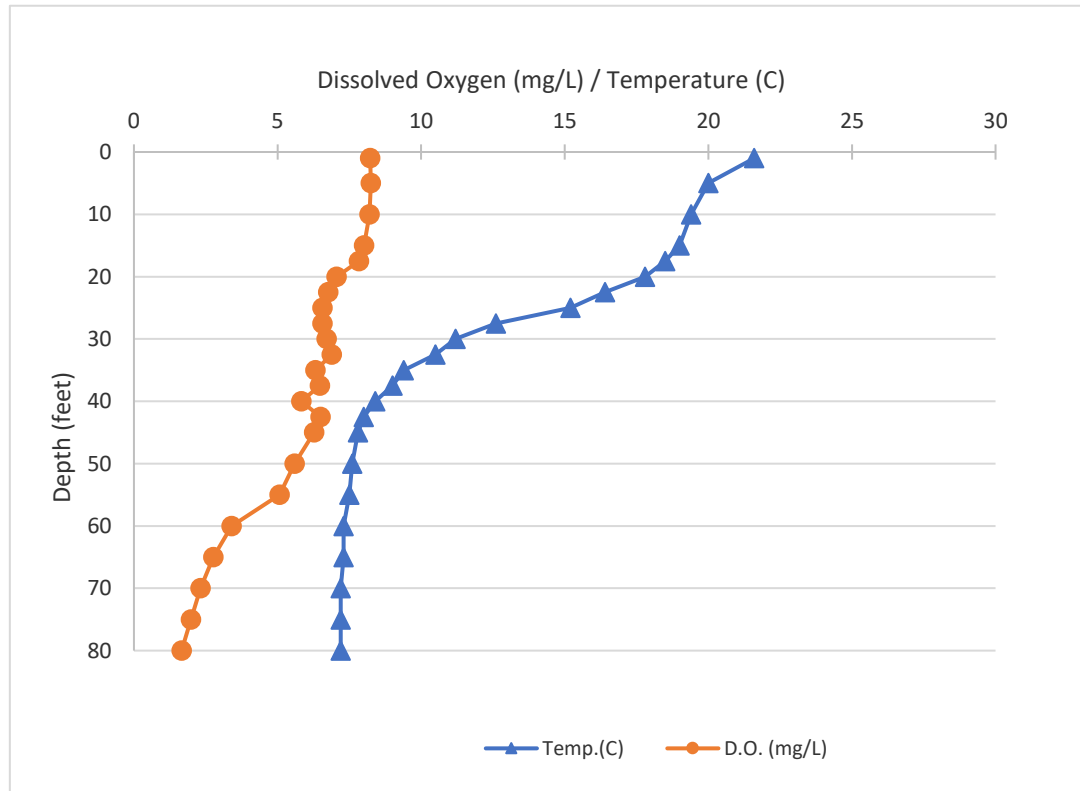
6/21/2019

Depth (ft)	Temp.(C)	D.O. (mg/L)
1	21.6	8.23
5	20	8.25
10	19.4	8.2
15	19	8.01
17.5	18.5	7.84
20	17.8	7.05
22.5	16.4	6.77
25	15.2	6.56
27.5	12.6	6.56
30	11.2	6.71
32.5	10.5	6.89
35	9.4	6.32
37.5	9	6.48
40	8.4	5.83
42.5	8	6.5
45	7.8	6.27
50	7.6	5.59
55	7.5	5.07
60	7.3	3.4
65	7.3	2.76
70	7.2	2.32
75	7.2	1.98
80	7.2	1.66

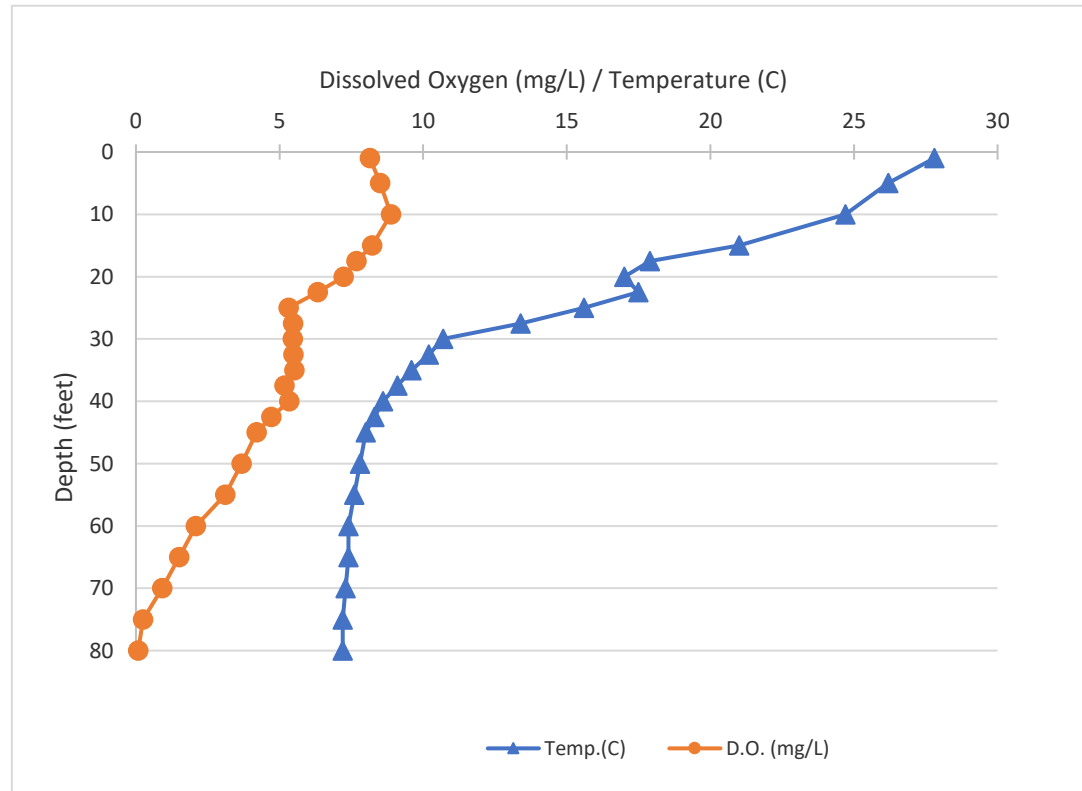
7/3/2019

Depth (ft)	Temp.(C)	D.O. (mg/L)
1	27.8	8.15
5	26.2	8.5
10	24.7	8.88
15	21	8.22
17.5	17.9	7.68
20	17	7.23
22.5	17.5	6.33
25	15.6	5.32
27.5	13.4	5.47
30	10.7	5.46
32.5	10.2	5.48
35	9.6	5.52
37.5	9.1	5.17
40	8.6	5.34
42.5	8.3	4.72
45	8	4.2
50	7.8	3.68
55	7.6	3.11
60	7.4	2.09
65	7.4	1.51
70	7.3	0.92
75	7.2	0.25
80	7.2	0.08

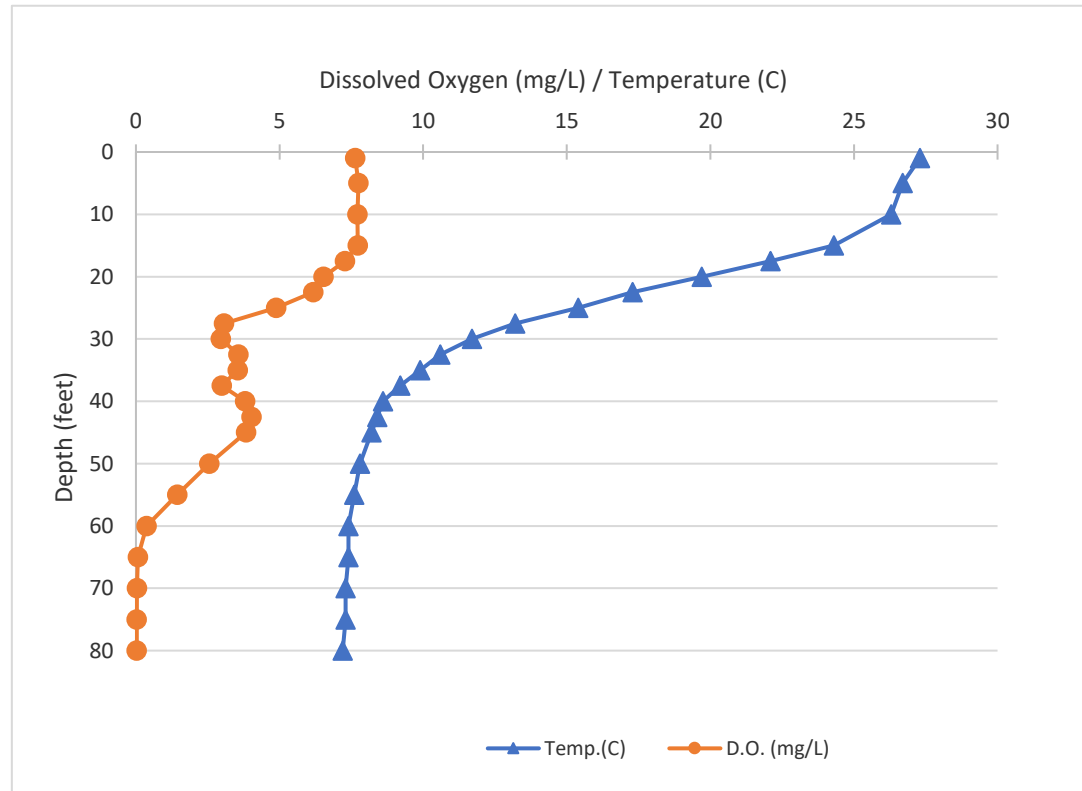
7/17/2019

Depth (ft)	Temp.(C)	D.O. (mg/L)
1	27.3	7.64
5	26.7	7.75
10	26.3	7.71
15	24.3	7.72
17.5	22.1	7.28
20	19.7	6.53
22.5	17.3	6.18
25	15.4	4.88
27.5	13.2	3.07
30	11.7	2.95
32.5	10.6	3.57
35	9.9	3.54
37.5	9.2	2.99
40	8.6	3.8
42.5	8.4	4.02
45	8.2	3.83
50	7.8	2.55
55	7.6	1.44
60	7.4	0.37
65	7.4	0.07
70	7.3	0.04
75	7.3	0.03
80	7.2	0.03

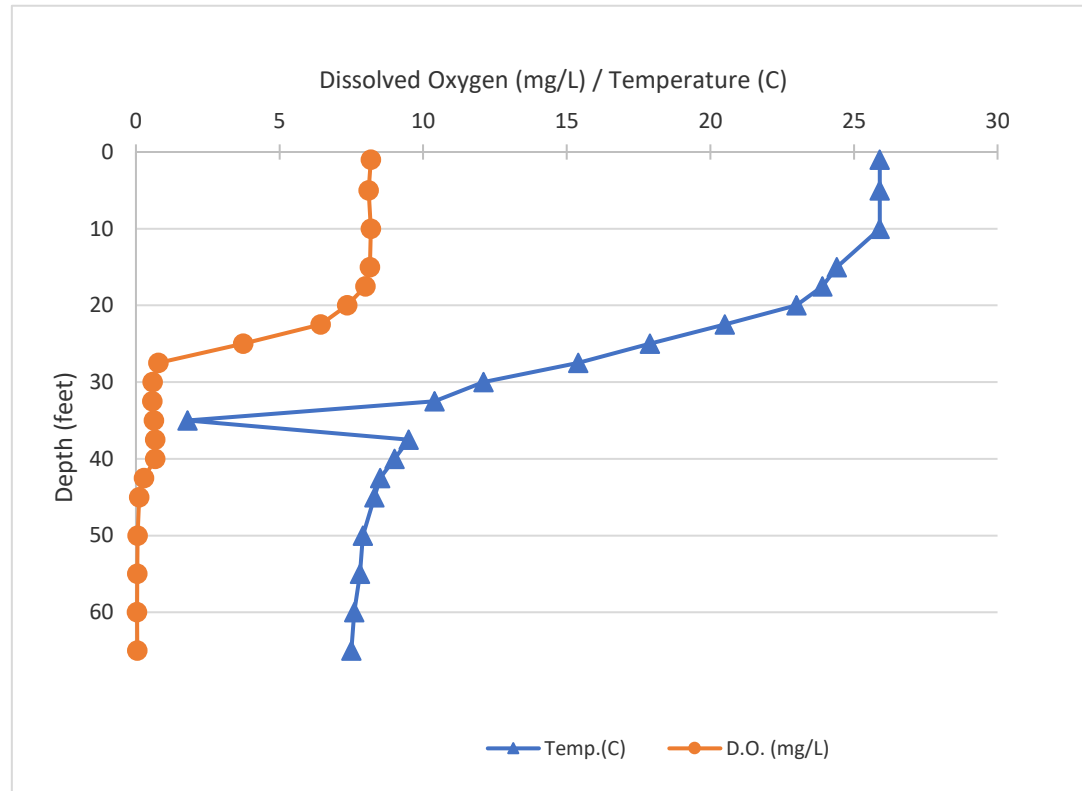
8/8/2019

Depth (ft)	Temp.(C)	D.O. (mg/L)
1	25.9	8.18
5	25.9	8.1
10	25.9	8.18
15	24.4	8.15
17.5	23.9	7.99
20	23	7.36
22.5	20.5	6.43
25	17.9	3.73
27.5	15.4	0.78
30	12.1	0.58
32.5	10.4	0.57
35	1.8	0.63
37.5	9.5	0.67
40	9	0.67
42.5	8.5	0.28
45	8.3	0.11
50	7.9	0.06
55	7.8	0.05
60	7.6	0.04
65	7.5	0.05

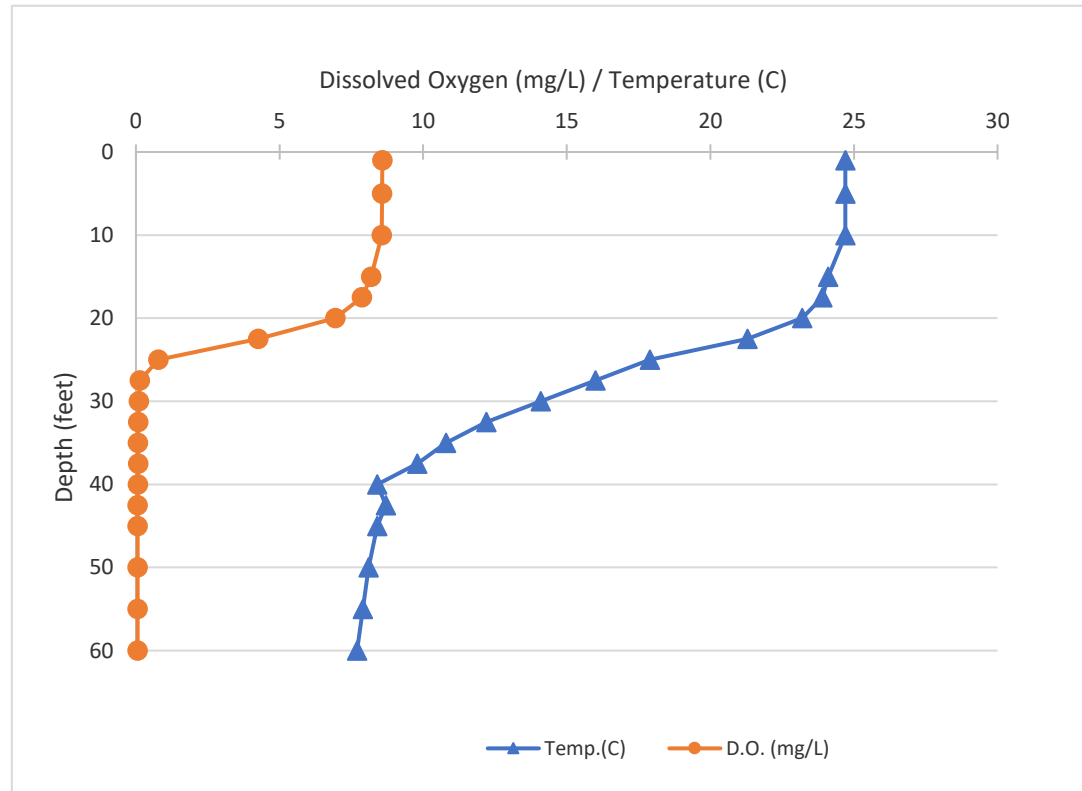
8/20/2019

Depth (ft)	Temp.(C)	D.O. (mg/L)
1	24.7	8.58
5	24.7	8.57
10	24.7	8.56
15	24.1	8.19
17.5	23.9	7.87
20	23.2	6.94
22.5	21.3	4.26
25	17.9	0.78
27.5	16	0.14
30	14.1	0.1
32.5	12.2	0.08
35	10.8	0.07
37.5	9.8	0.08
40	8.4	0.07
42.5	8.7	0.06
45	8.4	0.06
50	8.1	0.06
55	7.9	0.06
60	7.7	0.06

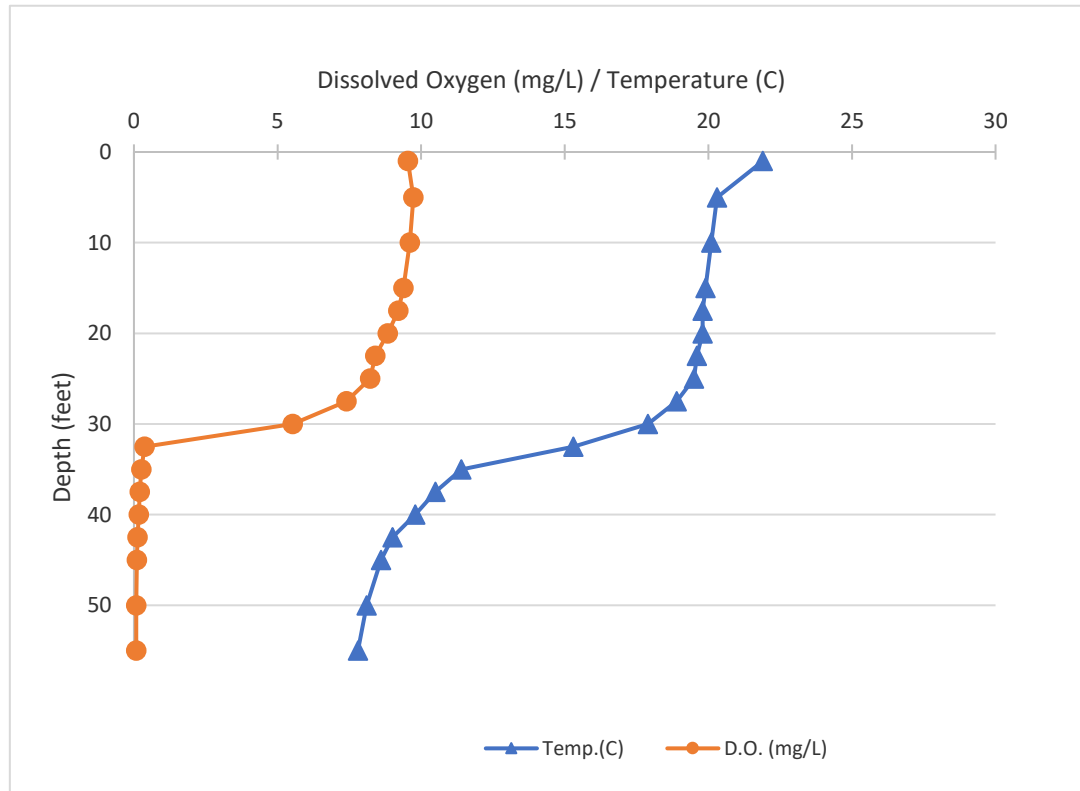
9/16/2019

Depth (ft)	Temp.(C)	D.O. (mg/L)
1	21.9	9.54
5	20.3	9.73
10	20.1	9.61
15	19.9	9.38
17.5	19.8	9.2
20	19.8	8.84
22.5	19.6	8.4
25	19.5	8.22
27.5	18.9	7.4
30	17.9	5.53
32.5	15.3	0.37
35	11.4	0.26
37.5	10.5	0.2
40	9.8	0.17
42.5	9	0.12
45	8.6	0.1
50	8.1	0.08
55	7.8	0.08
