2021 Data Report for

Lower Hamlin Lake, Mason County

Site ID: 530073

Lower Hamlin Lake, Mason County 2021 CLMP Results

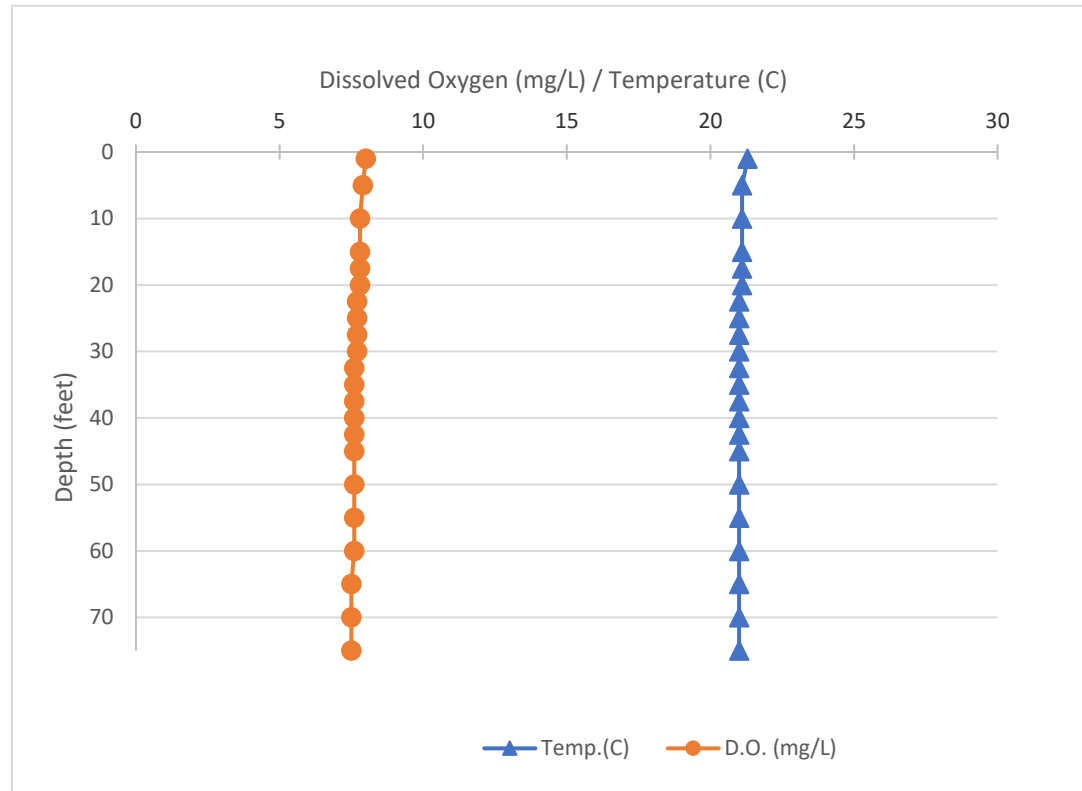
9/16/2021

Dissolved Oxygen and Temperature Profile

Depth (ft)	Temp.(C)	D.O. (mg/L)
1	21.3	8
5	21.1	7.9
10	21.1	7.8
15	21.1	7.8
17.5	21.1	7.8
20	21.1	7.8
22.5	21	7.7
25	21	7.7
27.5	21	7.7
30	21	7.7
32.5	21	7.6
35	21	7.6
37.5	21	7.6
40	21	7.6
42.5	21	7.6
45	21	7.6
50	21	7.6
55	21	7.6
60	21	7.6
65	21	7.5
70	21	7.5
75	21	7.5
