2021 Data Report for Kimball Lake, Newaygo County

Site ID: 620276

Kimball Lake, Newaygo County 2021 CLMP Results

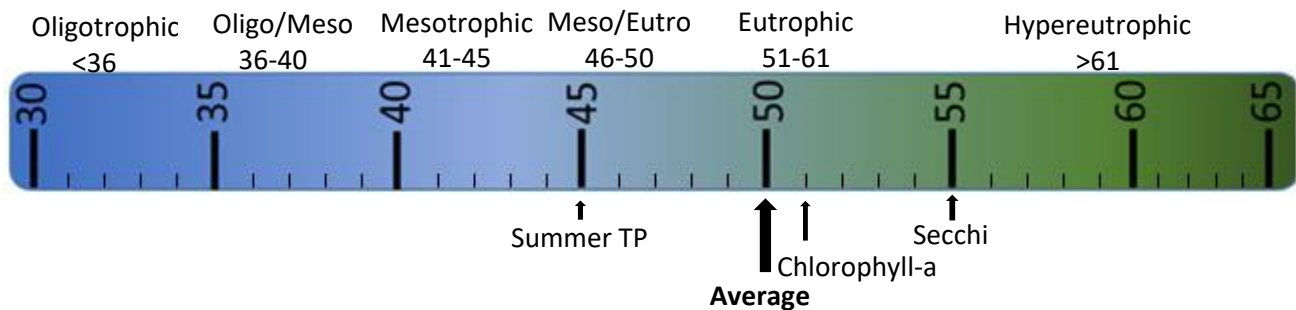
TSI for Kimball Lake in 2021	
Average	50
Secchi Disk	55
Summer TP	45
Chlorophyll-a	51

Oligotrophic: Generally deep and clear lakes with little aquatic plant or algae growth. These lakes maintain sufficient dissolved oxygen in the cool, deep-bottom waters during late summer to support cold water fish, such as trout and whitefish.

Mesotrophic: Lakes that fall between oligotrophic and eutrophic. Mid-ranged amounts of nutrients.

Eutrophic: Highly productive eutrophic lakes are generally shallow, turbid, and support abundant aquatic plant growth. In deep eutrophic lakes, the cool bottom waters usually contain little or no dissolved oxygen. Therefore, these lakes can only support warm water fish, such as bass and pike.

Hypereutrophic: A specialized category of eutrophic lakes. These lakes exhibit extremely high productivity, such as nuisance algae and weed growth.

With a TSI score of 50 based on 2021 Secchi disk transparency, this lake is rated between the mesotrophic and eutrophic lake classification. The lake leans slightly more eutrotrophic than mesotrophic.

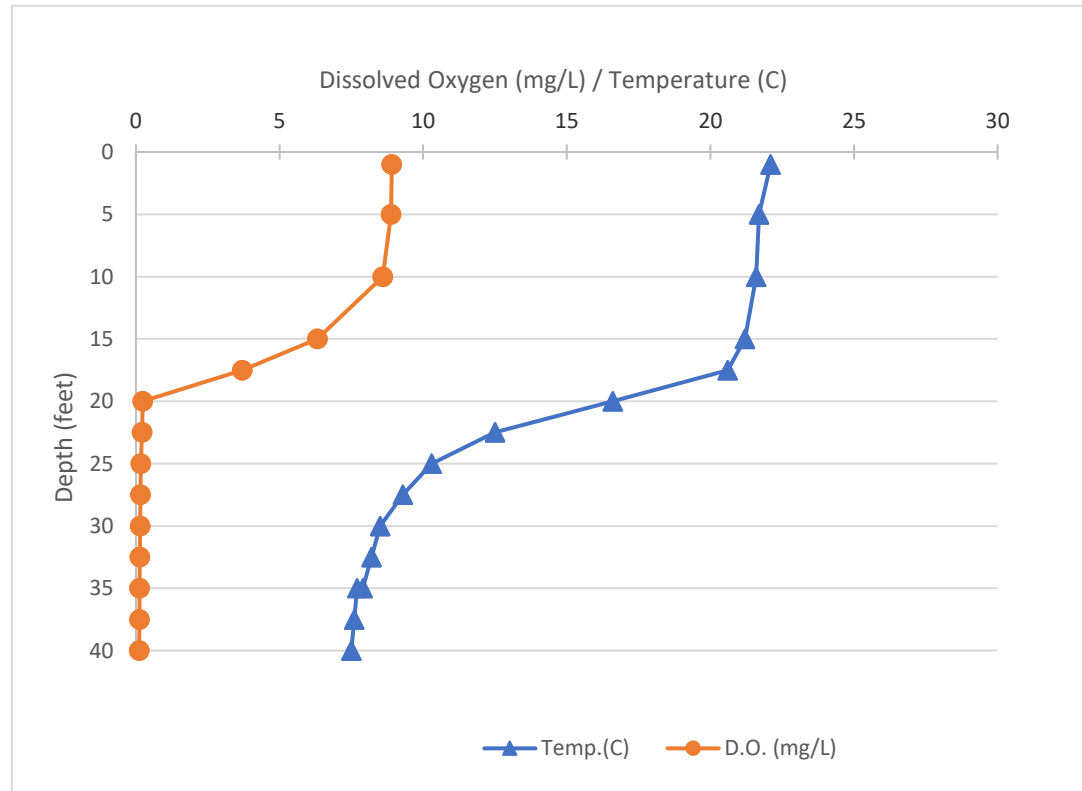
9/18/2021

Dissolved Oxygen and Temperature Profile

Depth (ft)	Temp.(C)	D.O. (mg/L)
1	22.1	8.91
1	22.1	8.91
5	21.7	8.88
5	21.7	8.88
10	21.6	8.59
10	21.6	8.59
15	21.2	6.32
15	21.2	6.32
17.5	20.6	3.7
17.5	20.6	3.7
20	16.6	0.24
20	16.6	0.24
22.5	12.5	0.21
22.5	12.5	0.21
25	10.3	0.17
25	10.3	0.17
27.5	9.3	0.16
27.5	9.3	0.16
30	8.5	0.15
30	8.5	0.15
32.5	8.2	0.14
32.5	8.2	0.14
35	7.9	0.12
35	7.7	0.12
37.5	7.6	0.12
37.5	7.6	0.12
40	7.5	0.11
40	7.5	0.11
