**2021 Data Report
for
North Lake Leelanau, Leelanau
County**

Site ID: 450236

North Lake Leelanau, Leelanau County 2021 CLMP Results

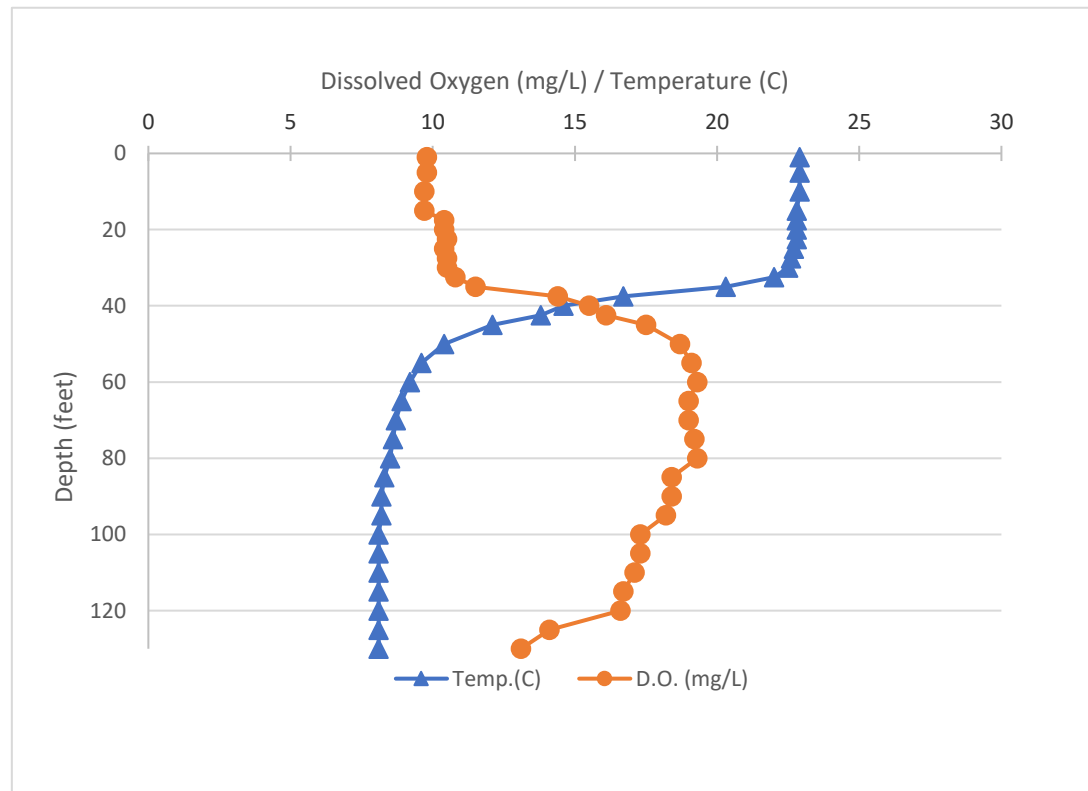
8/4/2021

Dissolved Oxygen and Temperature Profile
